# 2014 Oso Slide

The last 45,000 Years:

*Our*  
Observations and Current Thoughts  
On The

Geology and Failure Development/Causes

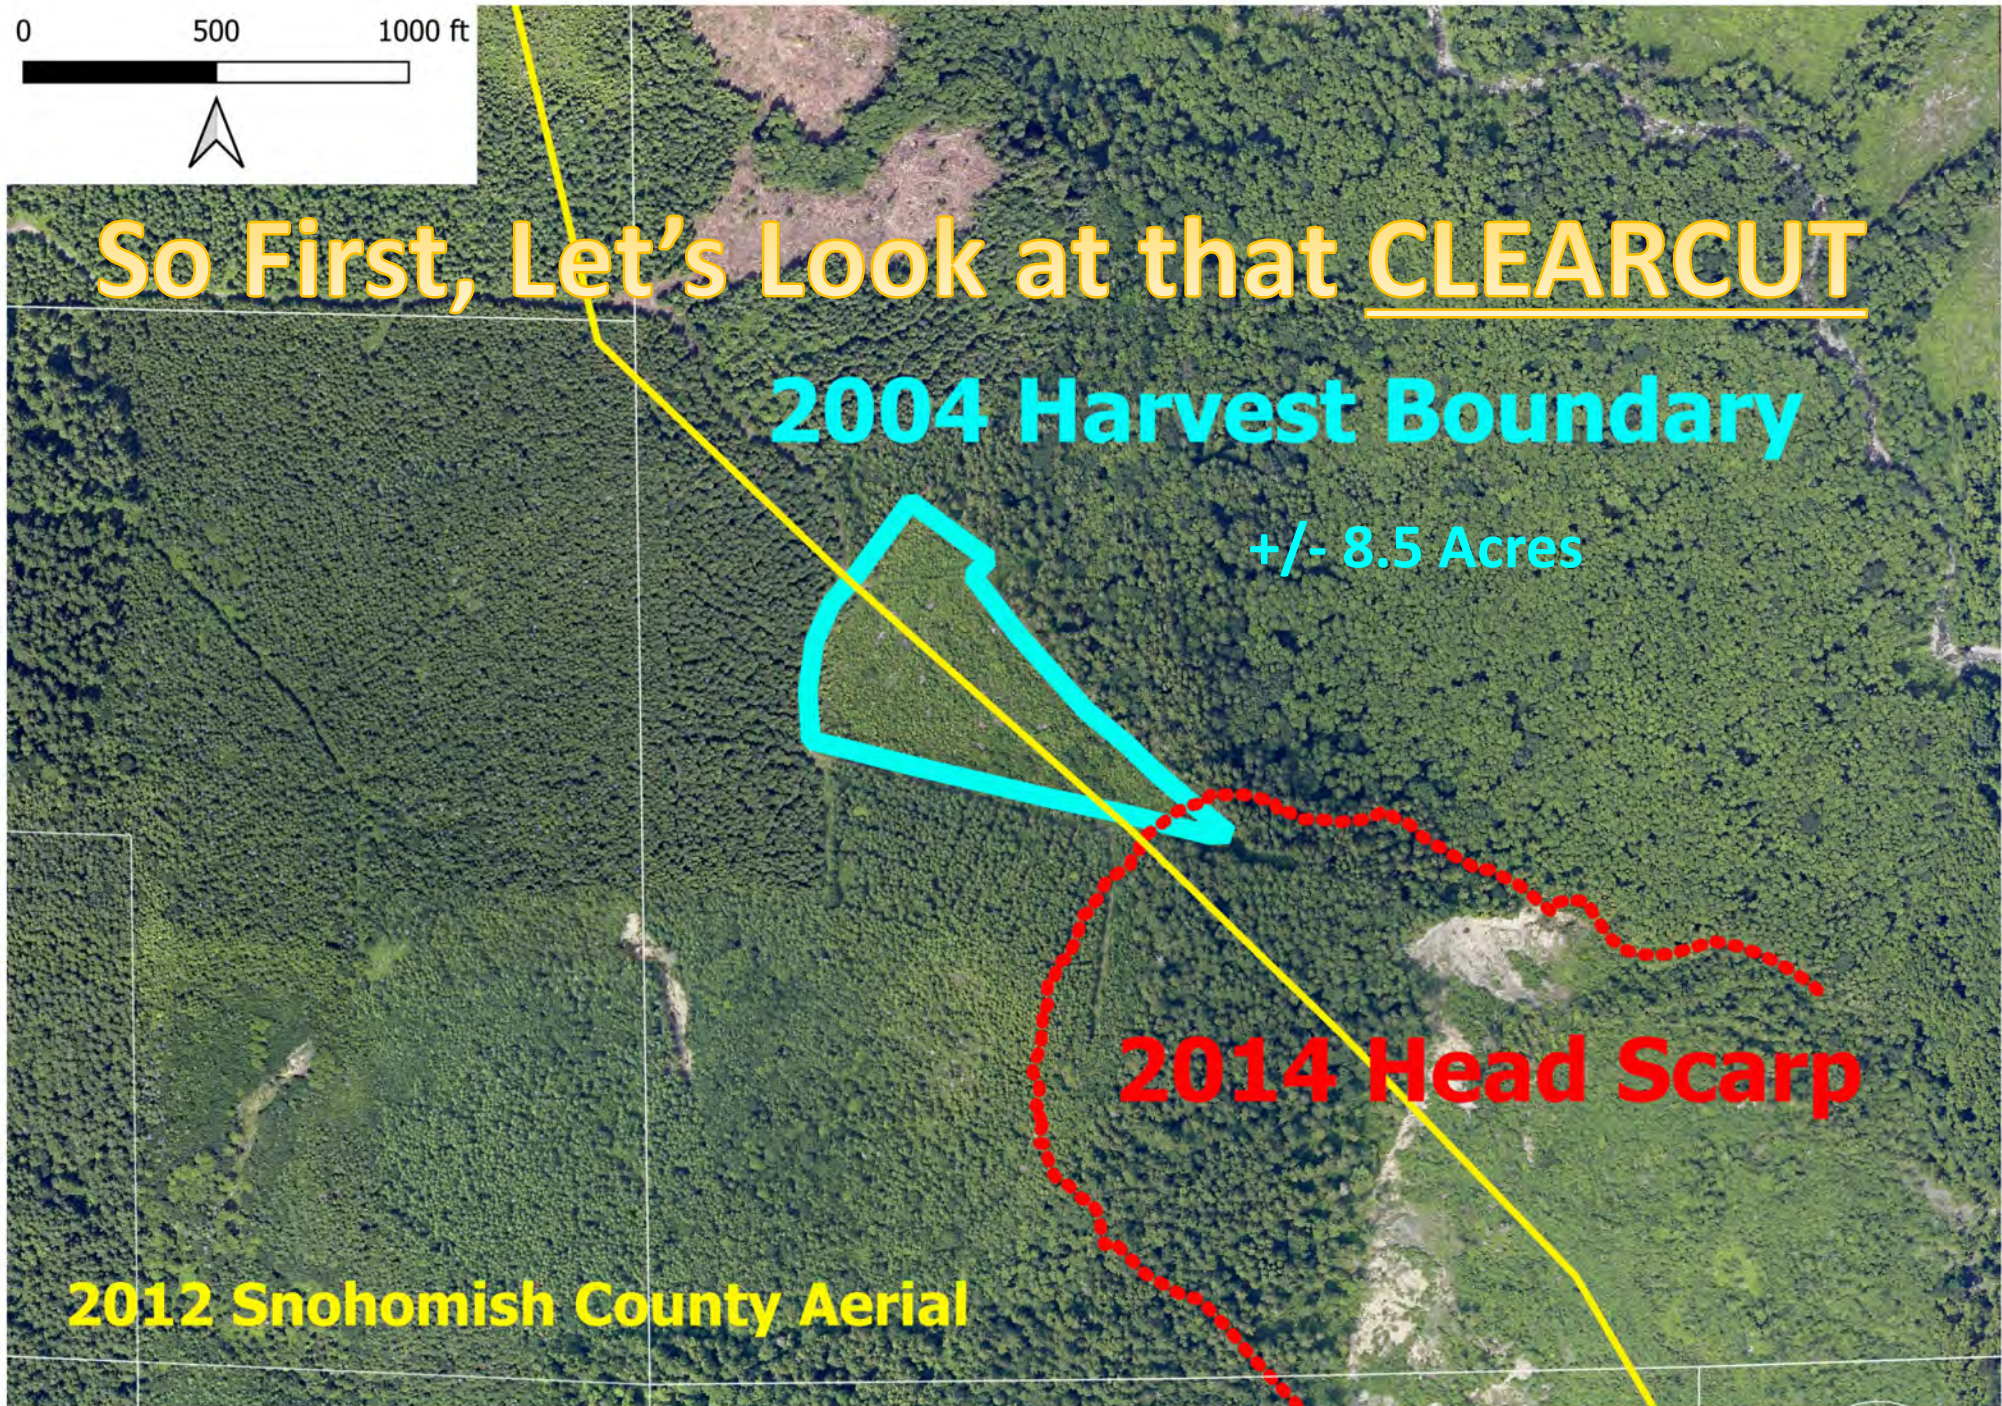
**2012 Snohomish County Aerial**

**2004 Harvest Boundary**

**+/- 8.5 Acres**

**2014 Head Scarp**

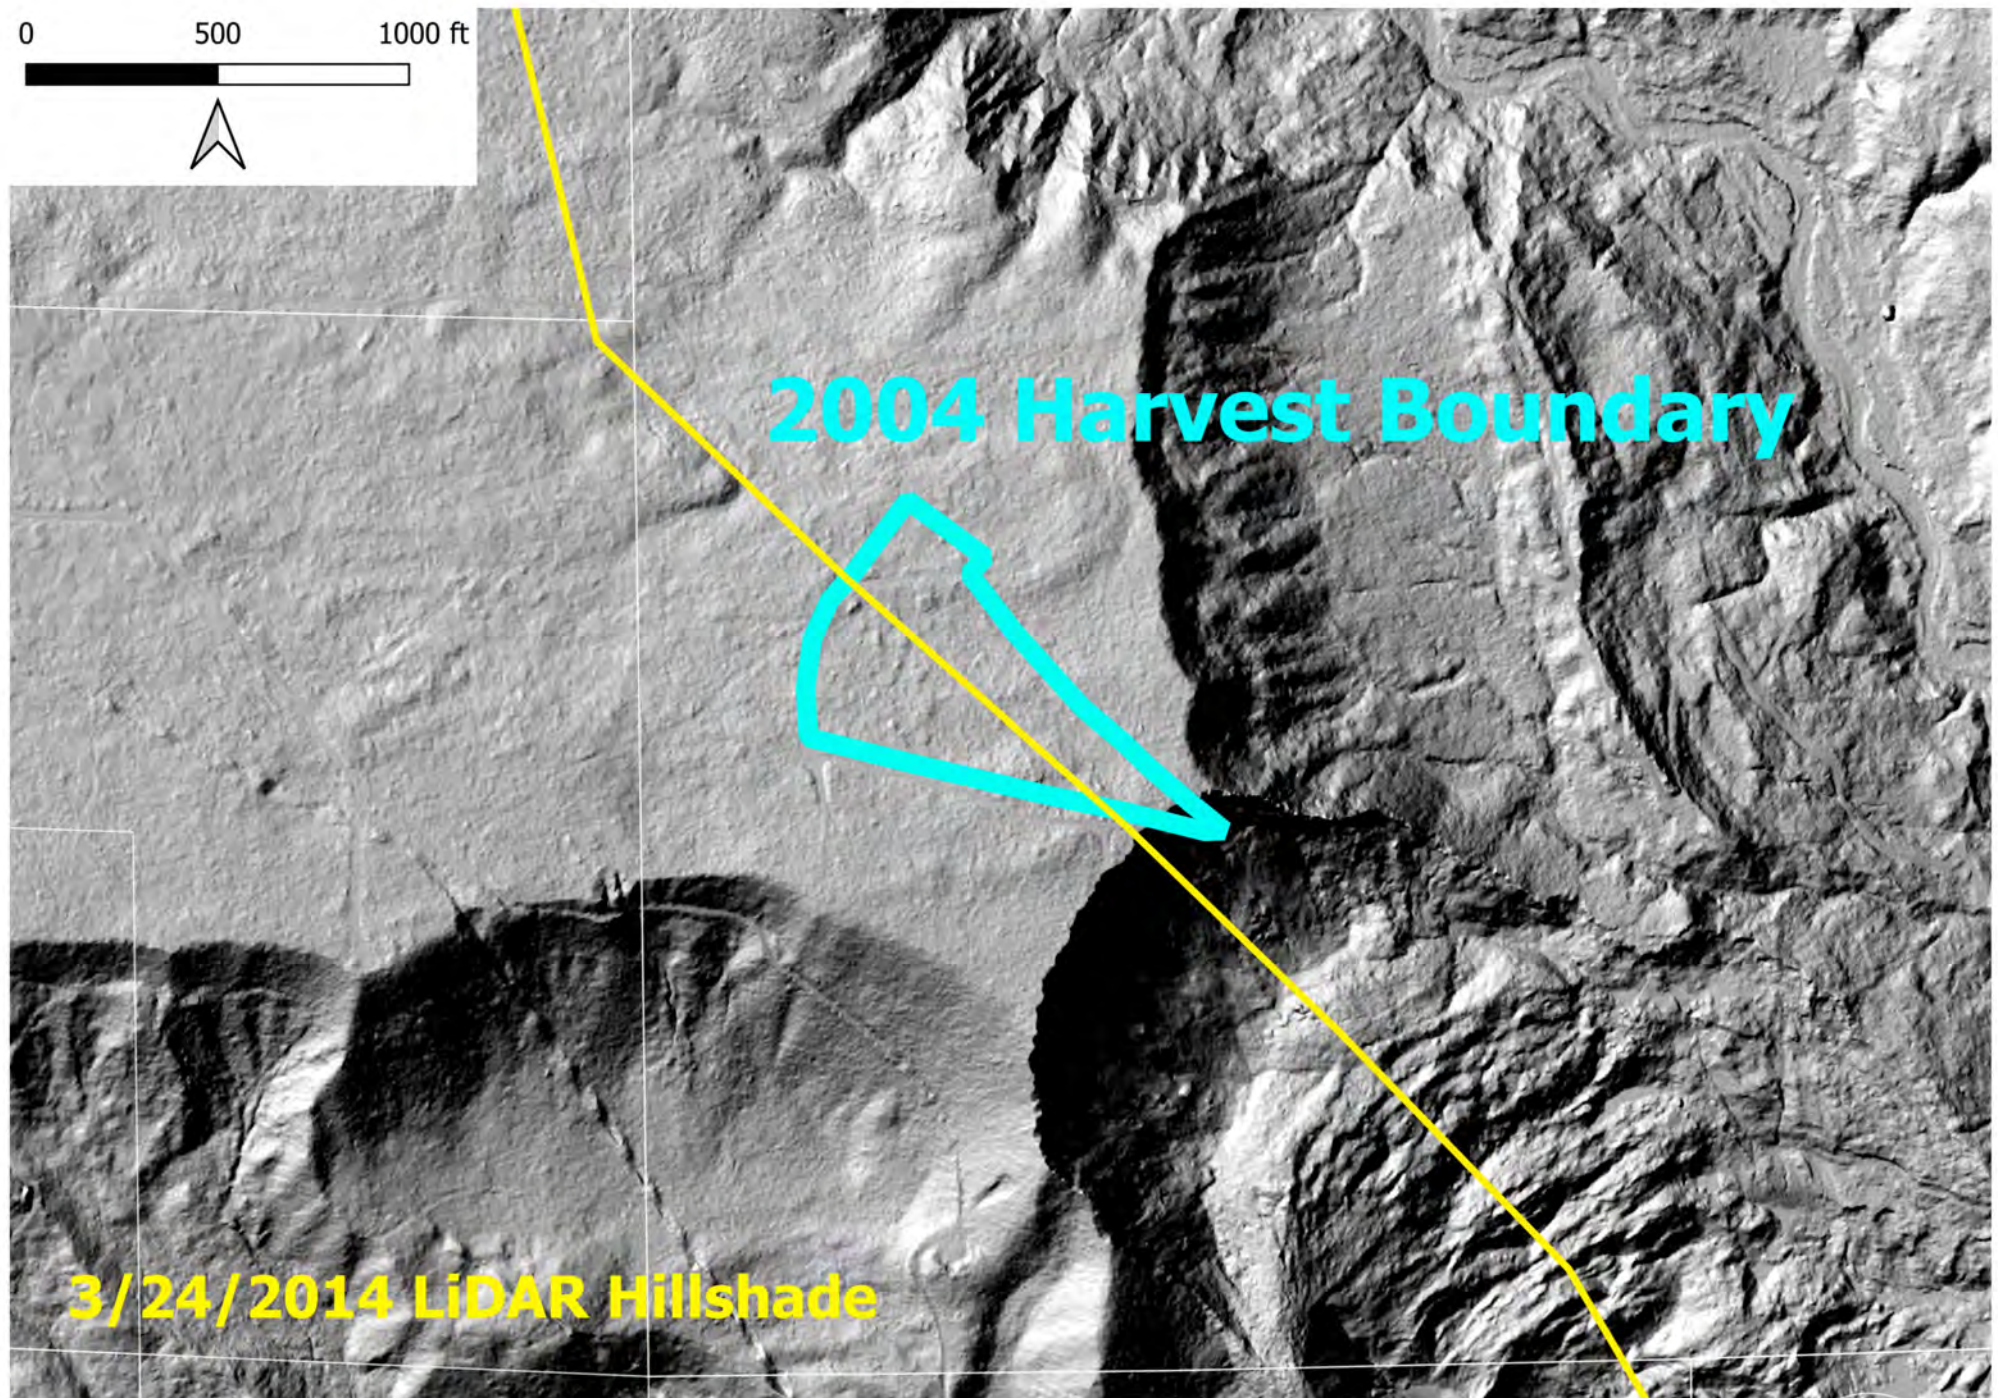
**3/24/2014 LiDAR Hillshade**

**2004 Harvest Boundary**

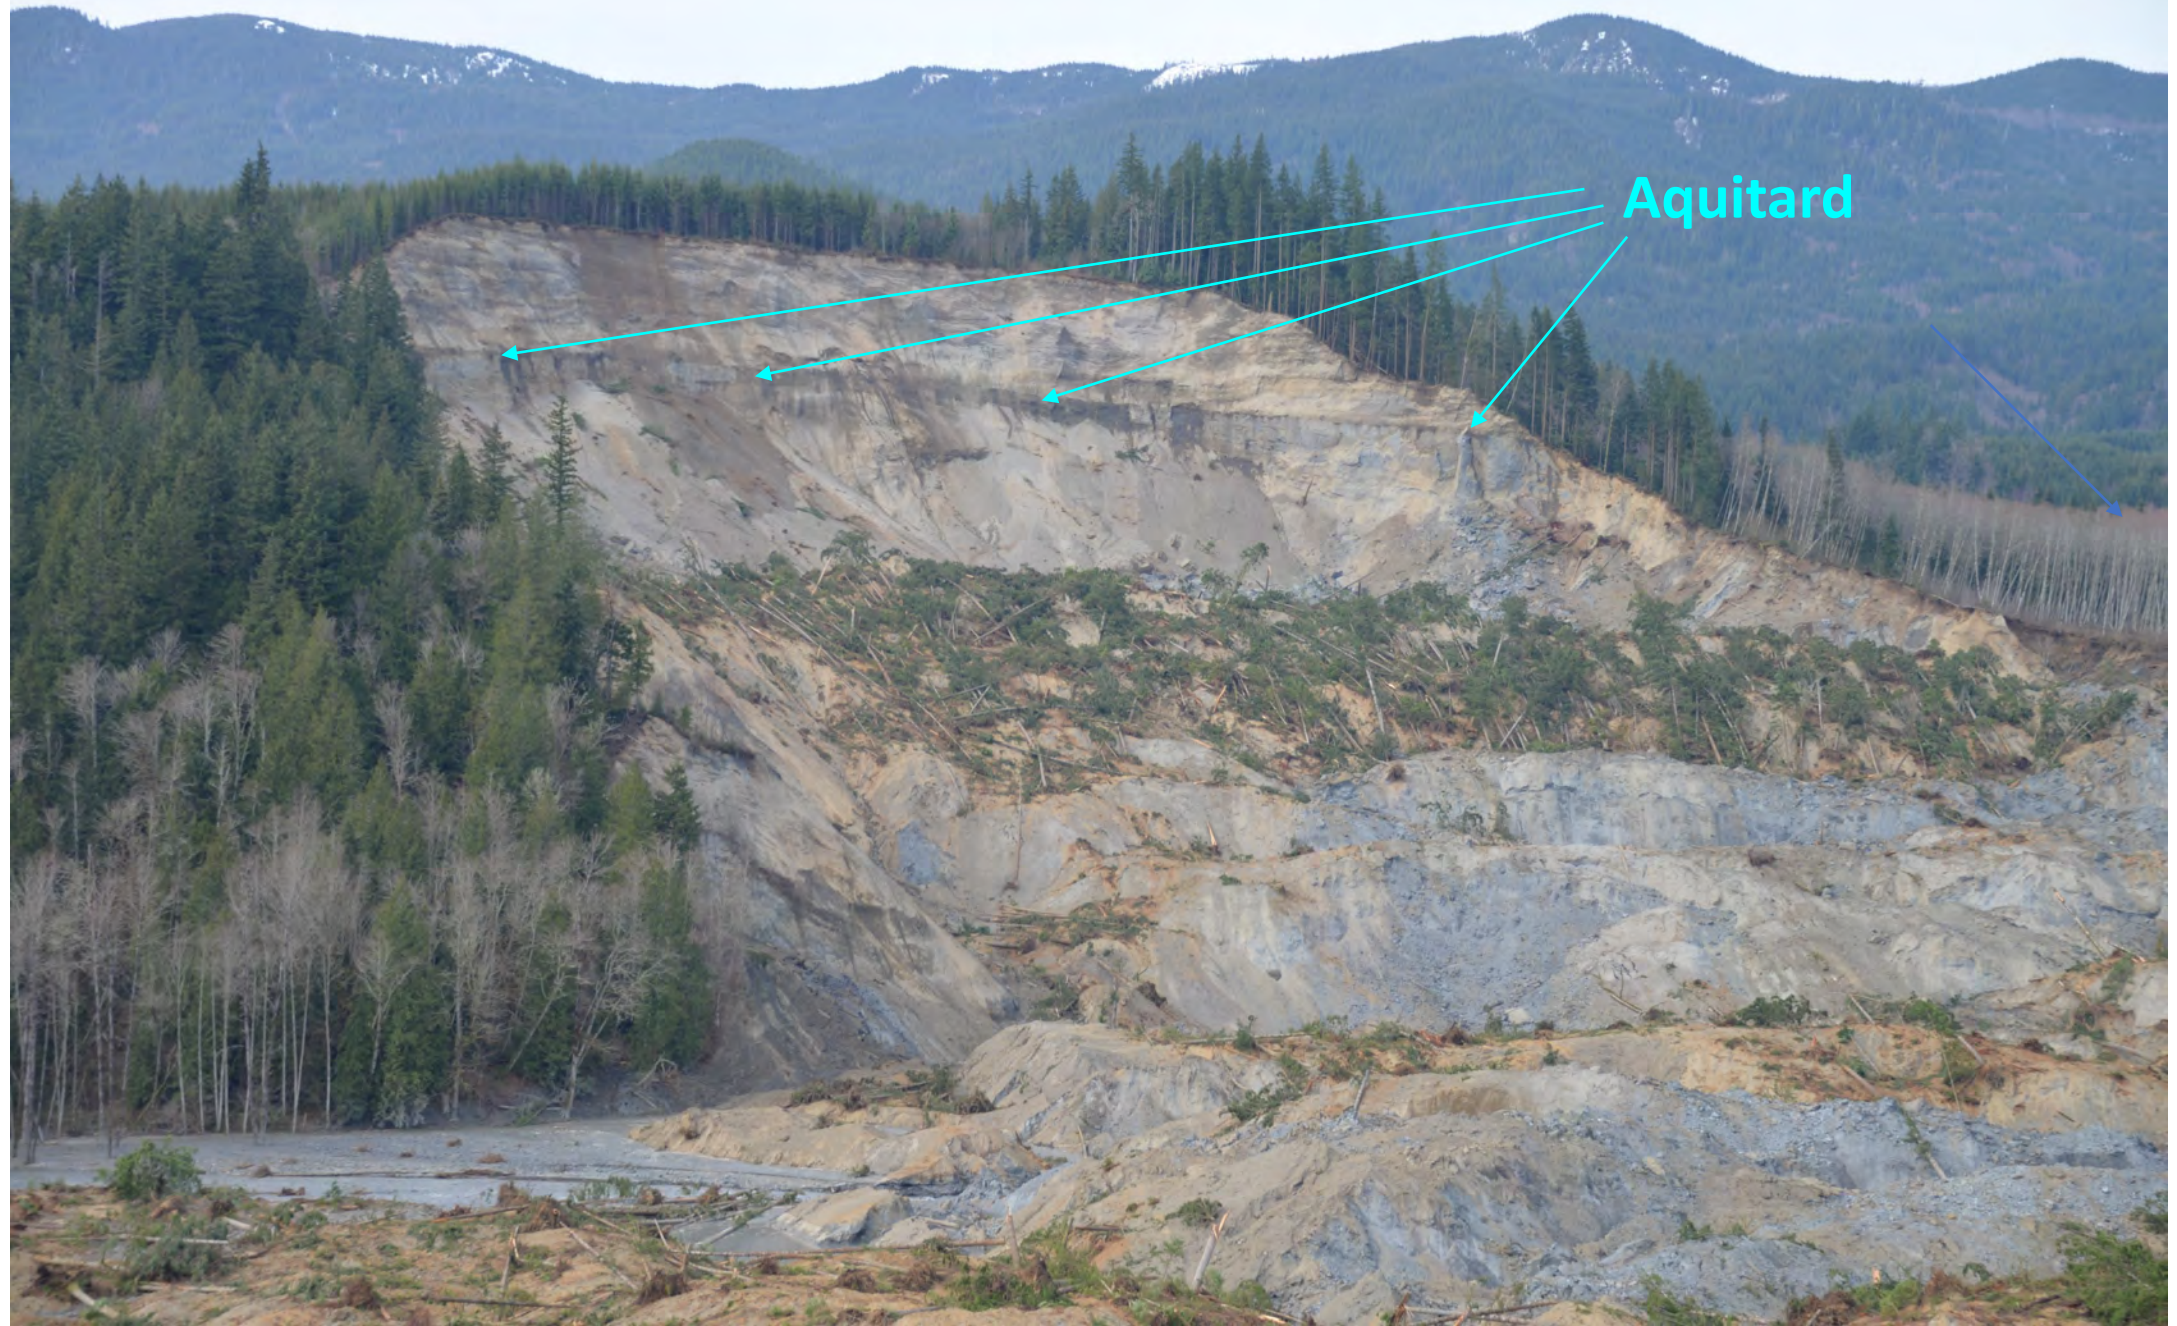
Photo 3-24-14, Courtesy King County Sheriff

**Aquitard**

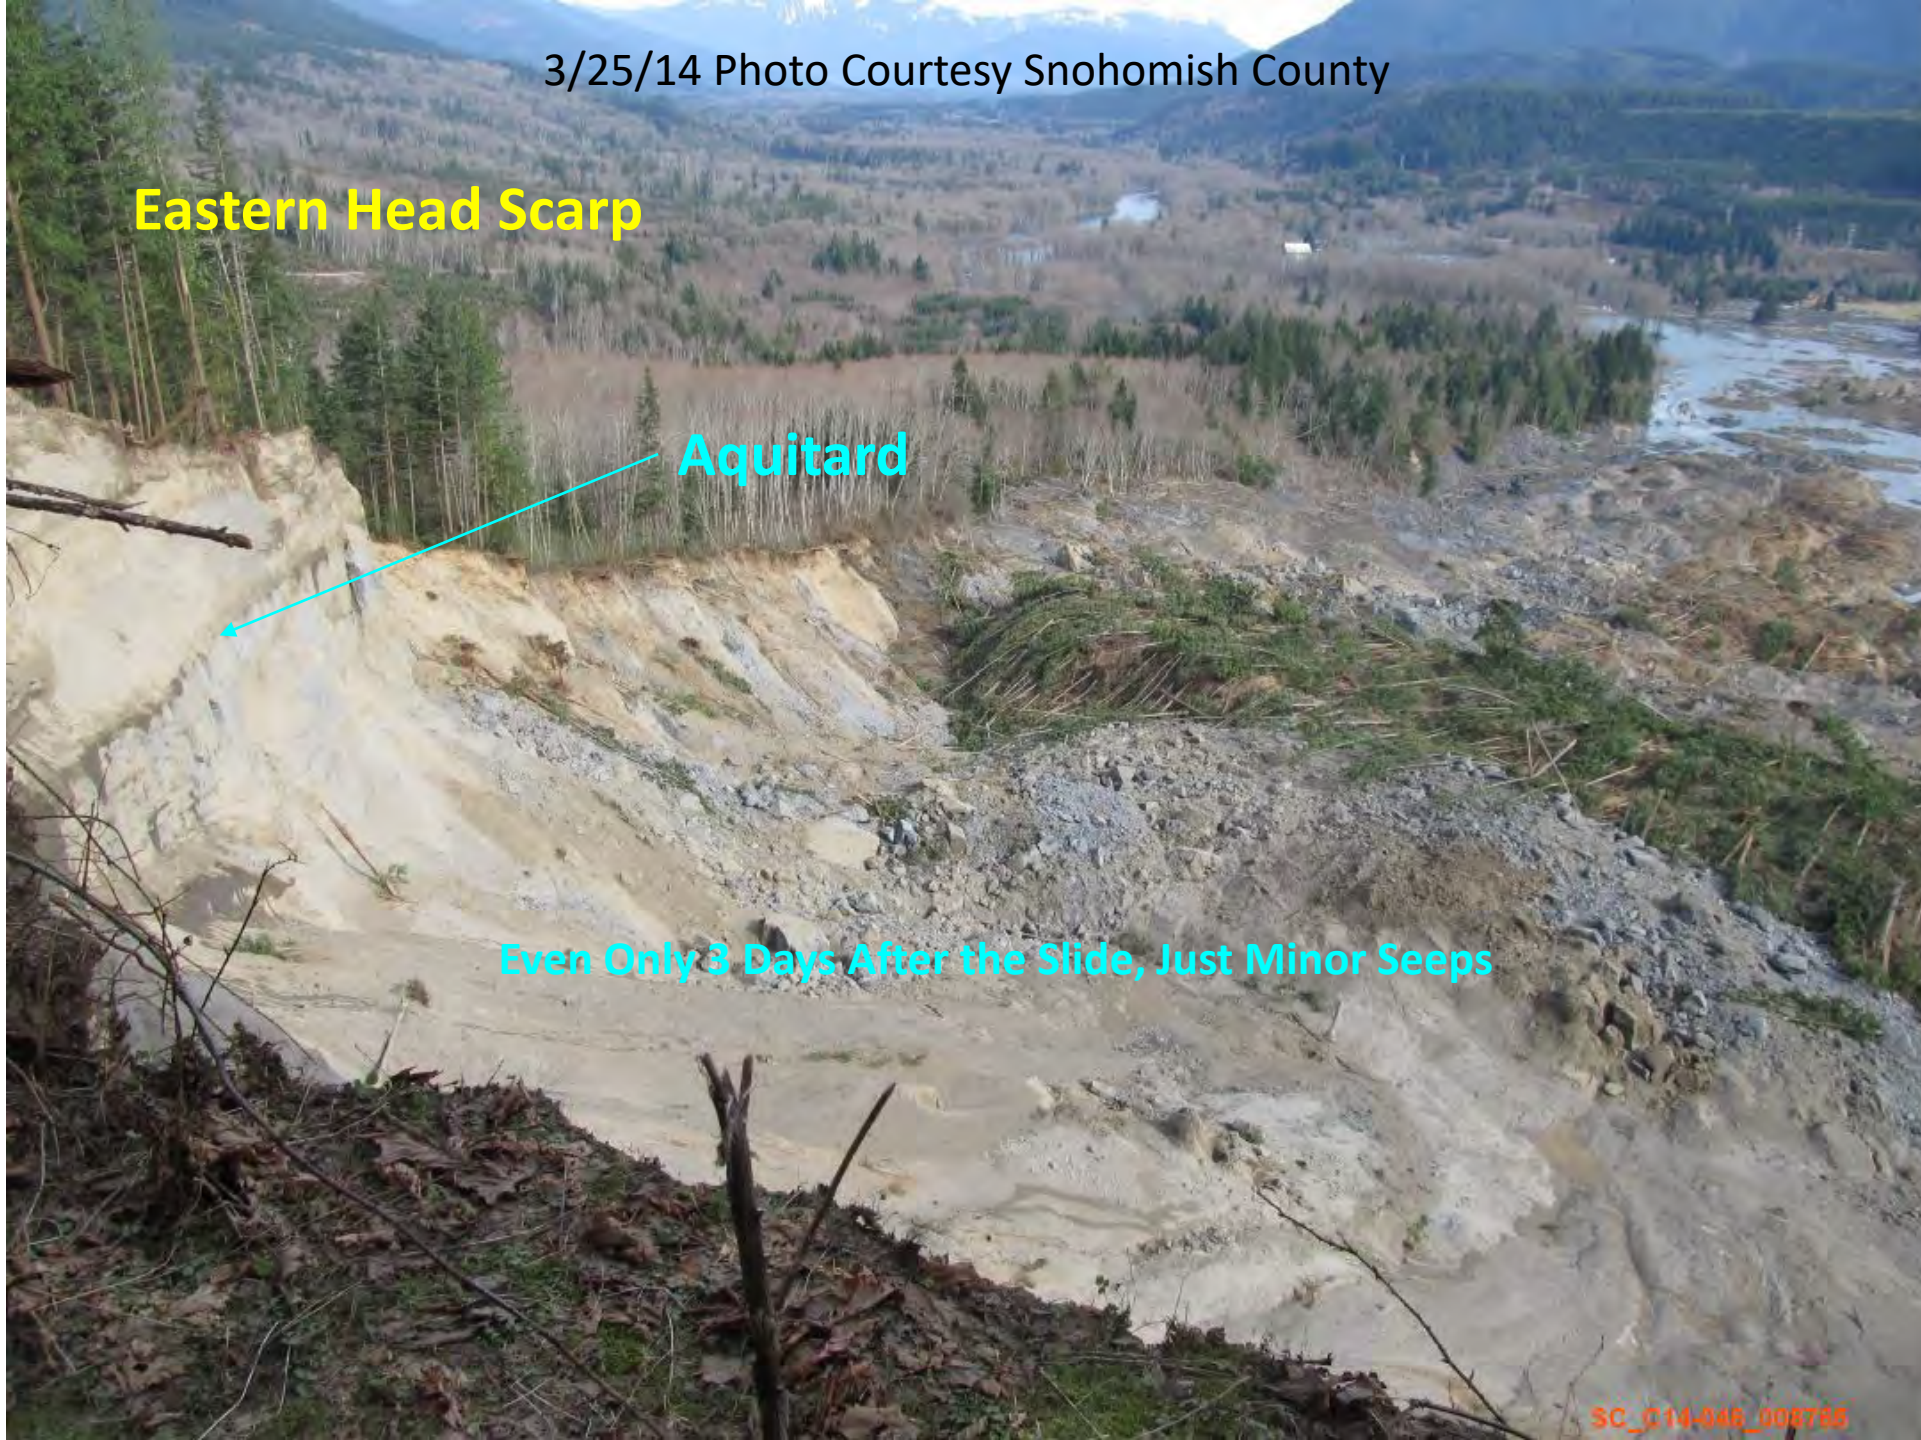
3/25/14 Photo Courtesy Snohomish County

**Eastern Head Scarp**

**Aquitard**

**Even Only 3 Days After the Slide, Just Minor Seeps**

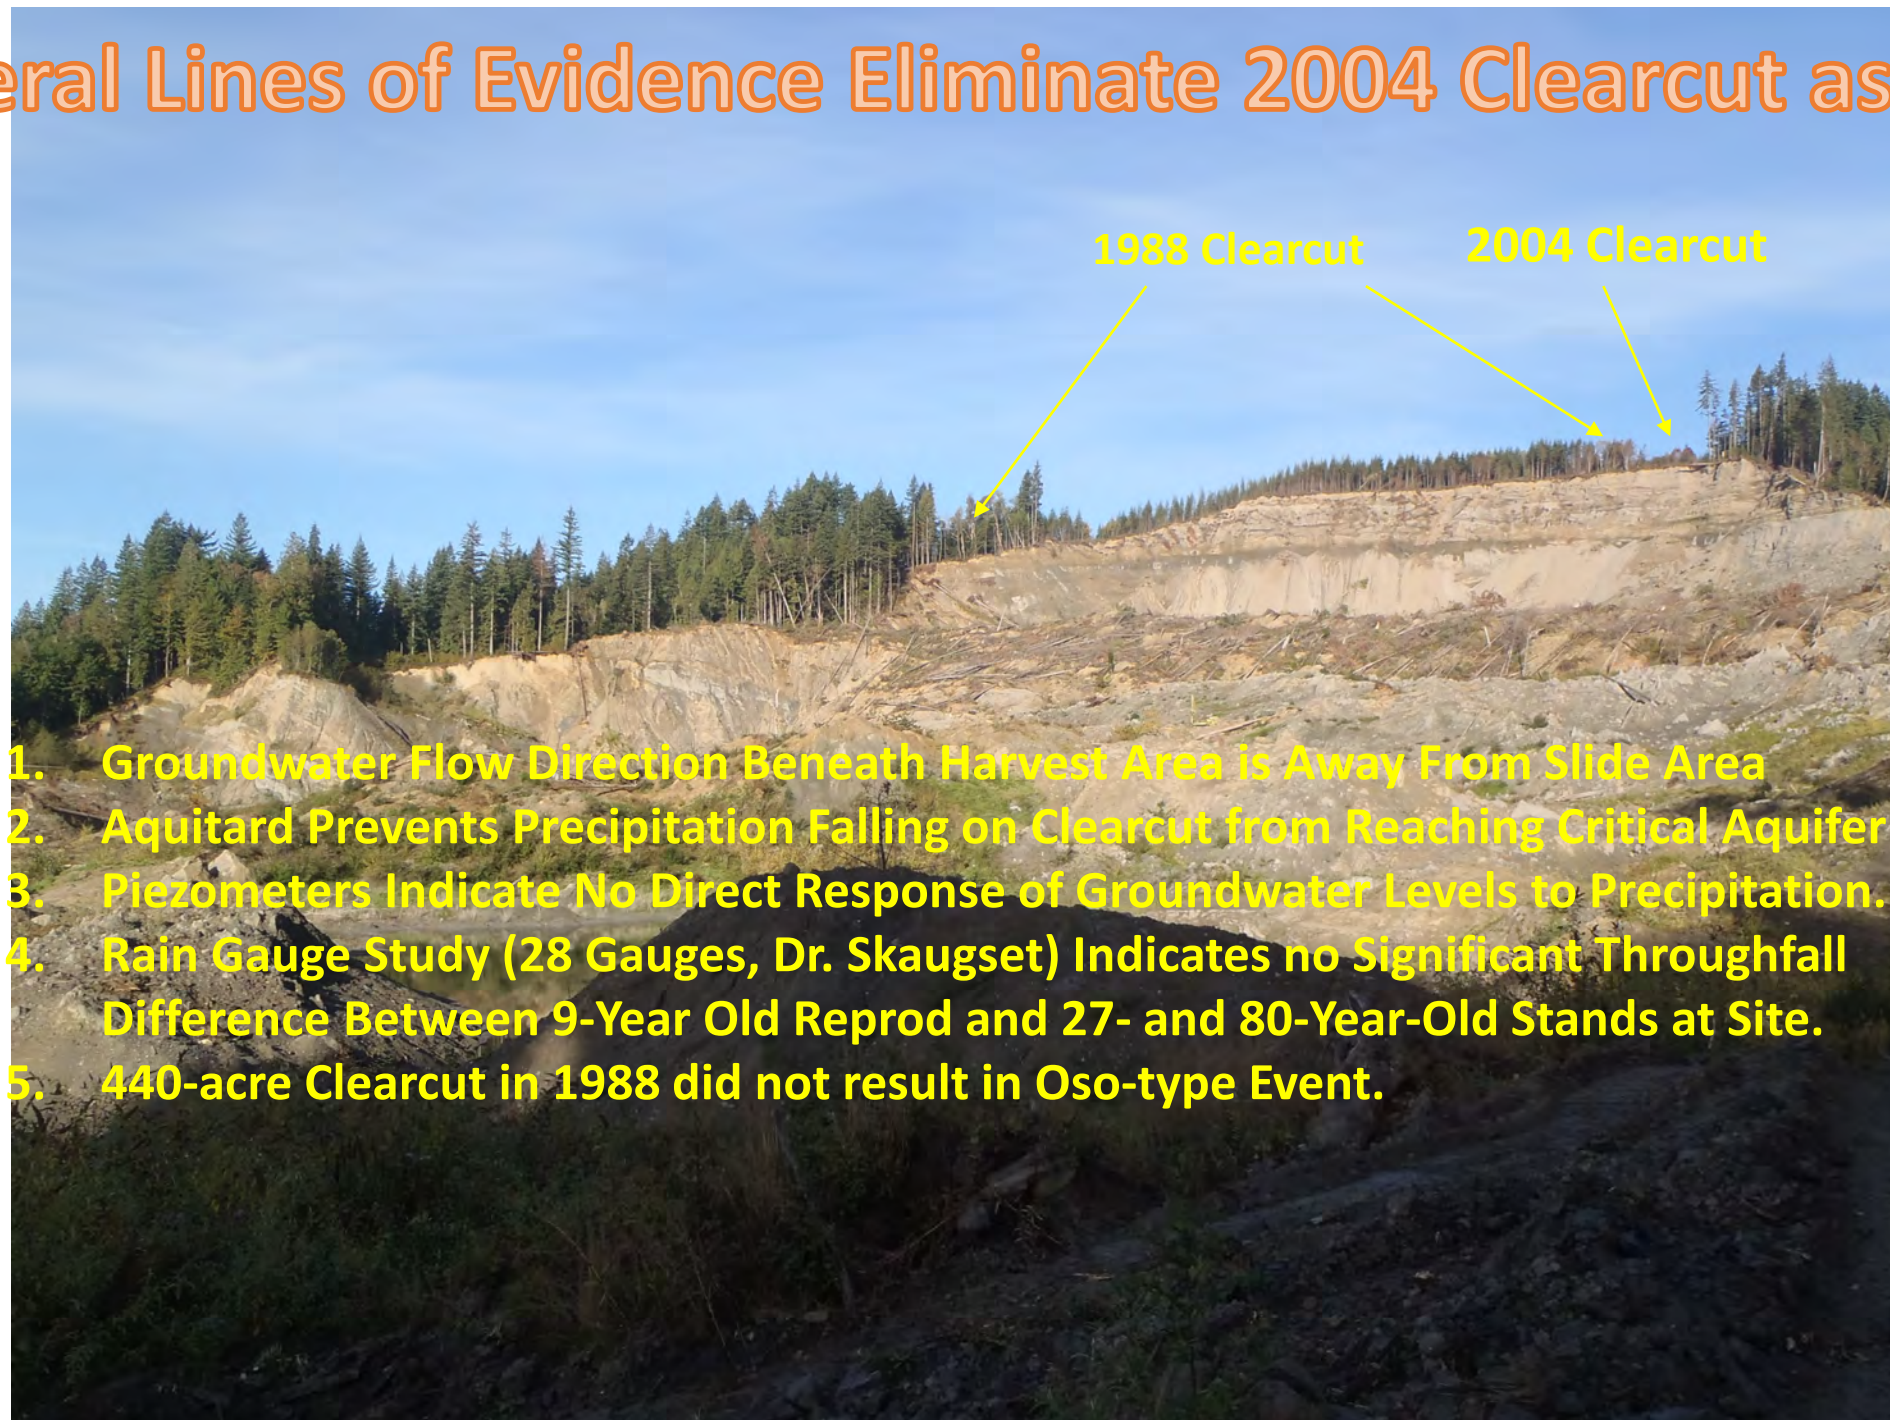
# Several Lines of Evidence Eliminate 2004 Clearcut as Cause

1. Groundwater Flow Direction Beneath Harvest Area is Away From Slide Area
2. Aquitard Prevents Precipitation Falling on Clearcut from Reaching Critical Aquifer
3. Piezometers Indicate No Direct Response of Groundwater Levels to Precipitation.
4. Rain Gauge Study (28 Gauges, Dr. Skaugset) Indicates no Significant Throughfall Difference Between 9-Year Old Reprod and 27- and 80-Year-Old Stands at Site.
5. 440-acre Clearcut in 1988 did not result in Oso-type Event.

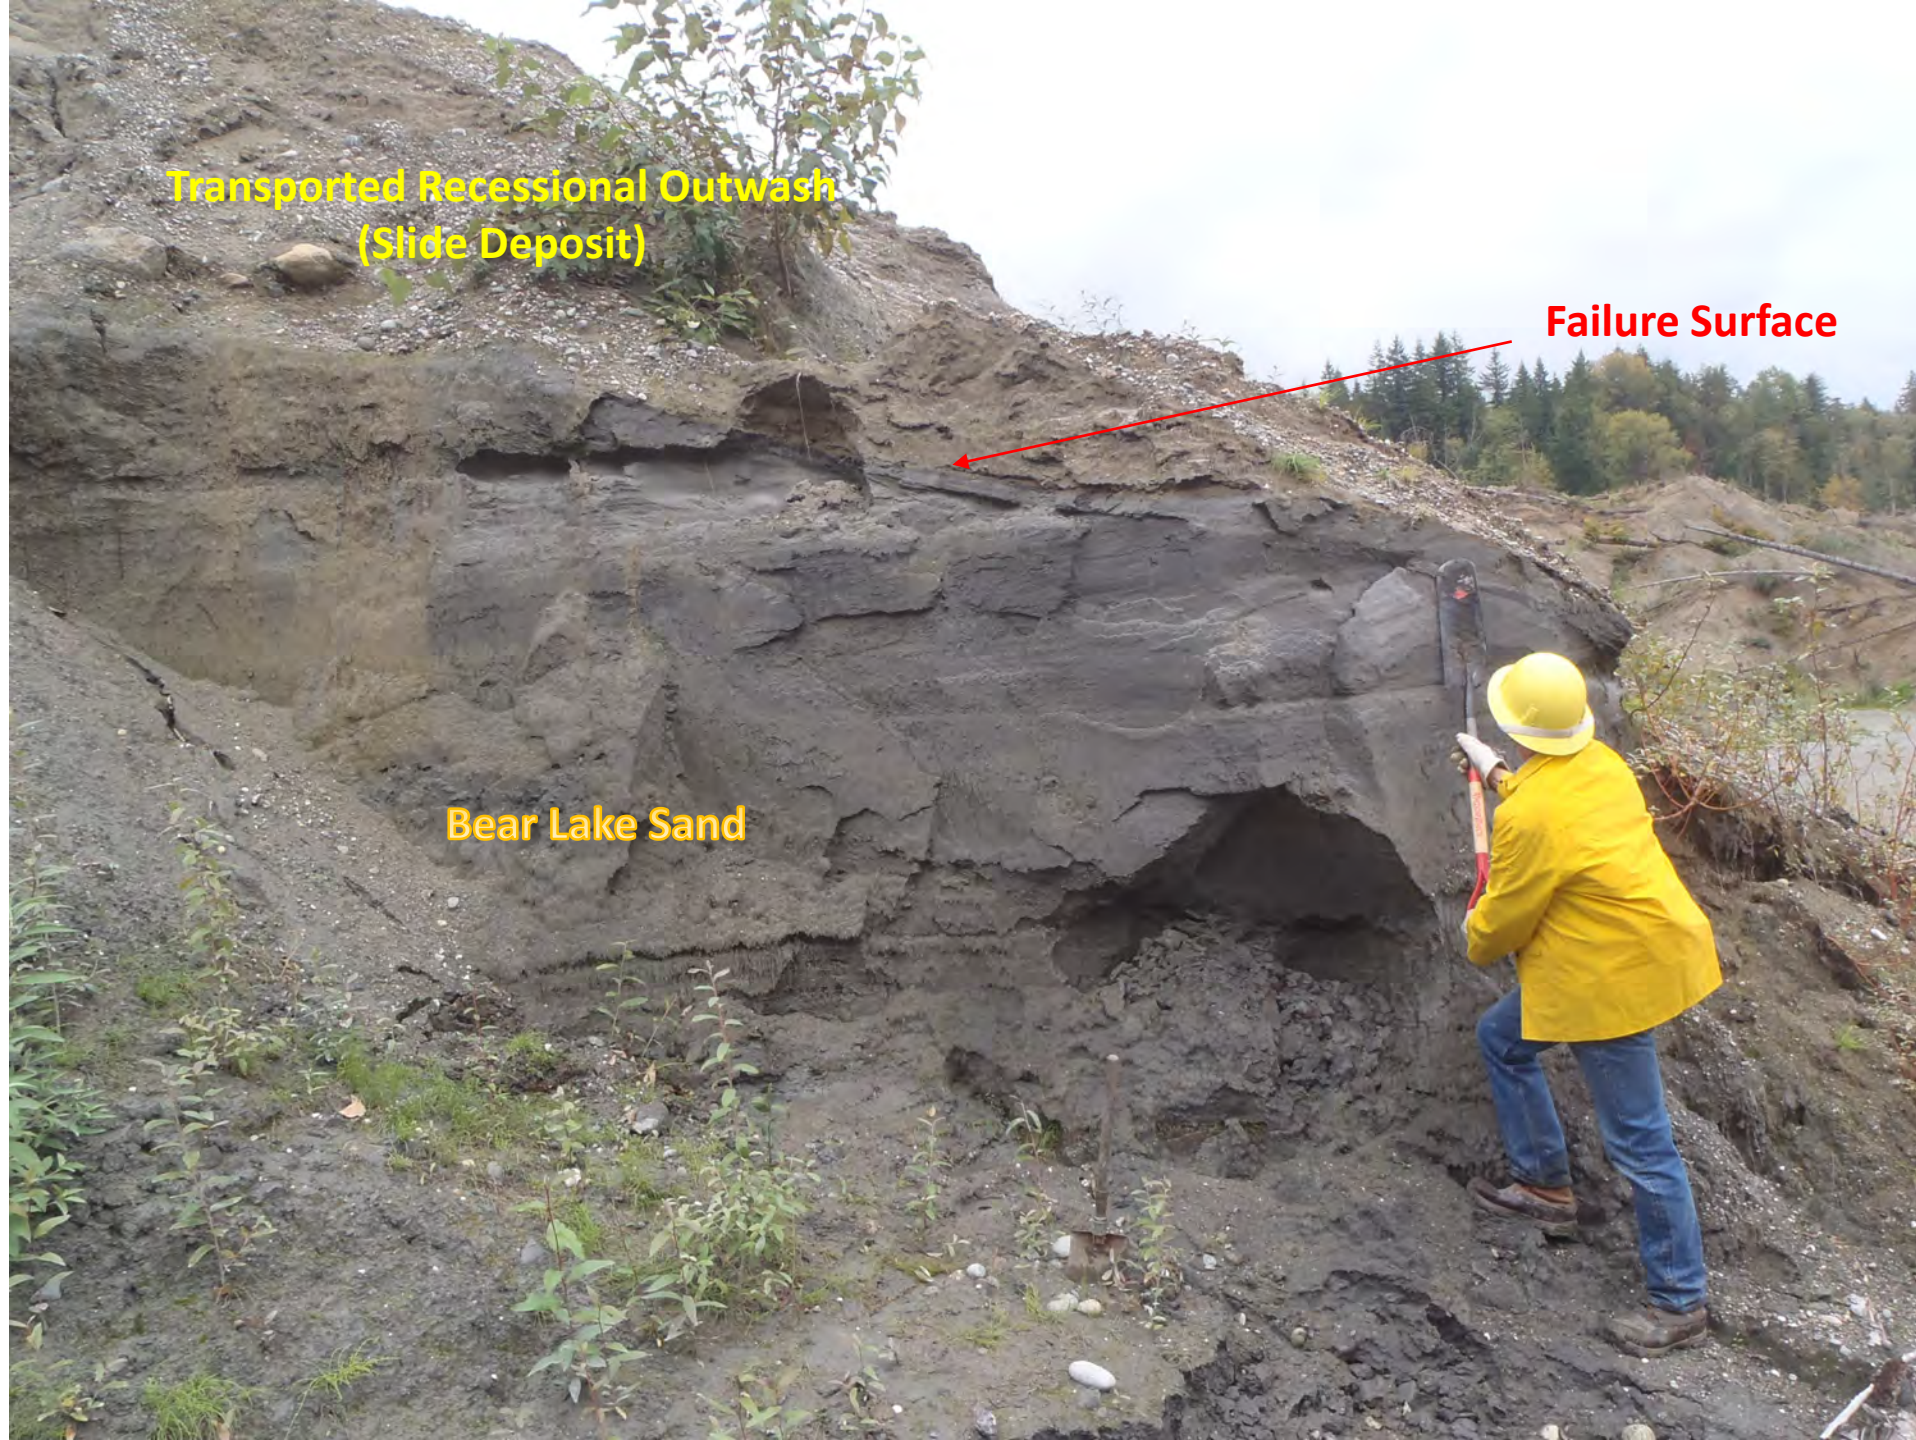
**Transported Recessional Outwash  
(Slide Deposit)**

**Failure Surface**

**Bear Lake Sand**

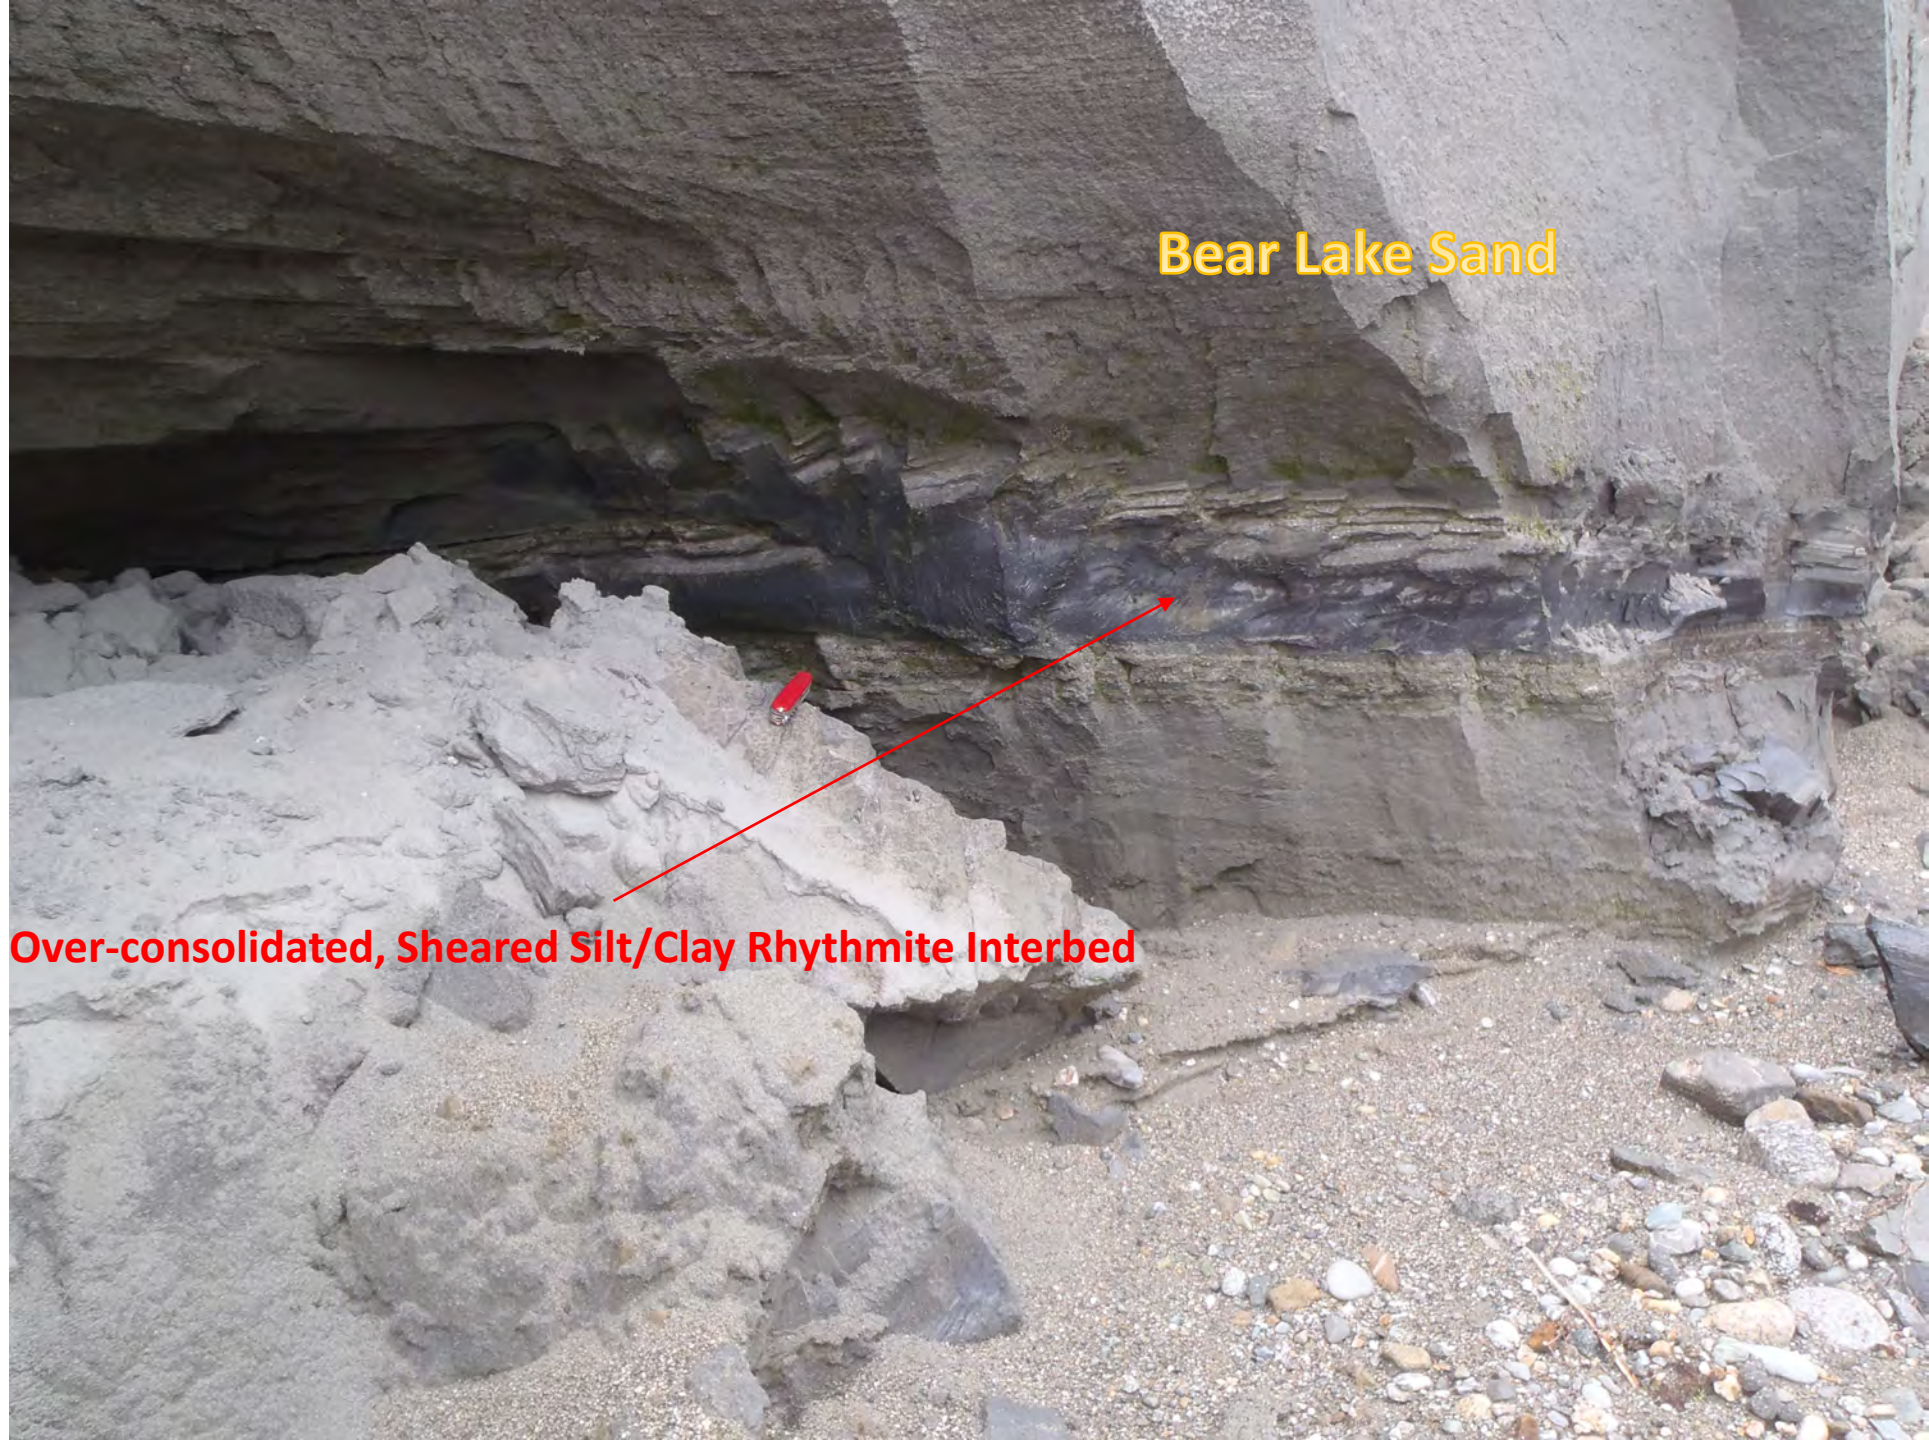
**Bear Lake Sand**

**Over-consolidated, Sheared Silt/Clay Rhythmite Interbed**

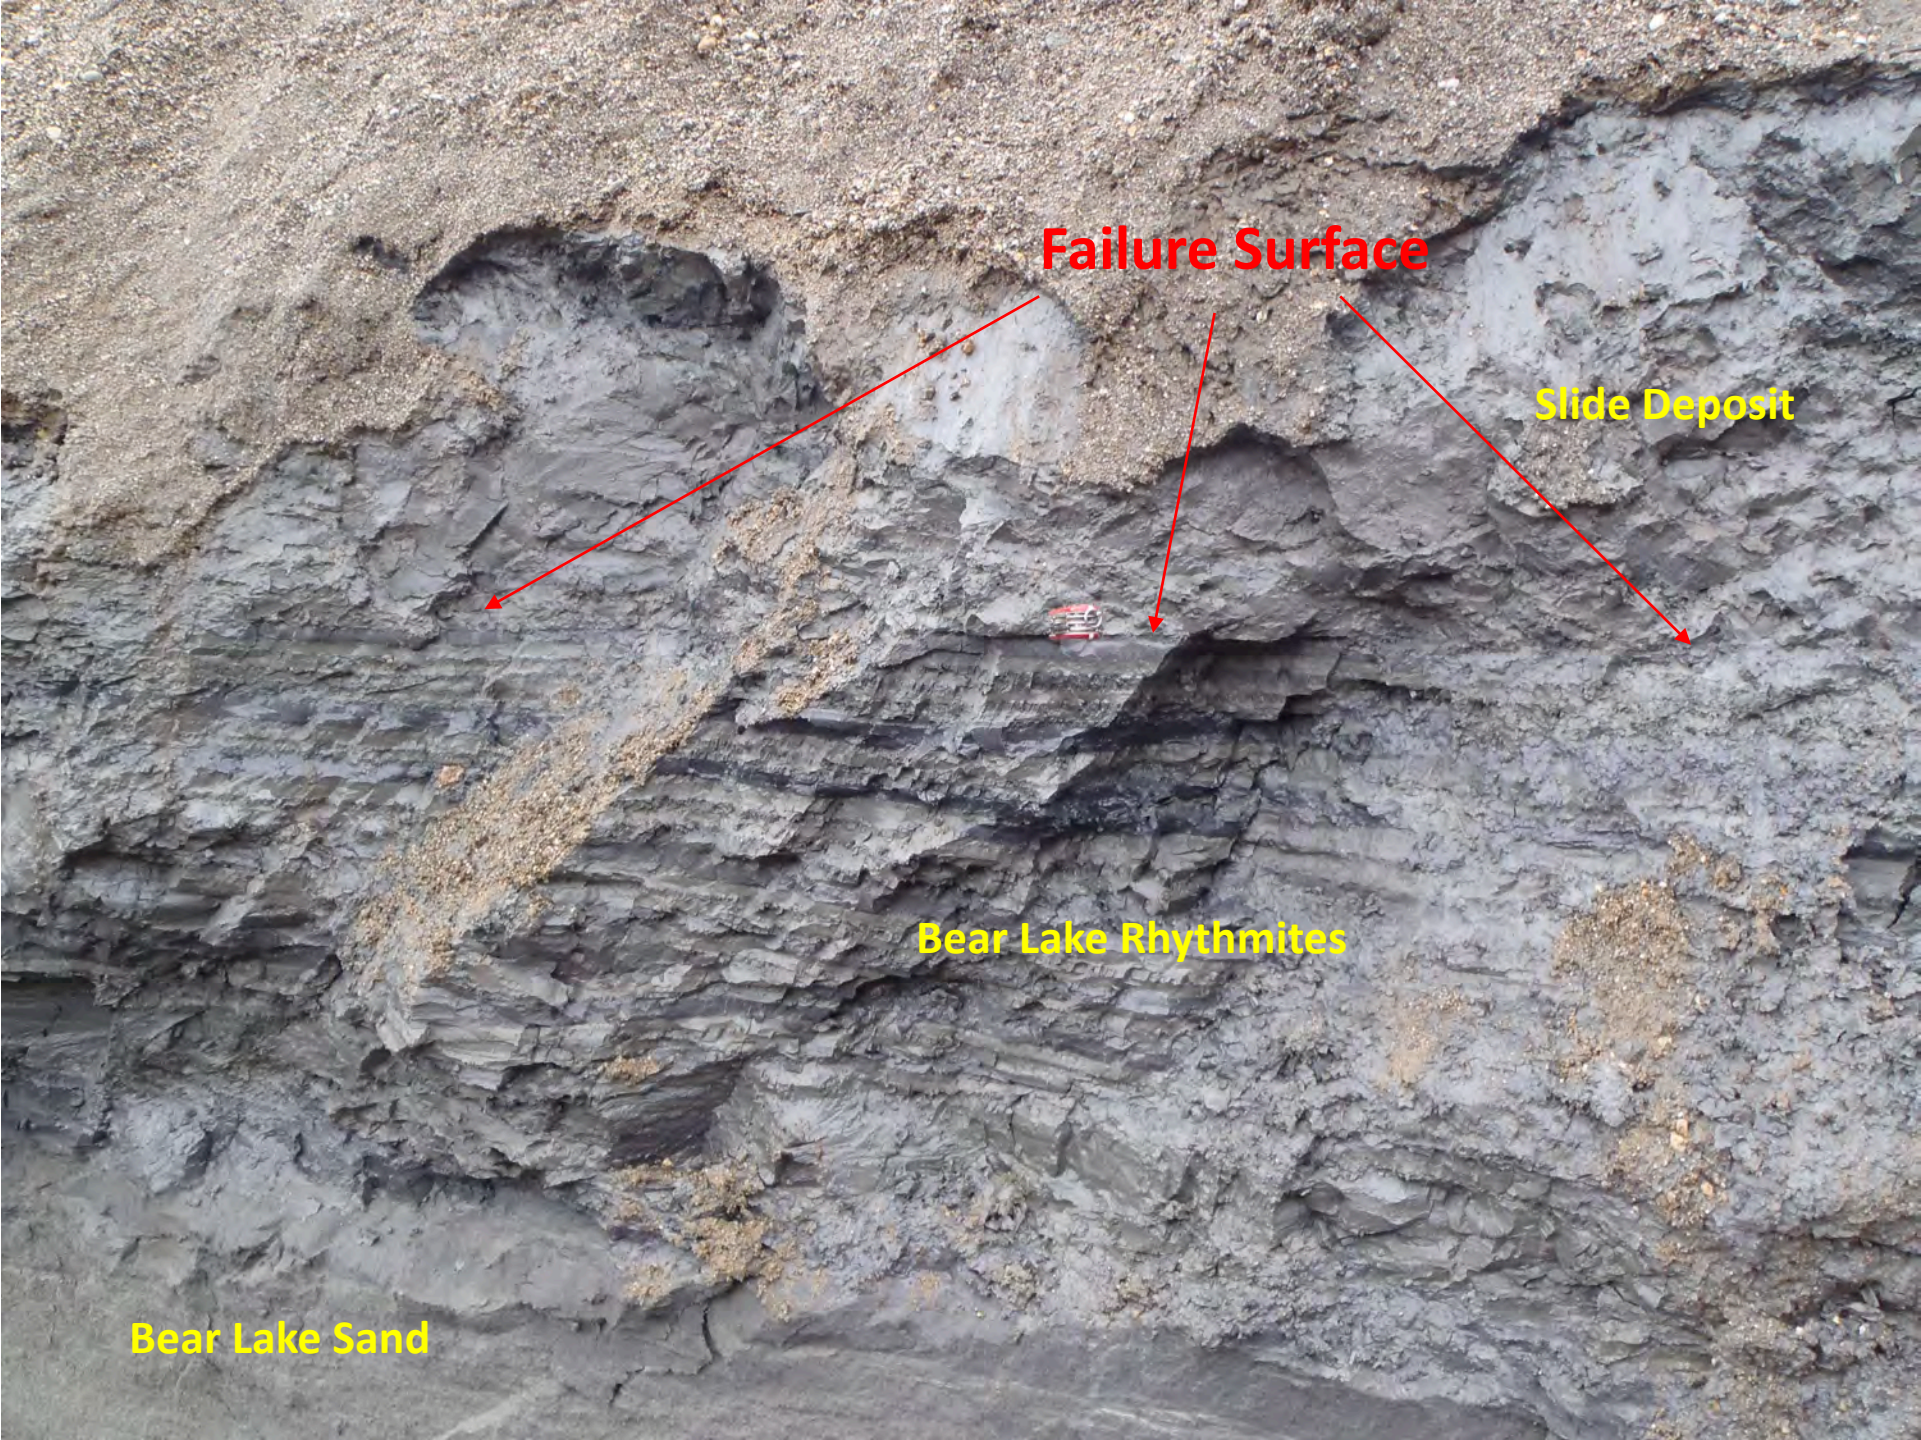
**Slide Deposit**

**Bear Lake Rhythmites**

**Bear Lake Sand**
