# 2014 Oso Slide

The last 45,000 Years:

*Our*  
Observations and Current Thoughts  
On The

Geology and Failure Development/Causes

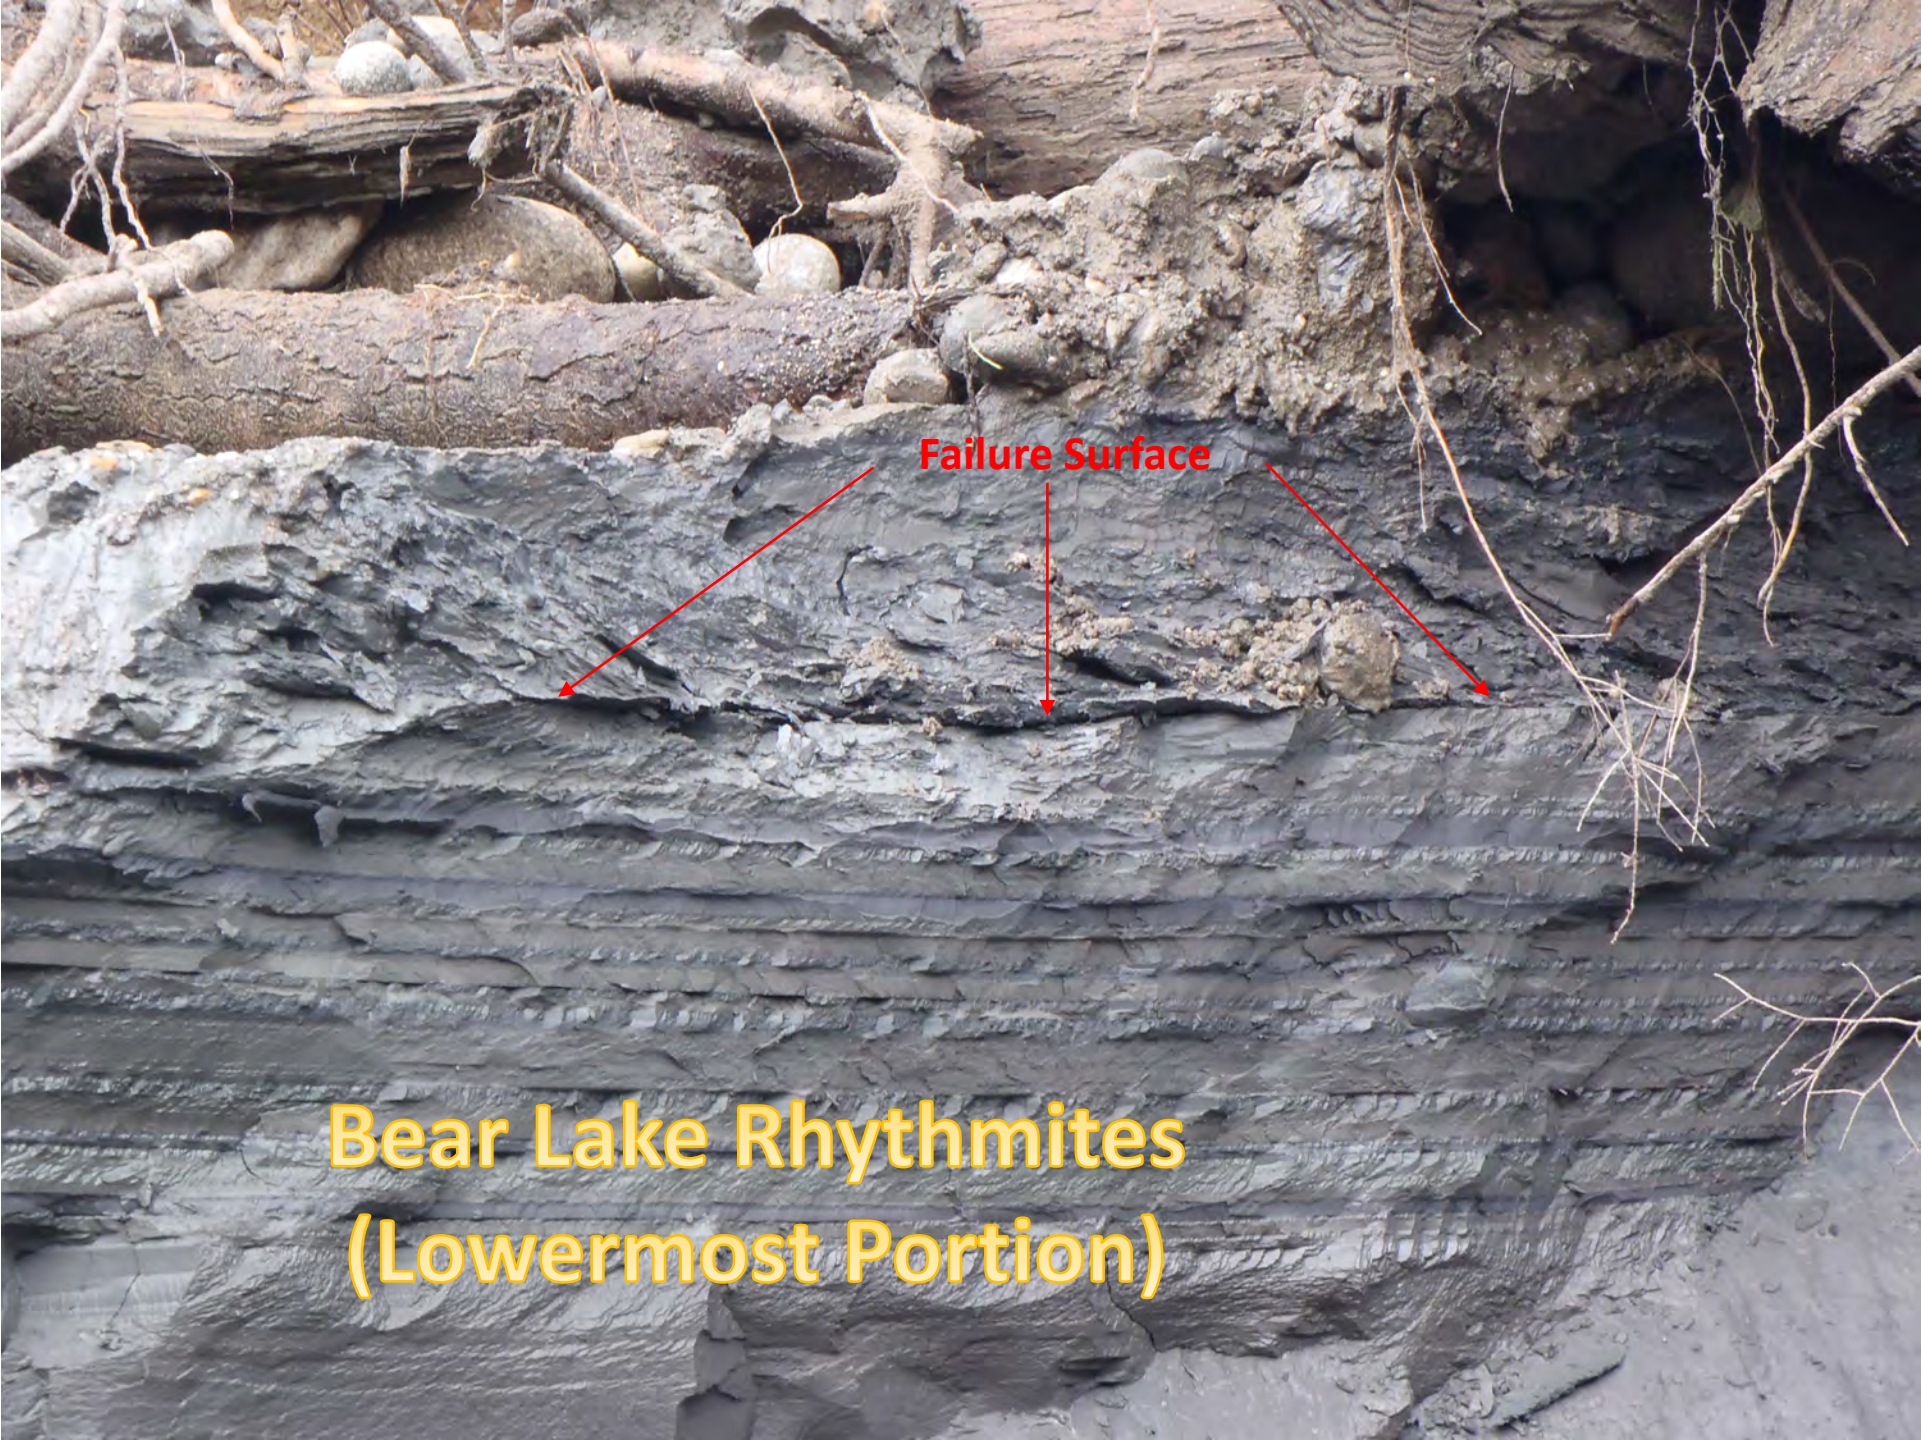
**Failure Surface**

**Slide Deposit**

**Bear Lake Rhythmites**

**Bear Lake Sand**

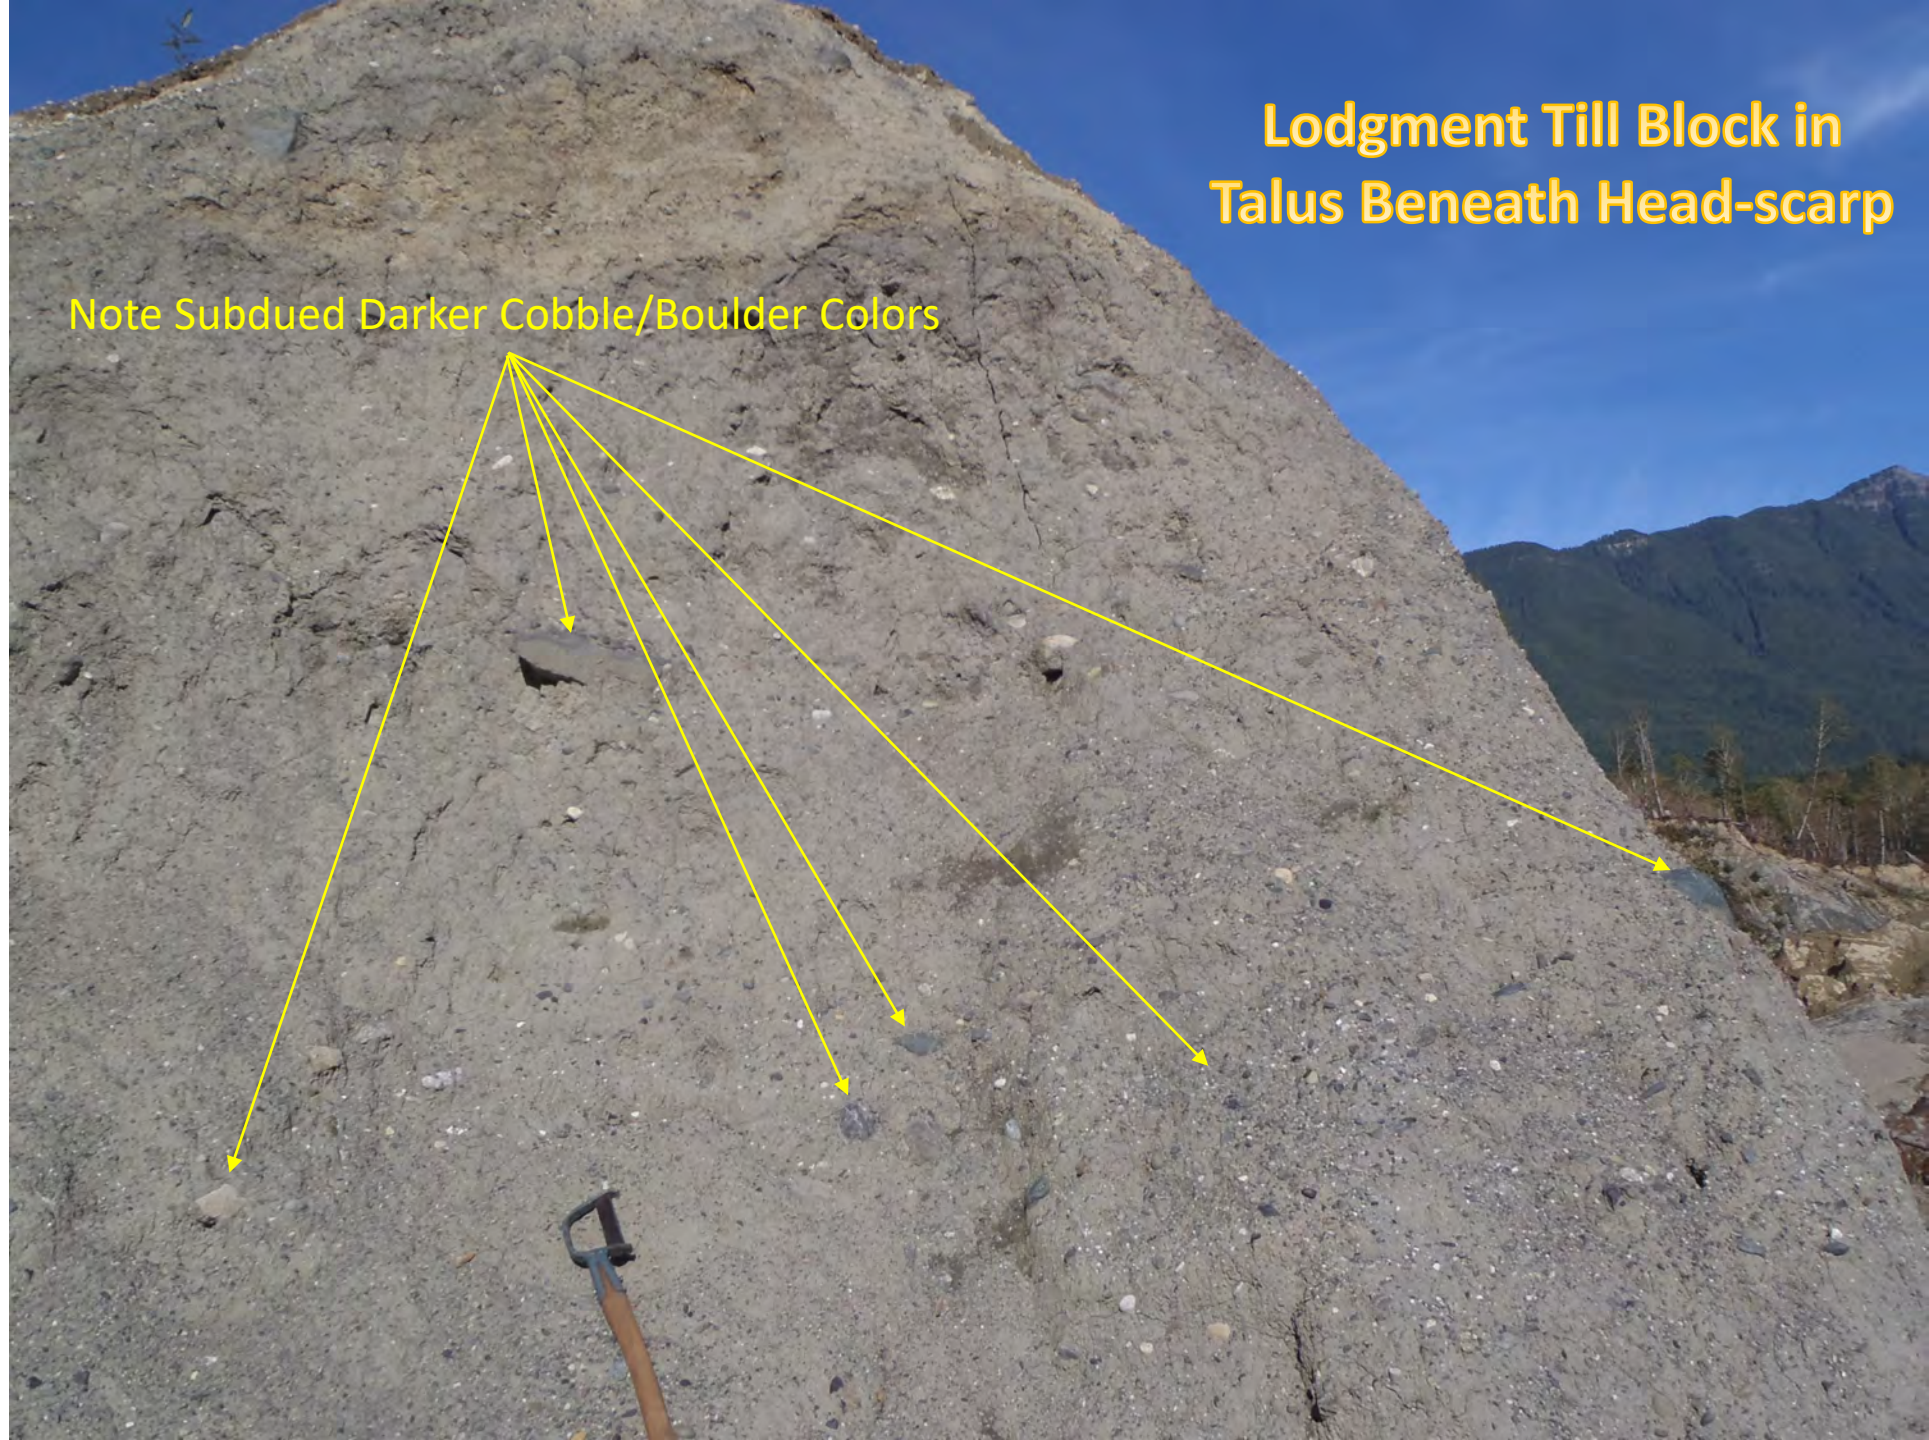
## Lodgment Till Block in Talus Beneath Head-scarp

Note Subdued Darker Cobble/Boulder Colors

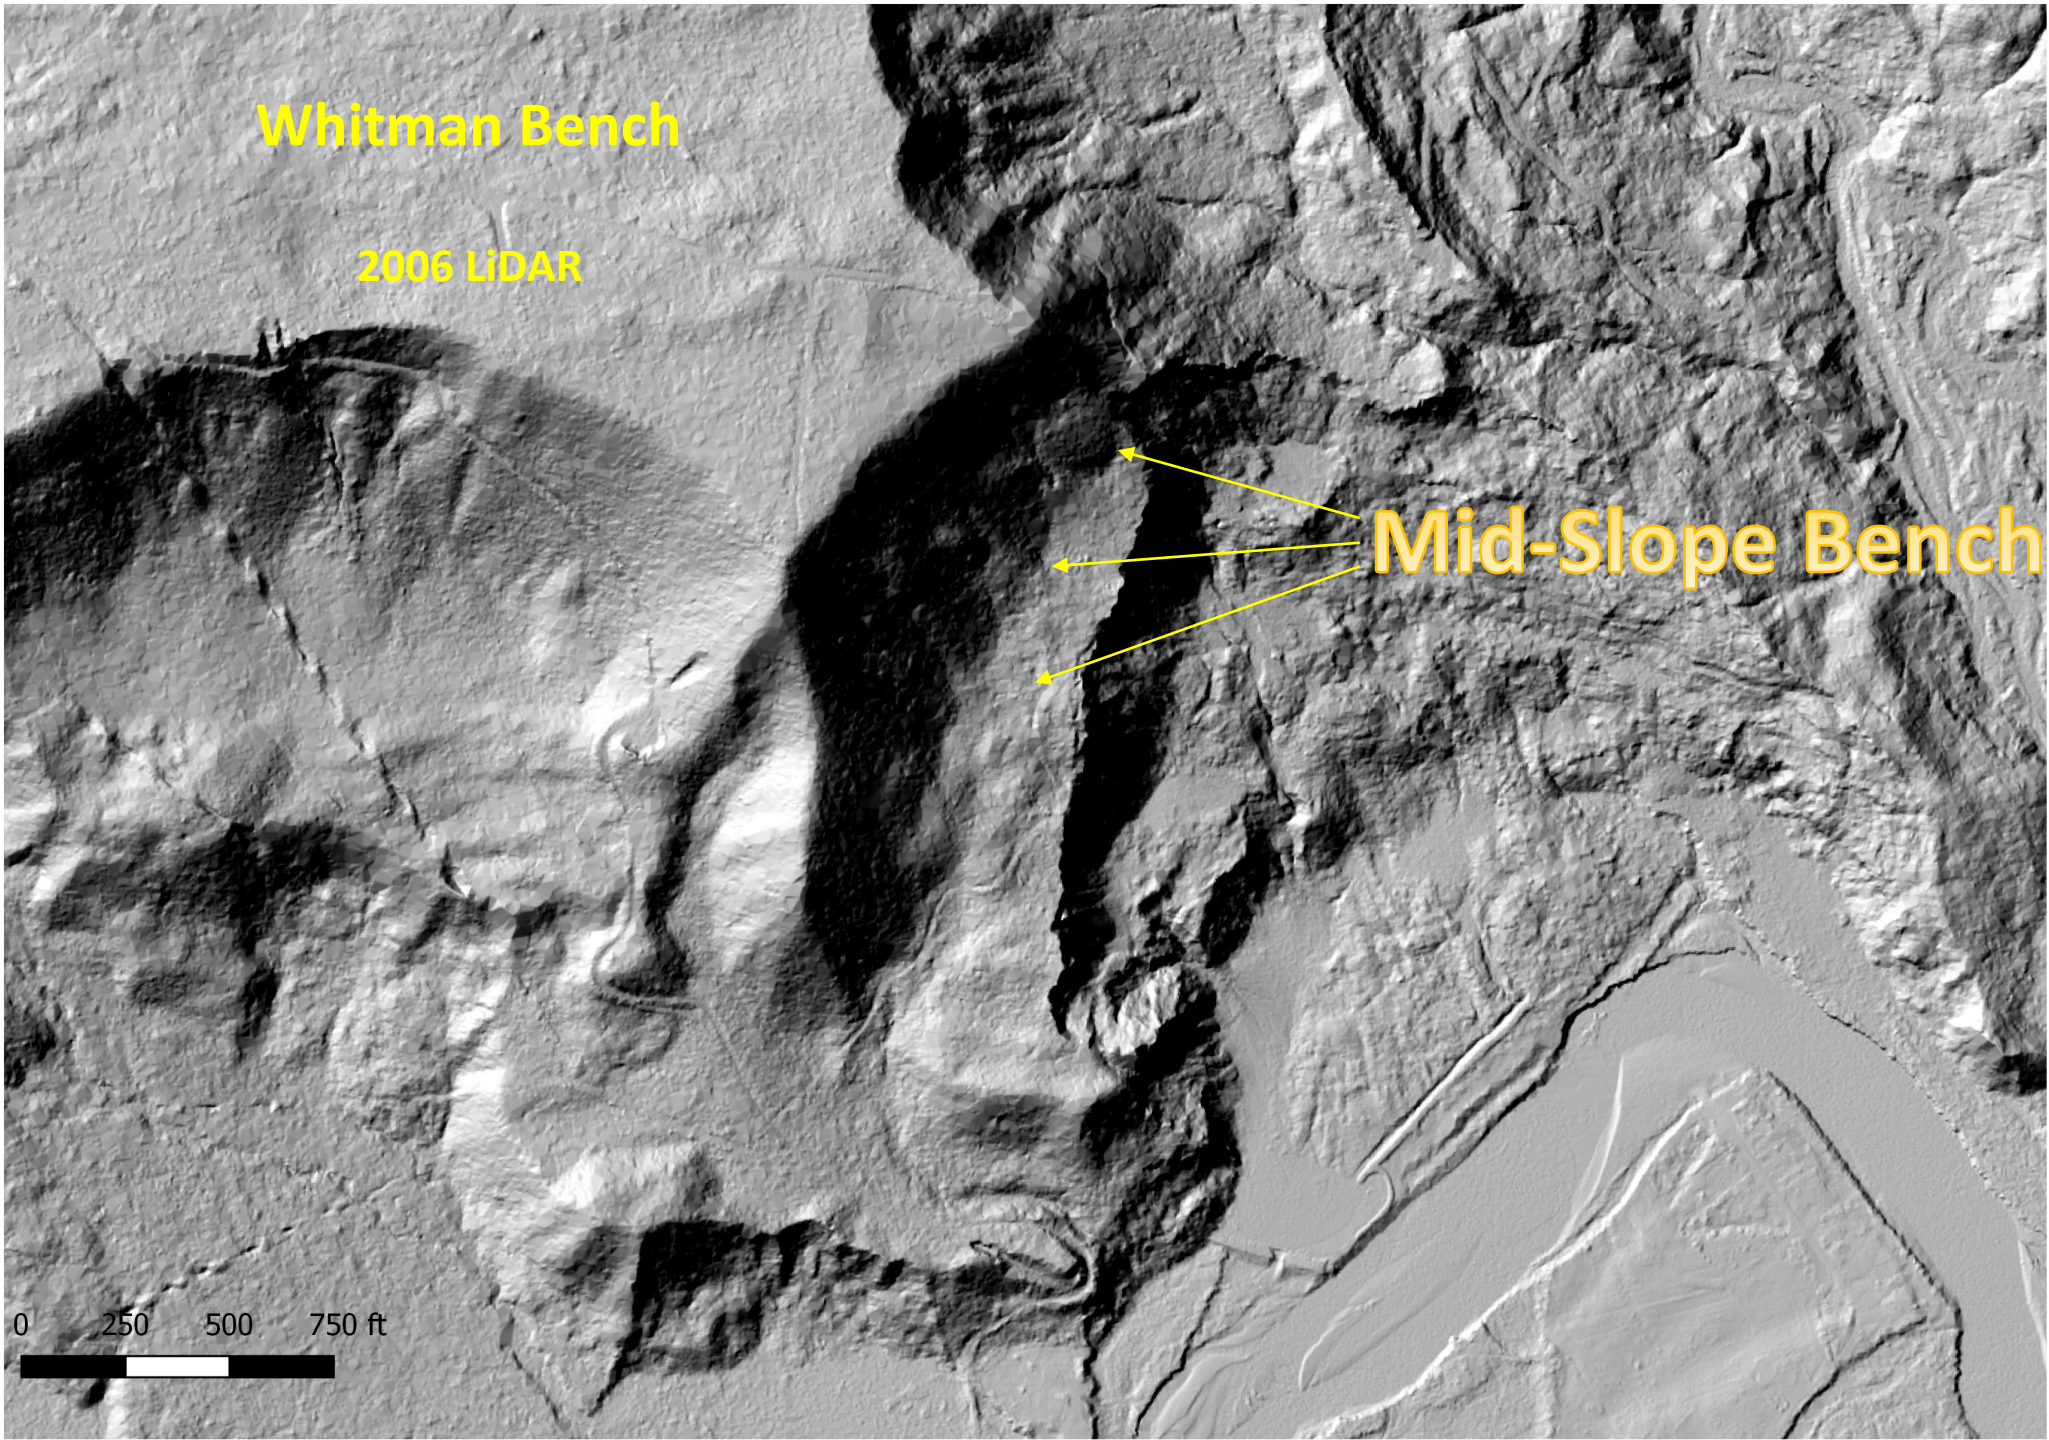
**2006 LIDAR**

**Whitman Bench**

**Mid-Slope Bench**

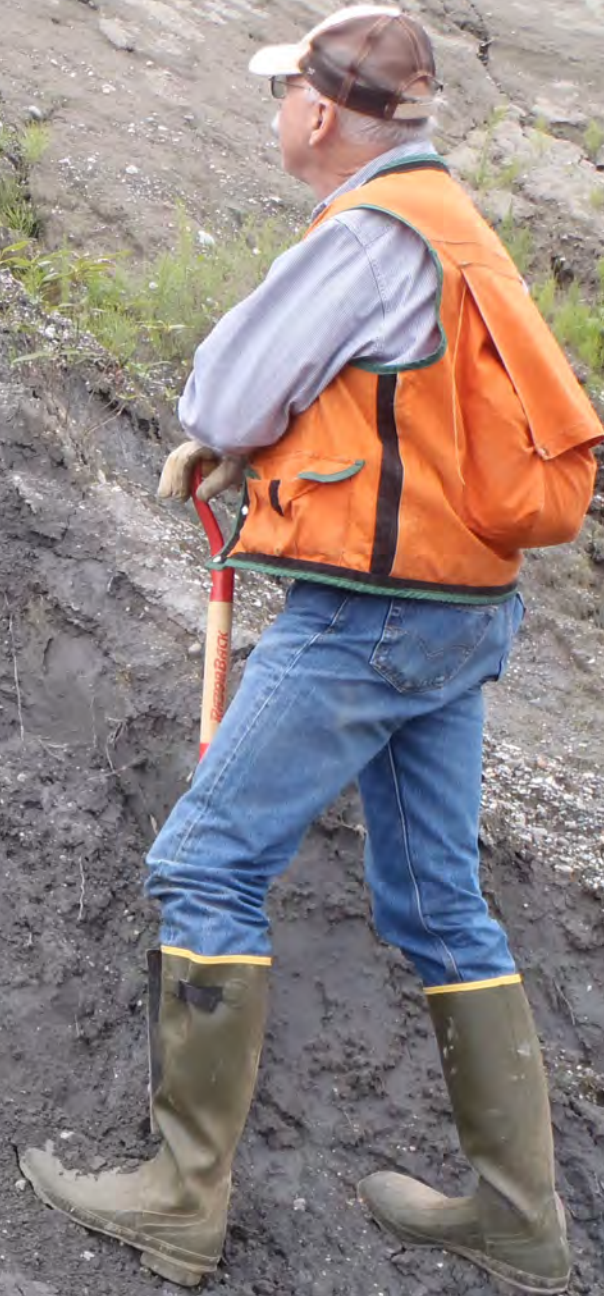
**Old Surface of Rupture at  
Base of Remaining  
Mid-Slope Bench Block,  
West Margin**

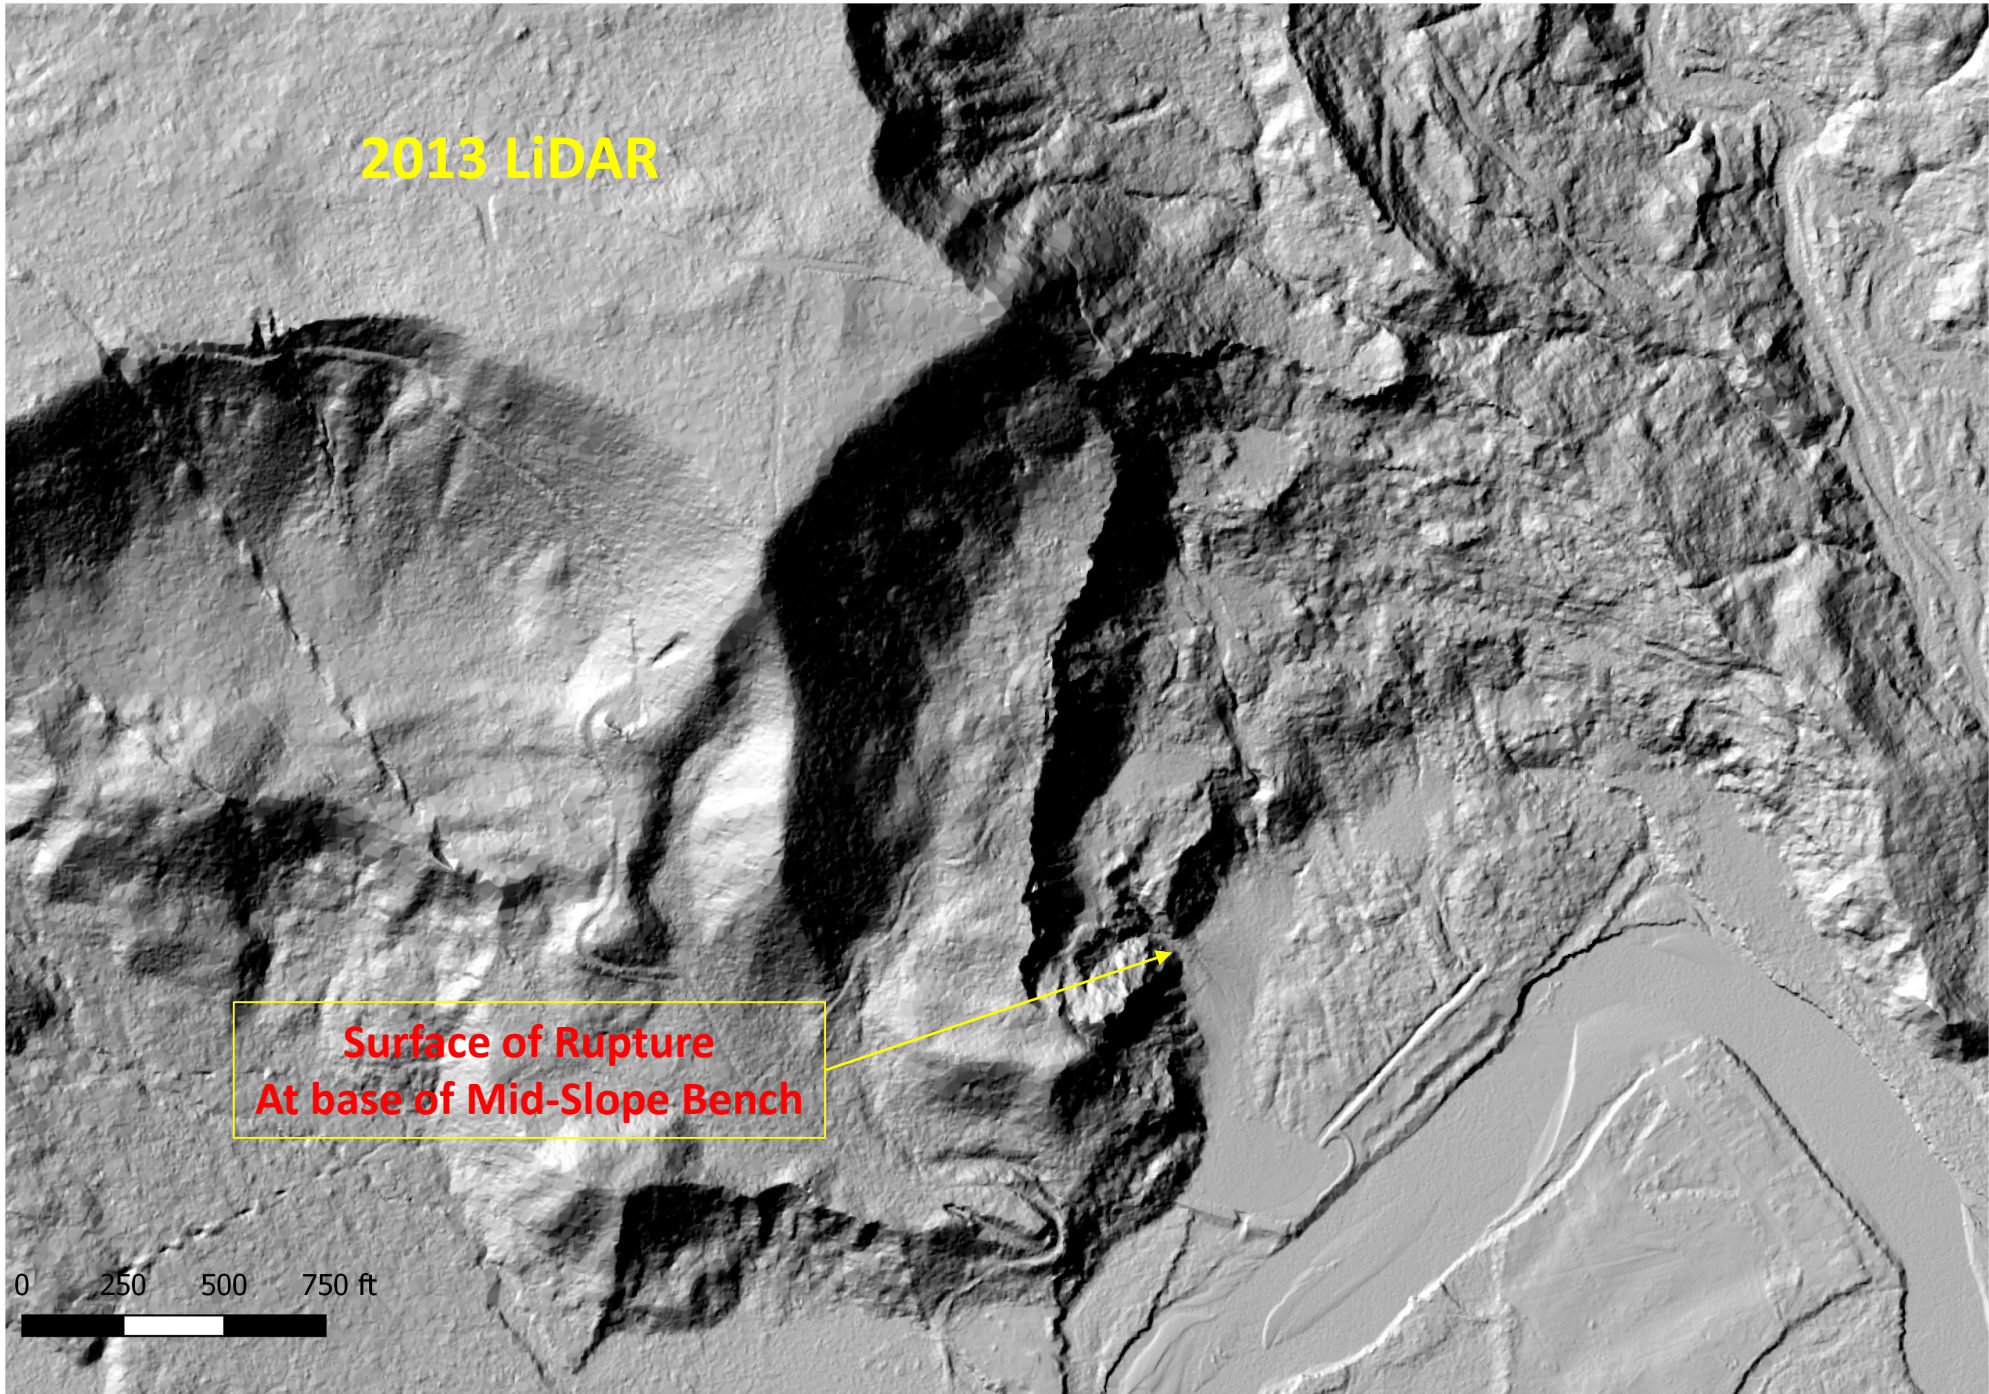
**2013 LiDAR**

**Surface of Rupture  
At base of Mid-Slope Bench**

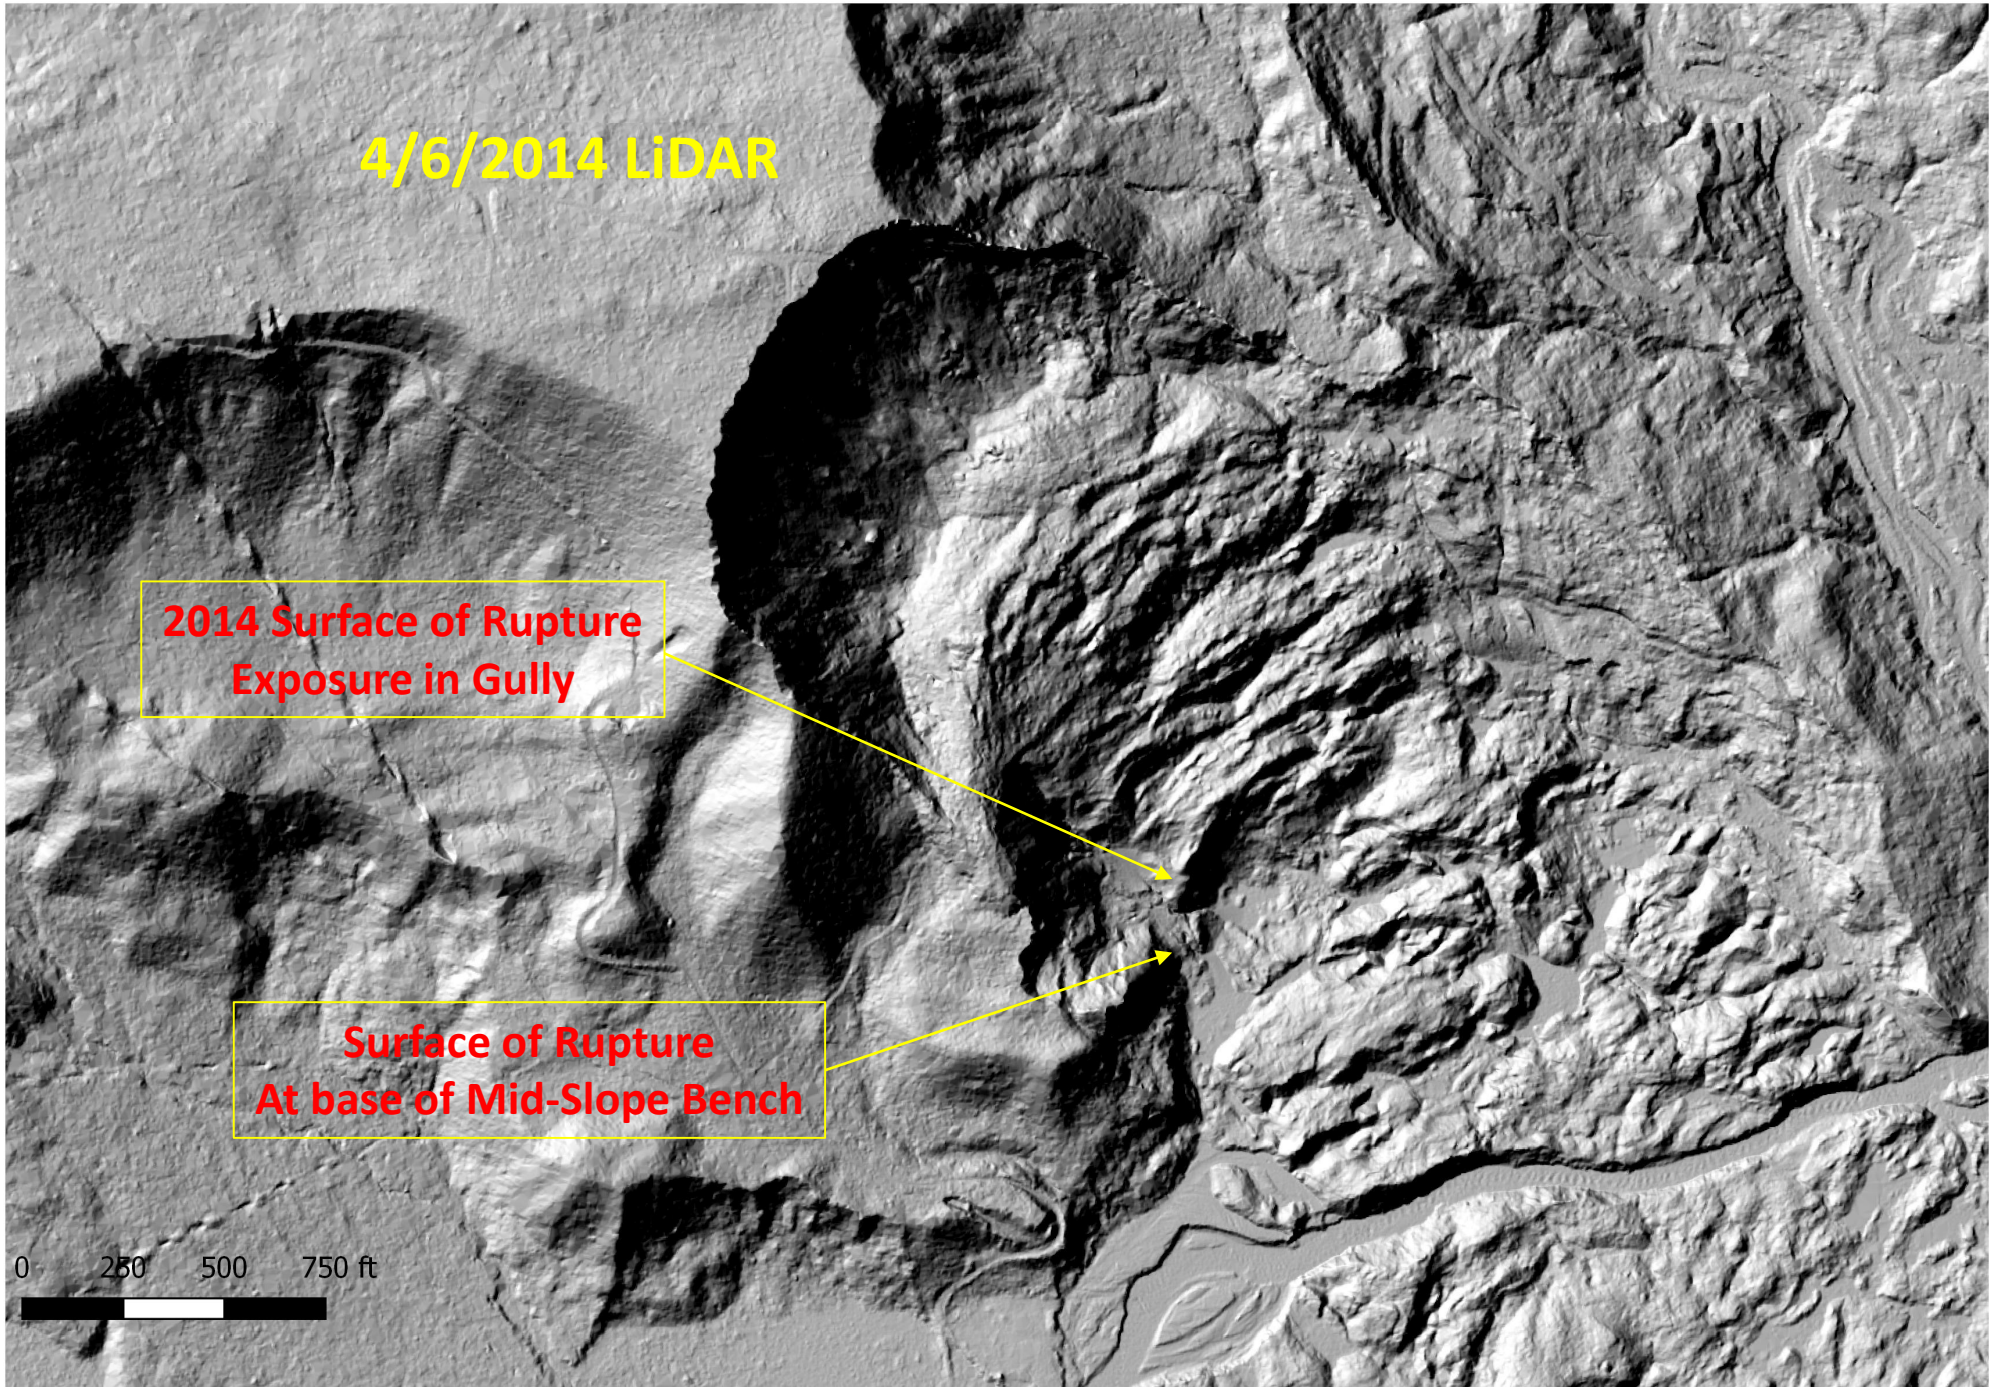
**4/6/2014 LiDAR**

**2014 Surface of Rupture  
Exposure in Gully**

**Surface of Rupture  
At base of Mid-Slope Bench**

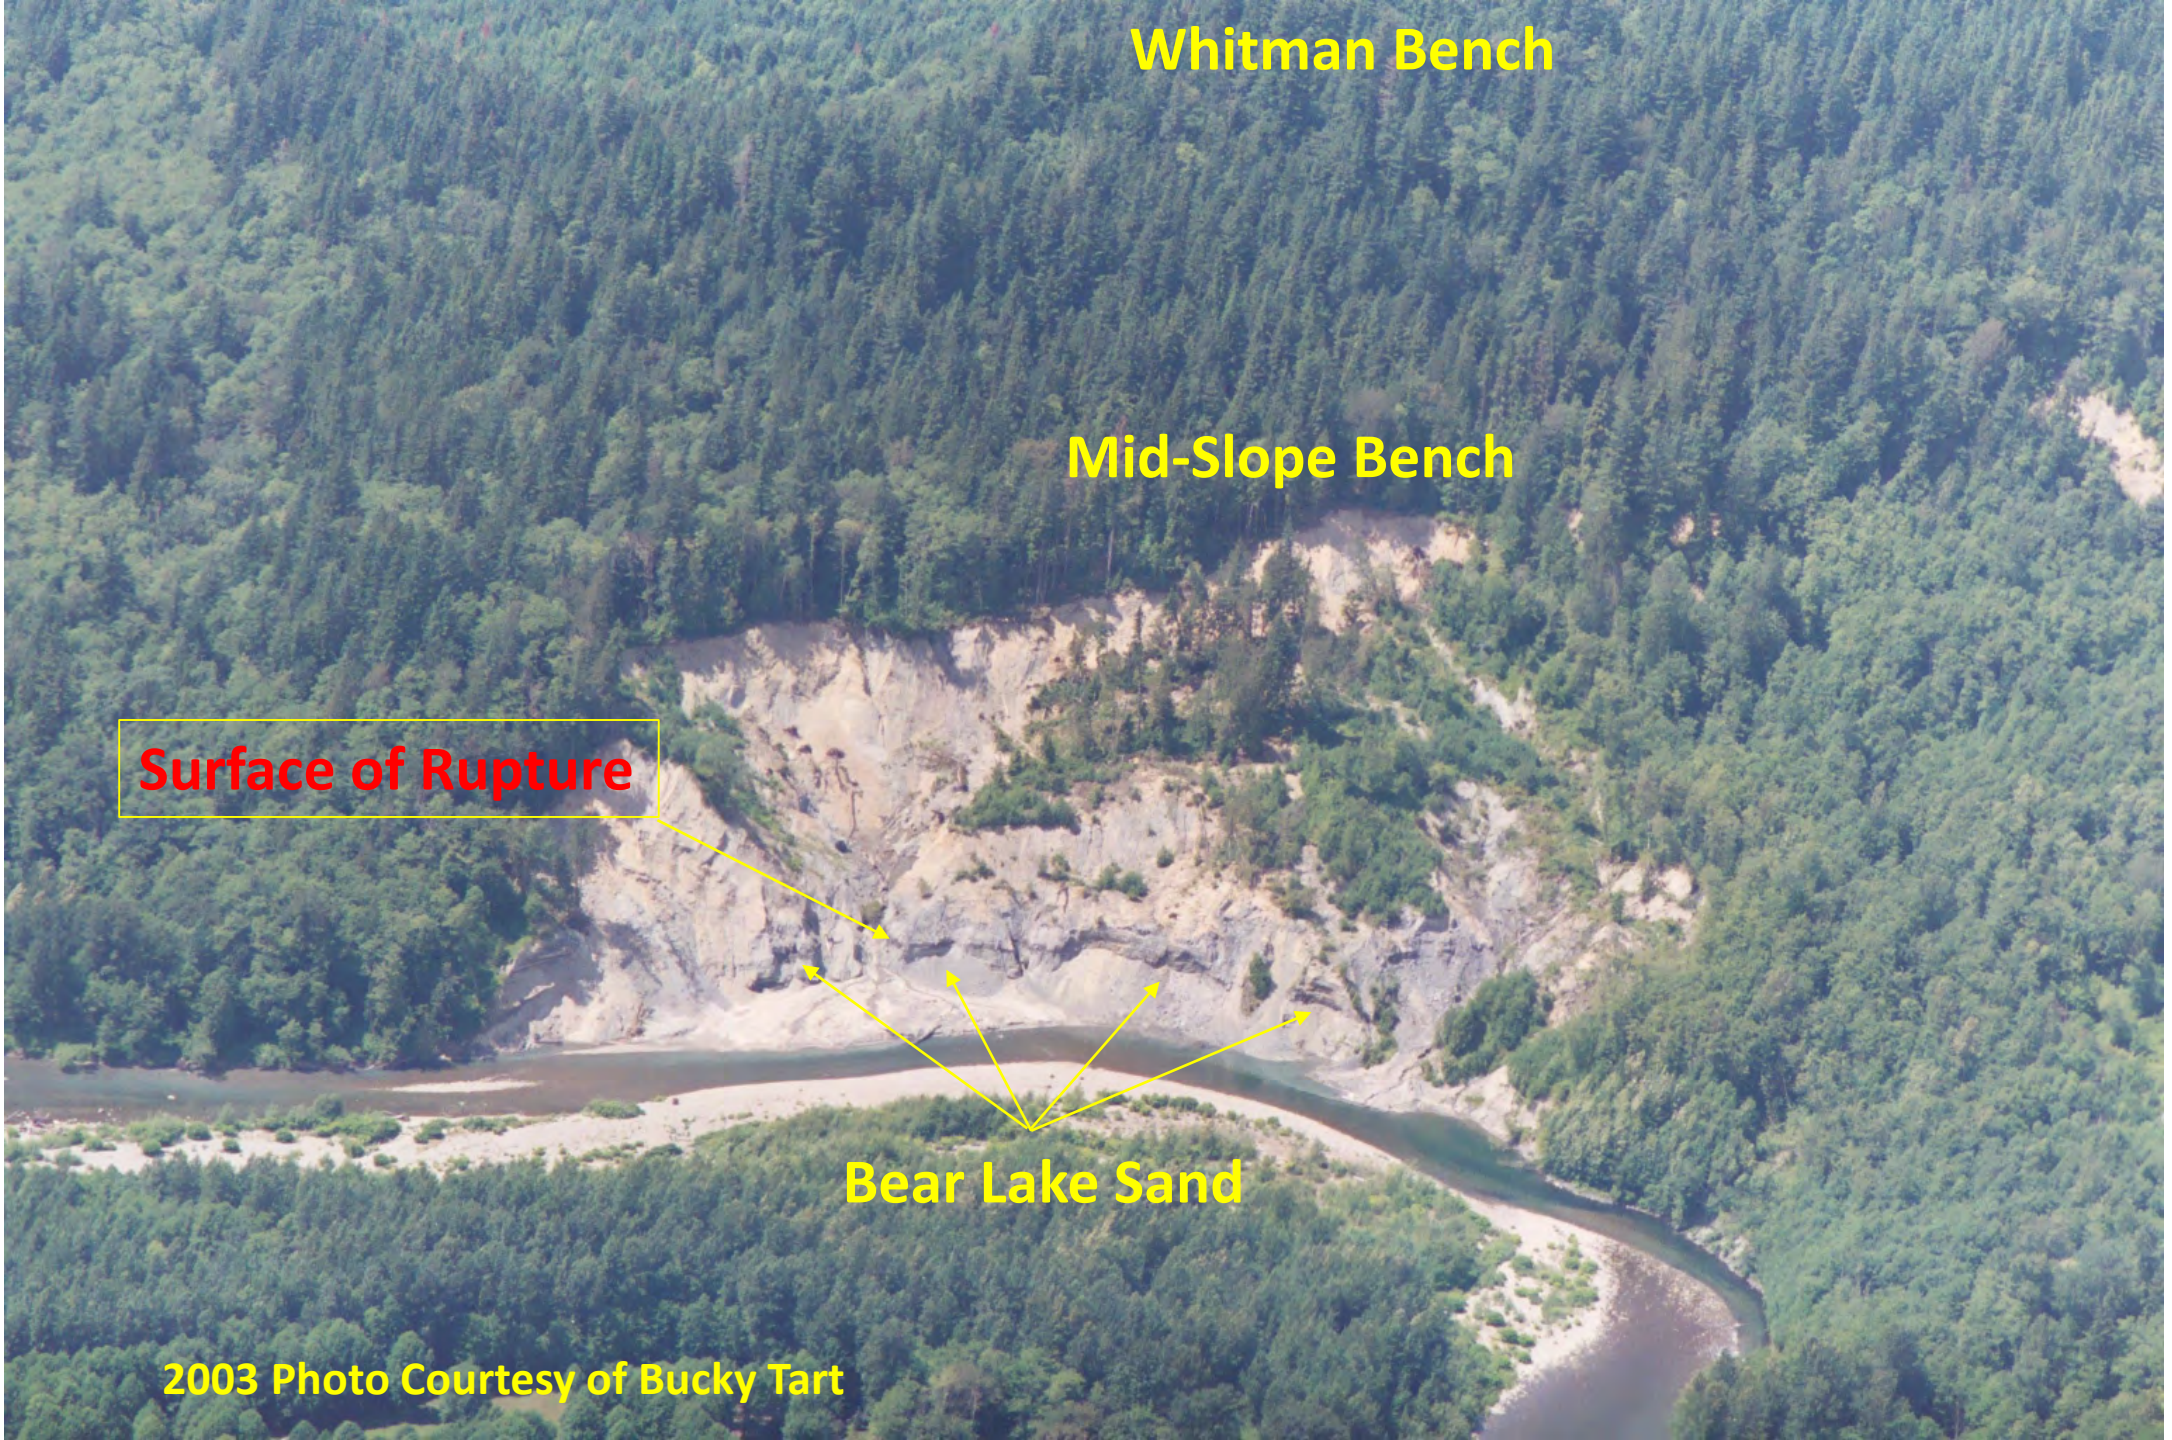
**2003 Photo Courtesy of Bucky Tart**

**Whitman Bench**

**Mid-Slope Bench**

**Surface of Rupture**

**Bear Lake Sand**

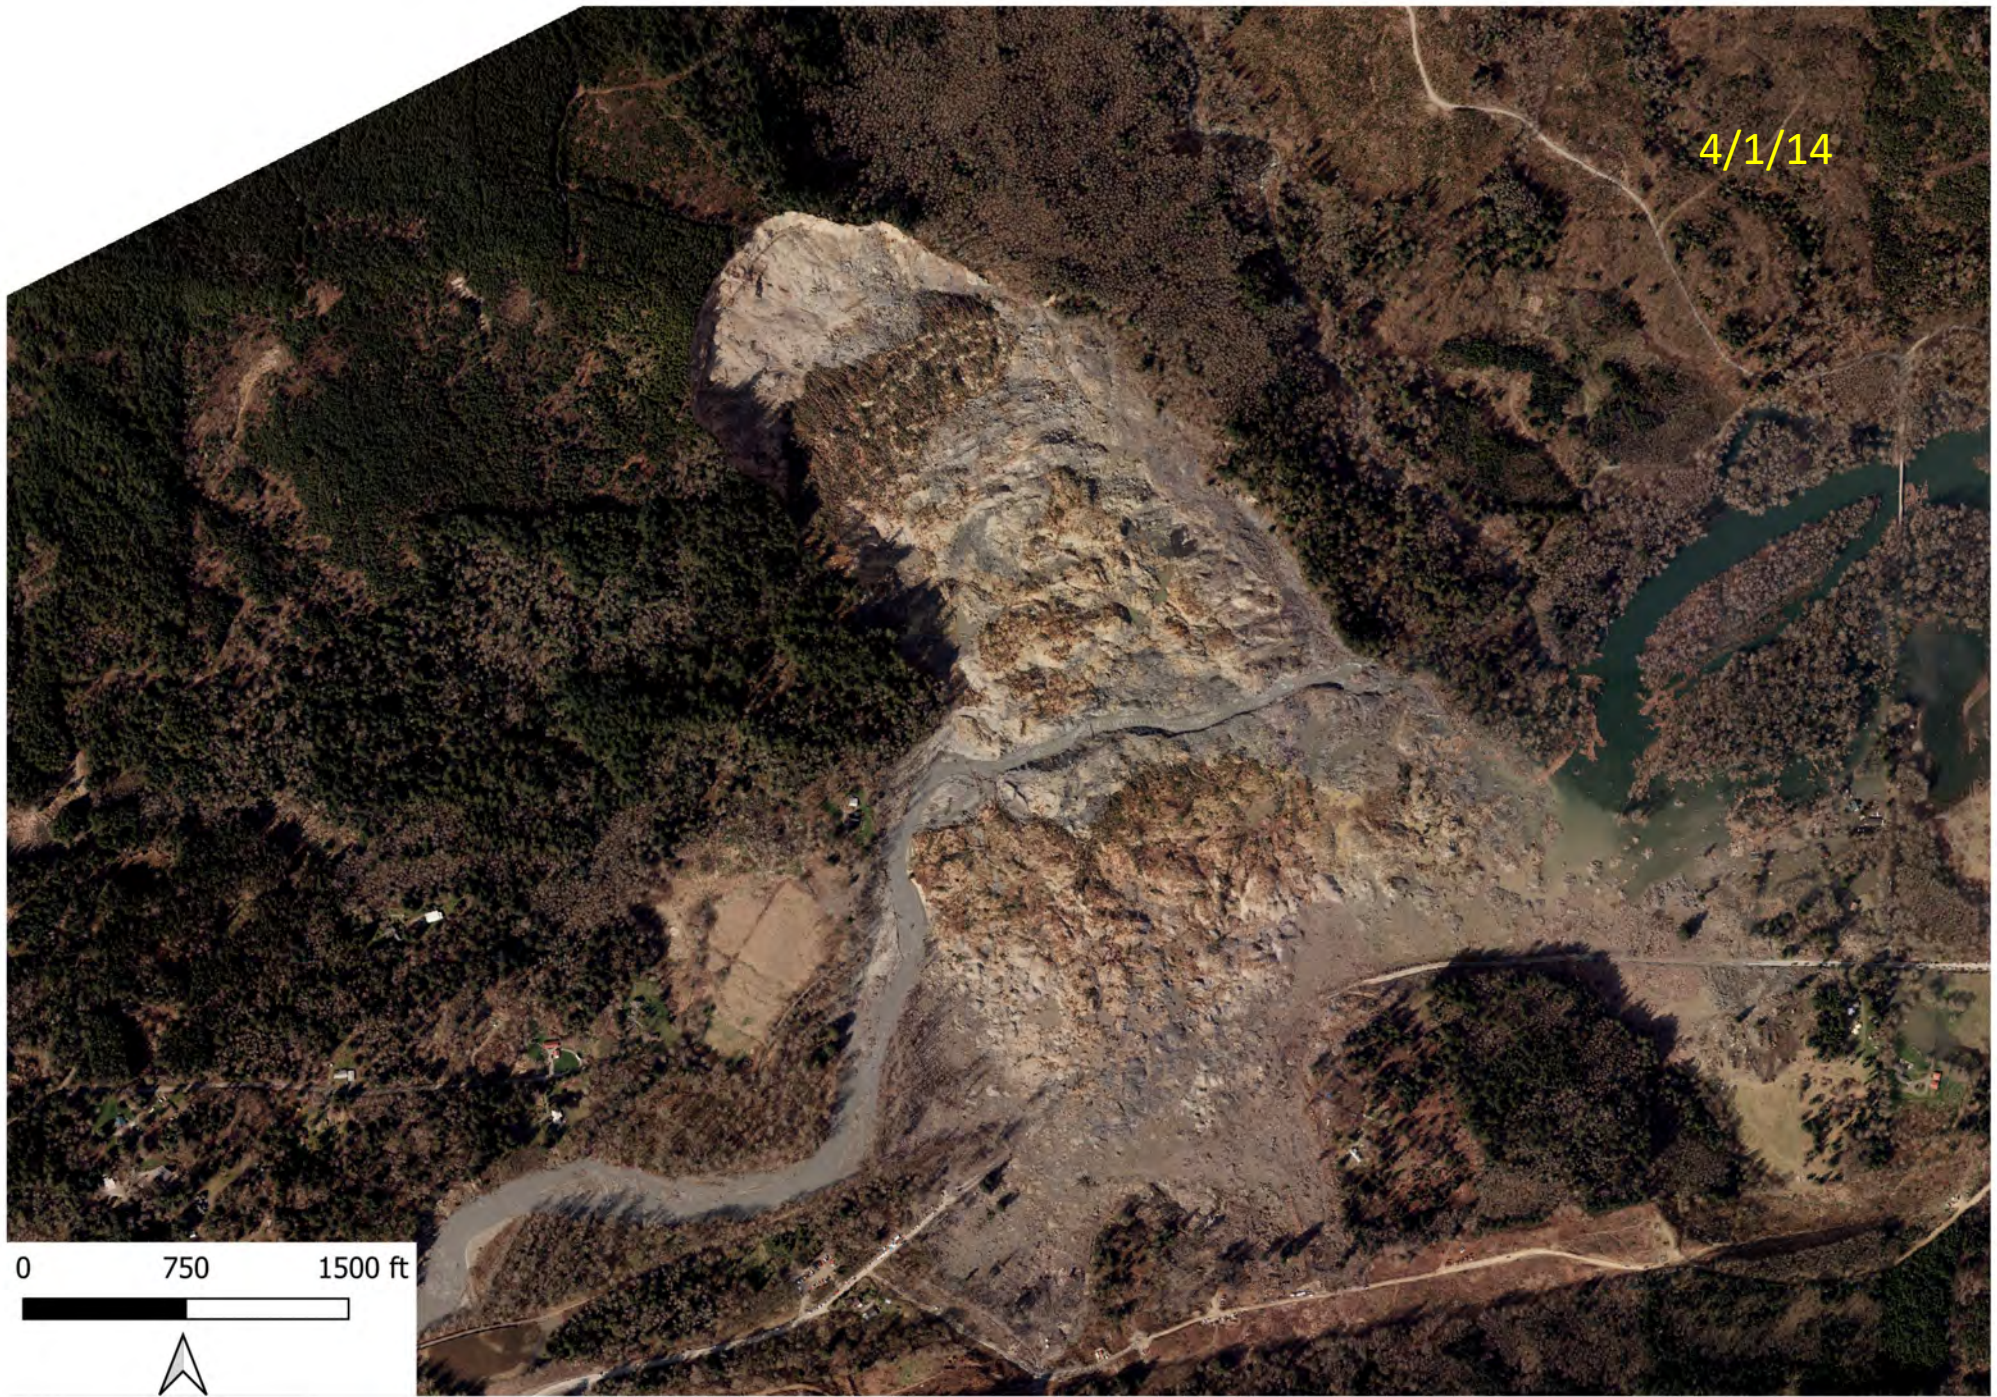
4/1/14

River Has Moved NW a Maximum of 175' in 4 Years

- Resume Monitoring of the Current Slide Area (all Instrumentation has been Removed)  
This seems to be an inappropriate stick-your-head-in-the-sand approach
