Slope Stabilization Case Studies

SLOPE STABILIZATION CASE STUDIES IN A FOREST ENVIRONMENT

“Typical Landslide, Cut/Fill Slope Problems Encountered on Low Volume Roads in Steep Mountainous Terrain and Their Solutions”

Courtesy of: Ed Rose (Retired)
R1 Geotechnical Engineer

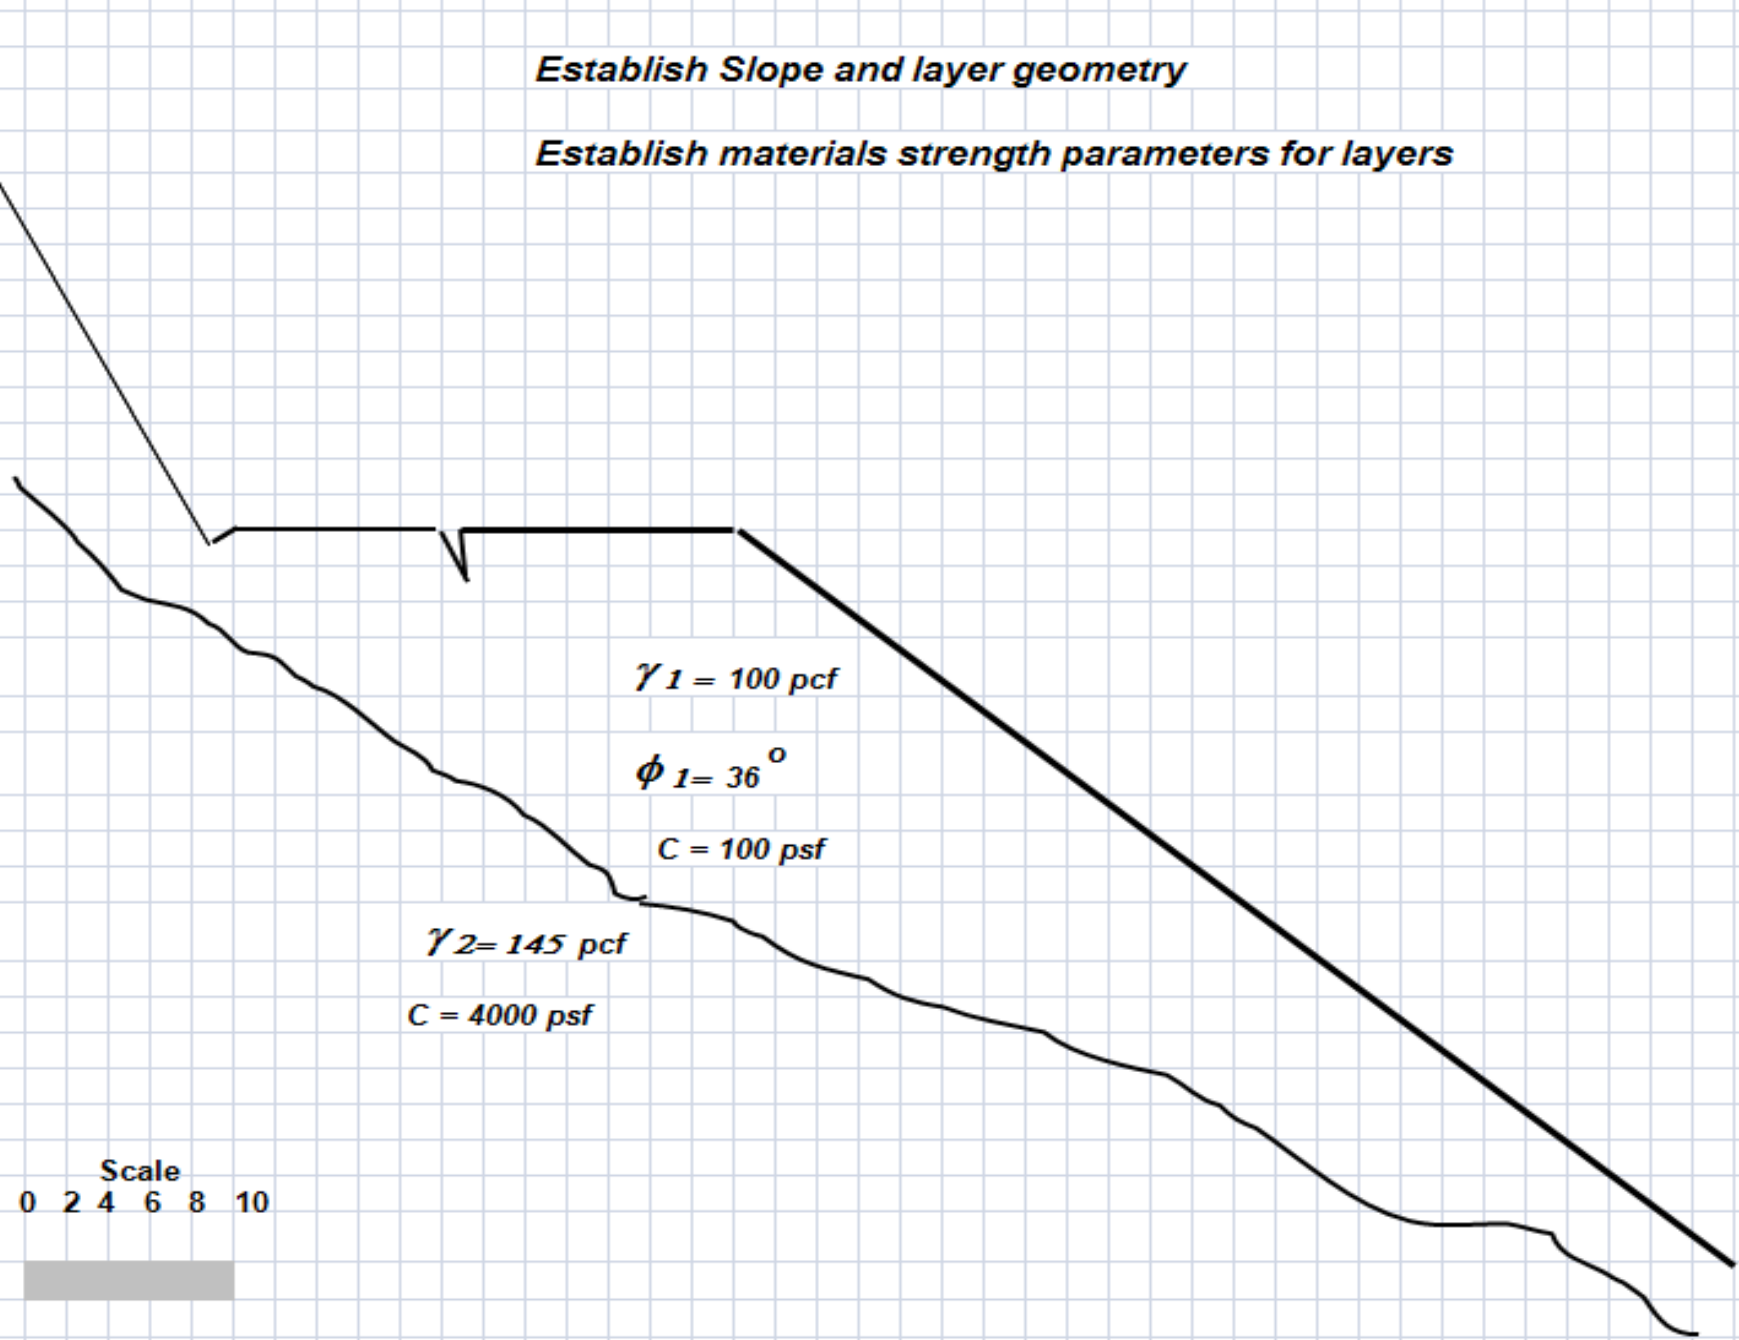
Establish Slope and layer geometry

Establish materials strength parameters for layers

$\gamma_1 = 100 \text{ pcf}$

$\phi_1 = 36^\circ$

$C = 100 \text{ psf}$

$\gamma_2 = 145 \text{ pcf}$

$C = 4000 \text{ psf}$

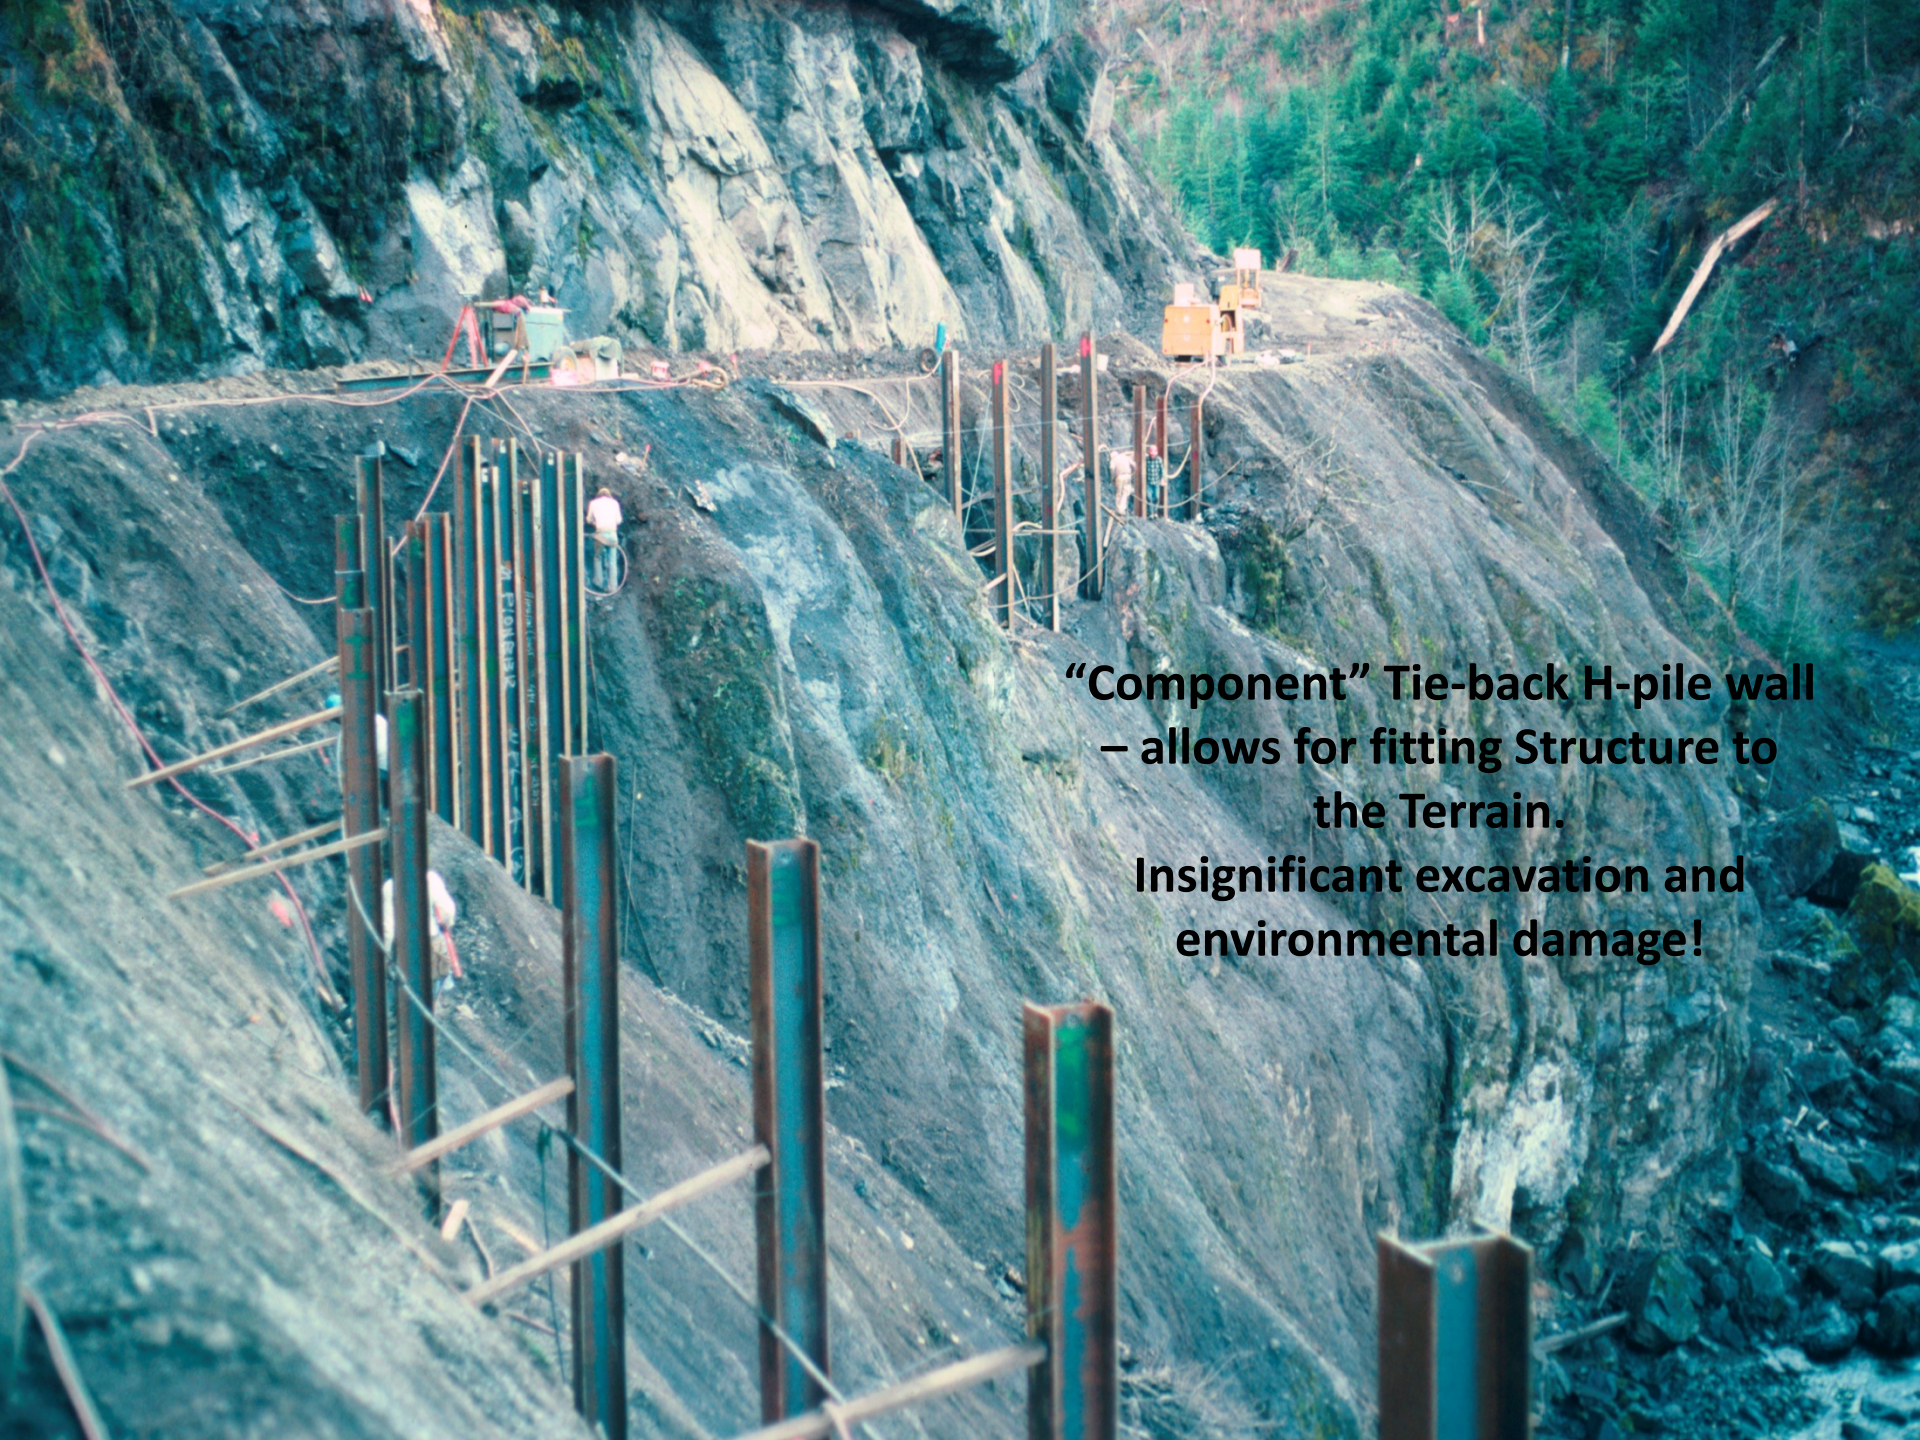
**“Component” Tie-back H-pile wall
– allows for fitting Structure to
the Terrain.
Insignificant excavation and
environmental damage!**

- Allows one to fit component design to terrain rather than try to modify terrain to fit structure.
- Quite often try to fit MSE wall or other gravity type structure in to bedrock
 - Needless rock excavation because of base width requirement
 - Environmental impact!

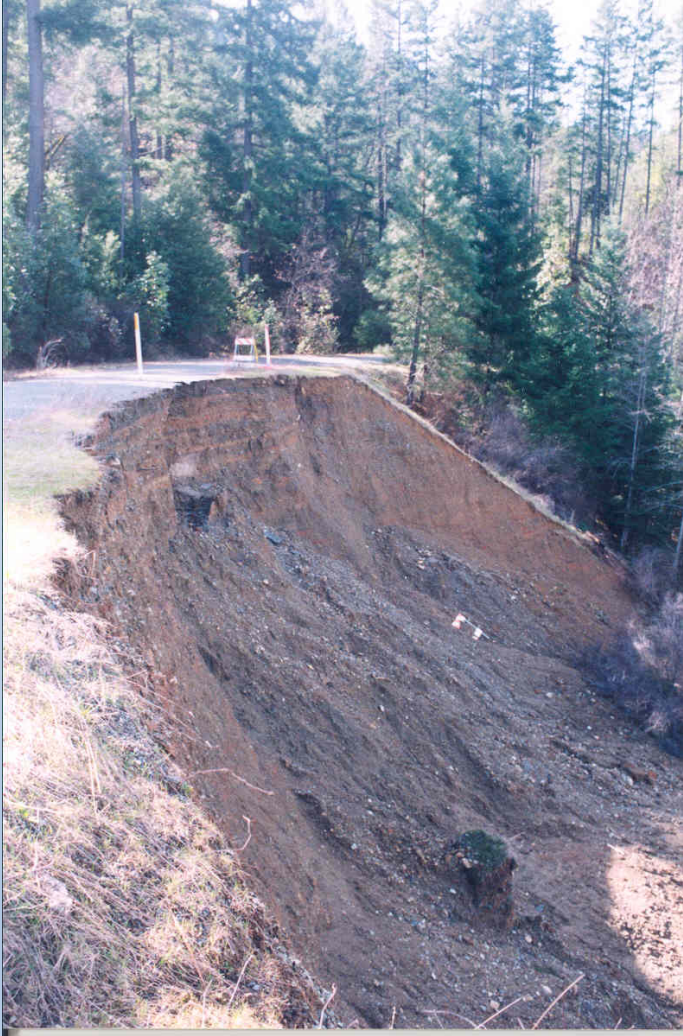
Typical Over Steepened Fill Failures - Klamath N.F. Region 5

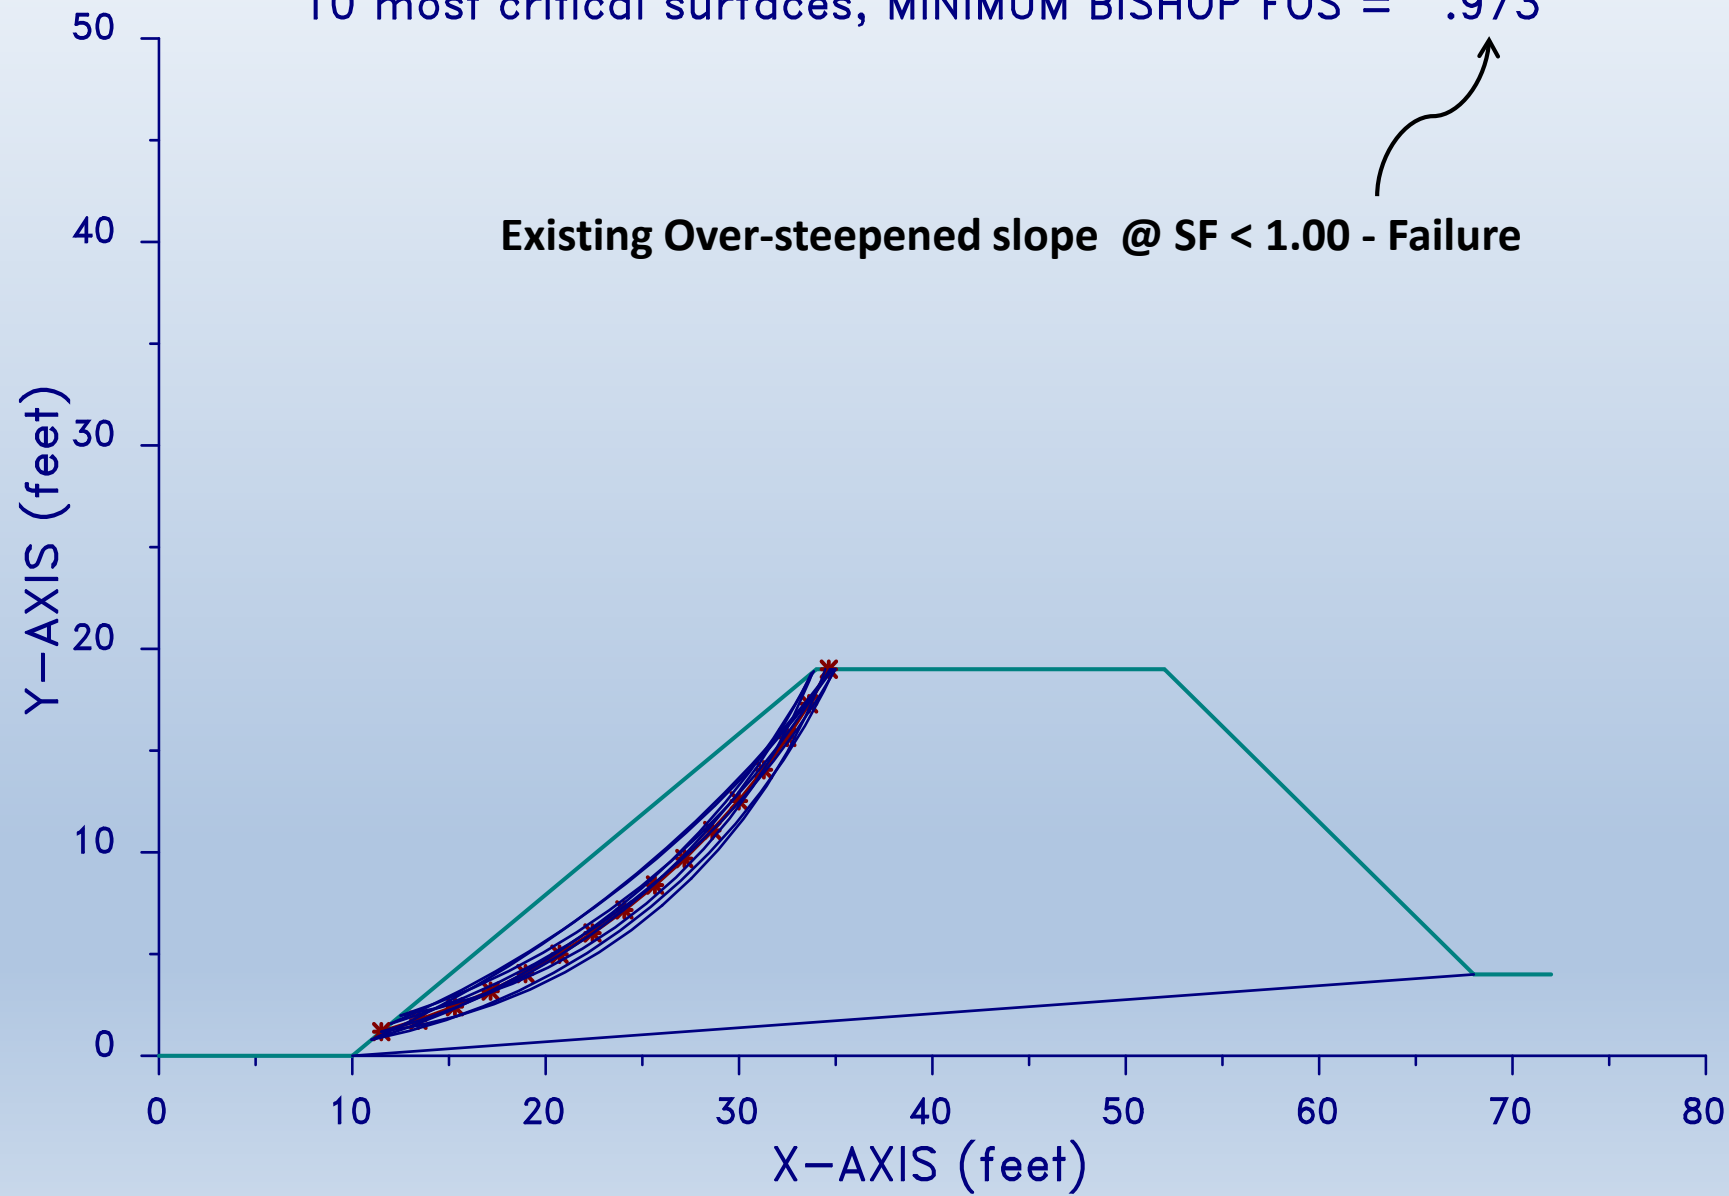
Reinforced Fill reconstruction

10 most critical surfaces, MINIMUM BISHOP FOS = .973

Existing Over-steepened slope @ SF < 1.00 - Failure

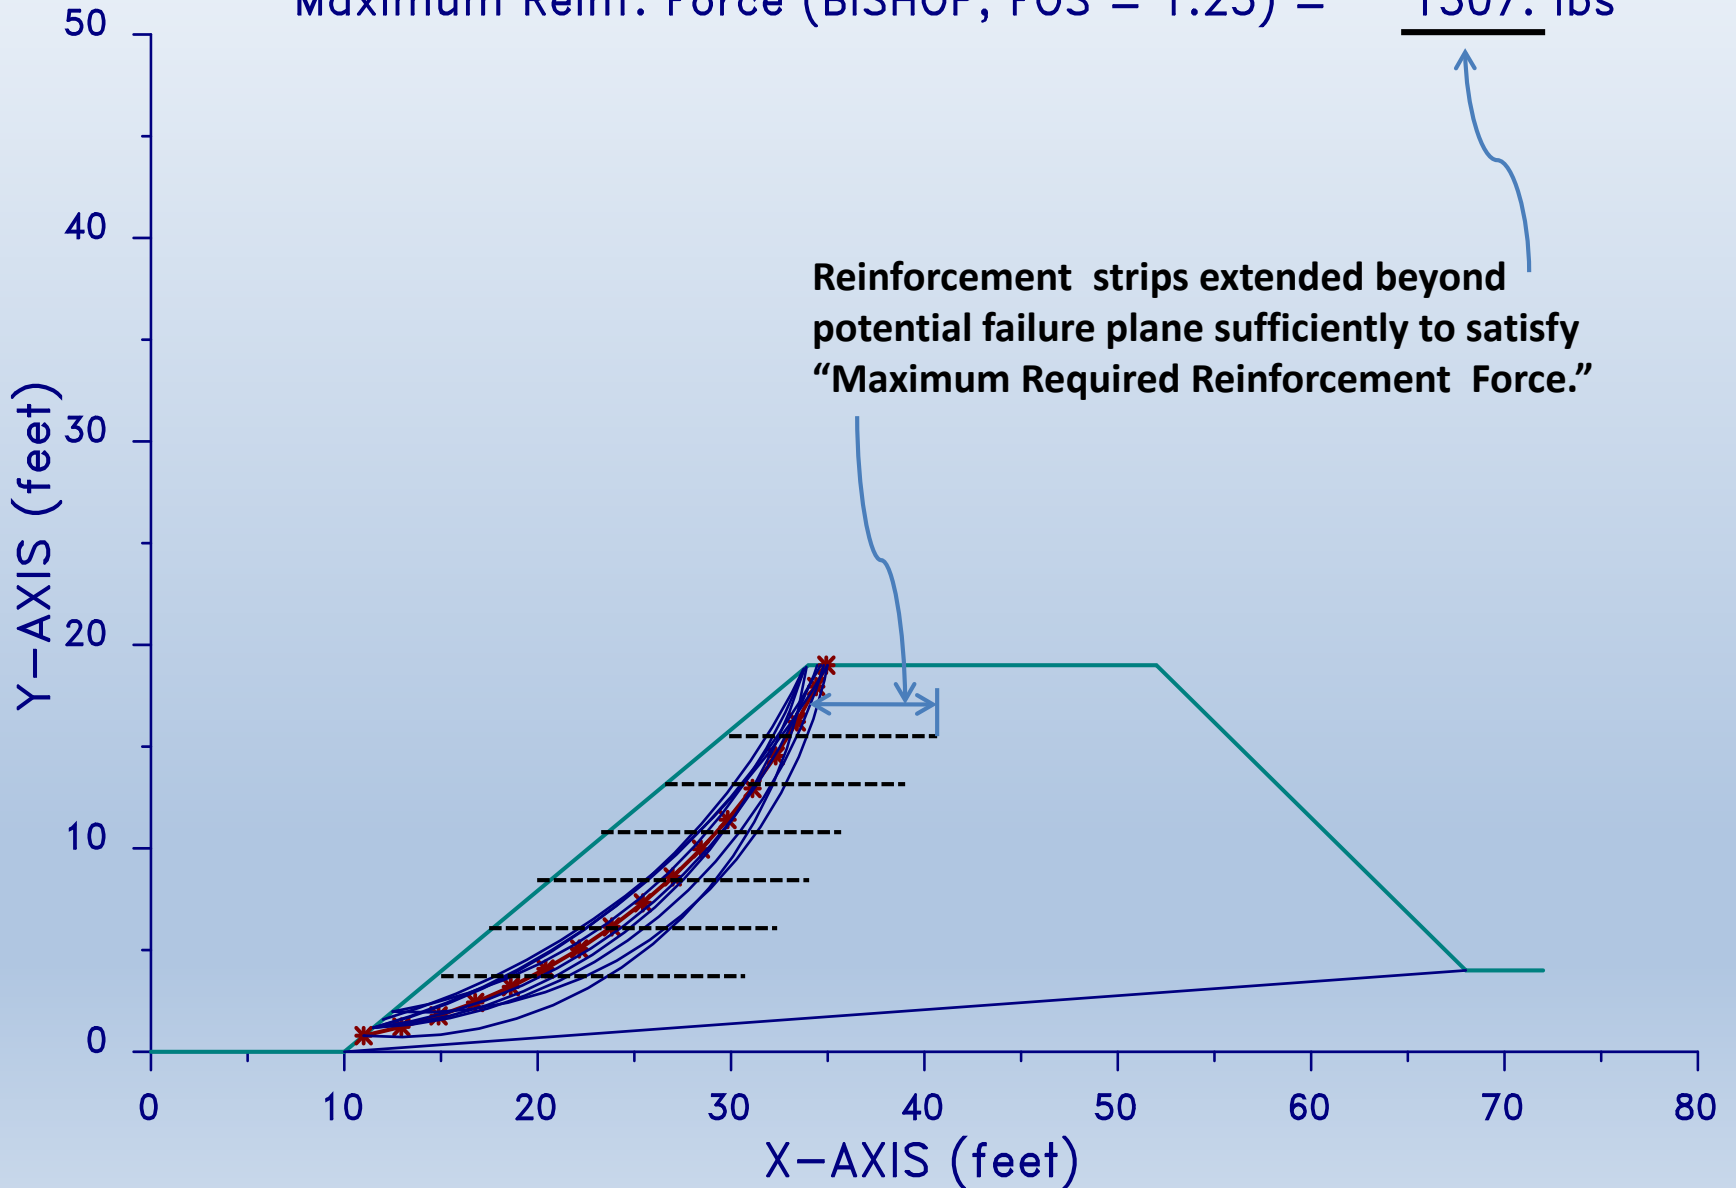
Reinforced Fill reconstruction

Maximum Reinf. Force (BISHOP, FOS = 1.25) = 1307. lbs

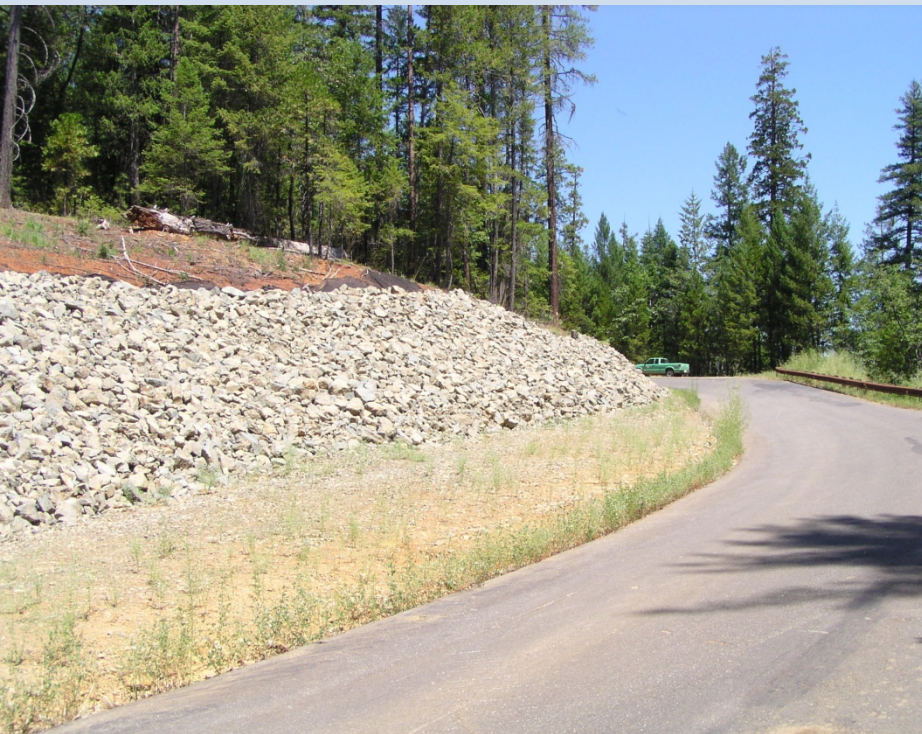
Buttress in Failed Cut-Slope
Shasta Trinity N.F. Region 5

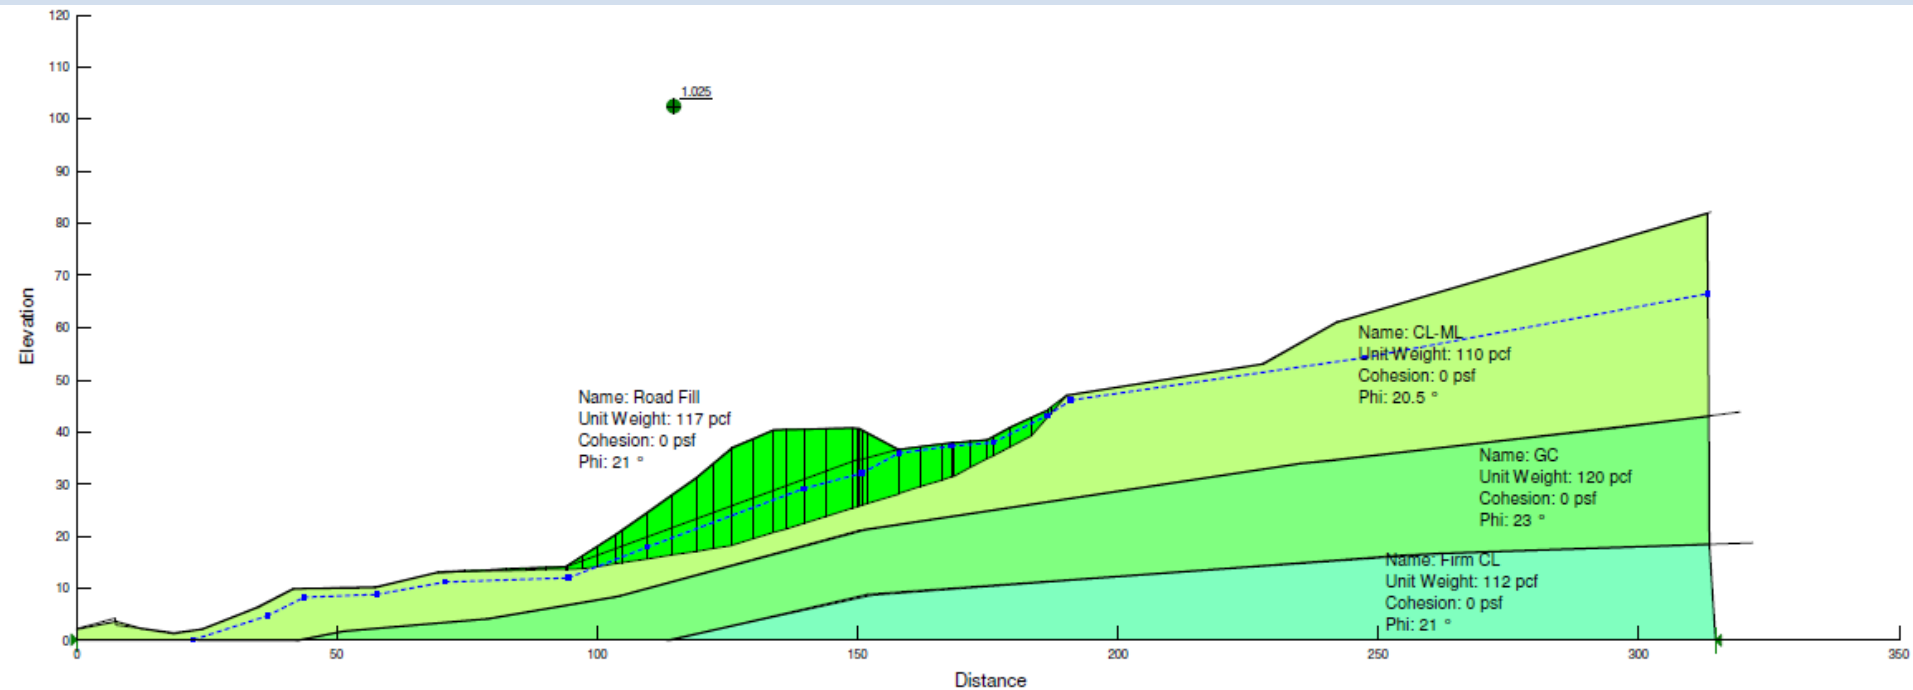
Station 1+20 – first failure

Existing Ground

- Using field data
 - Come up with a layering system
 - Determine appropriate phreatic surface
 - Failure scarps to tie in a reasonable failure plane
 - Failure plane used to refine soil properties at $FS \sim 1$ for an existing ground model

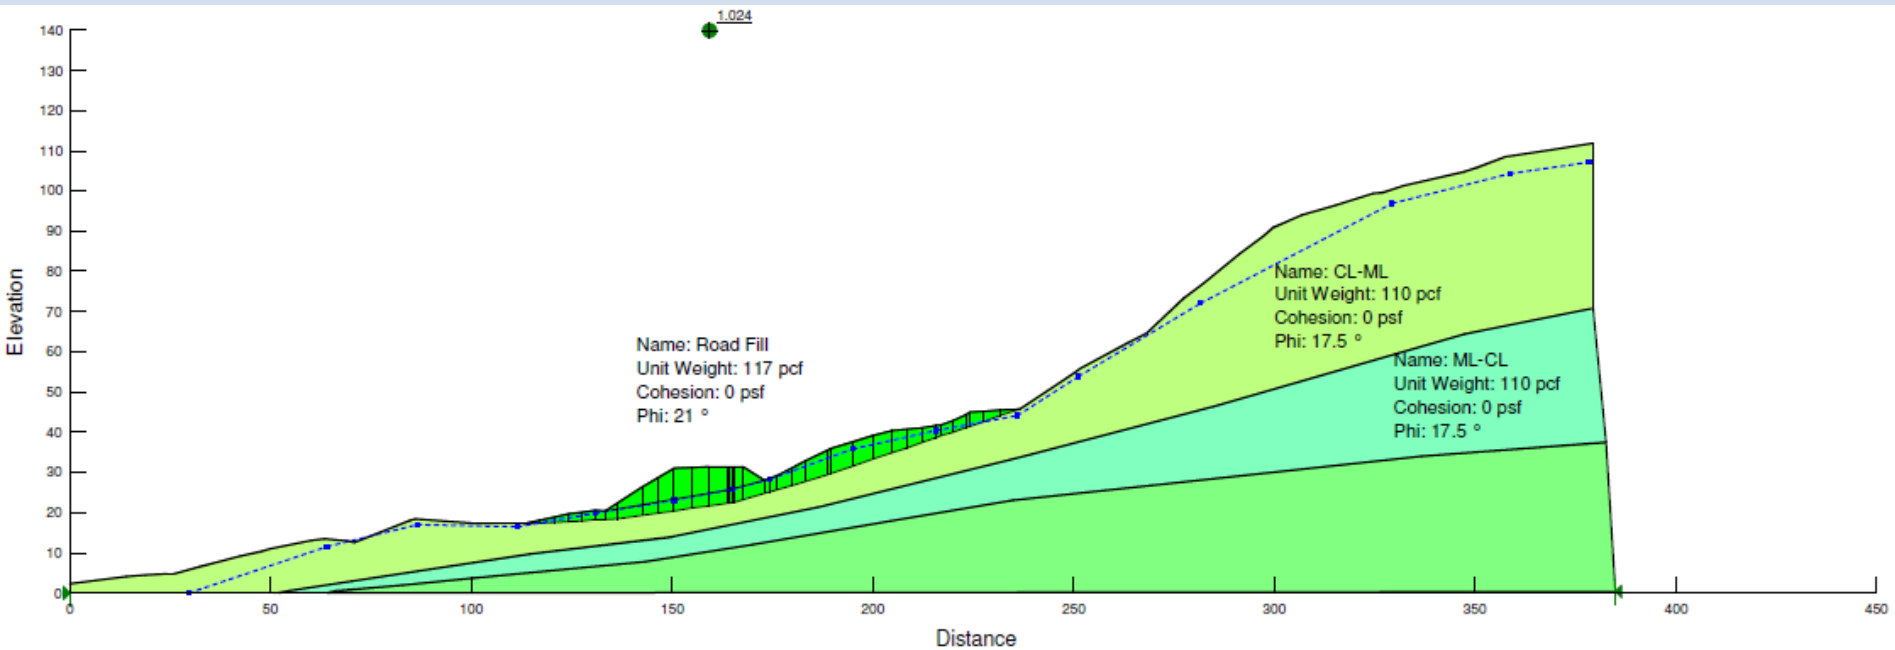
Station 3+00 – second failure

Existing Ground

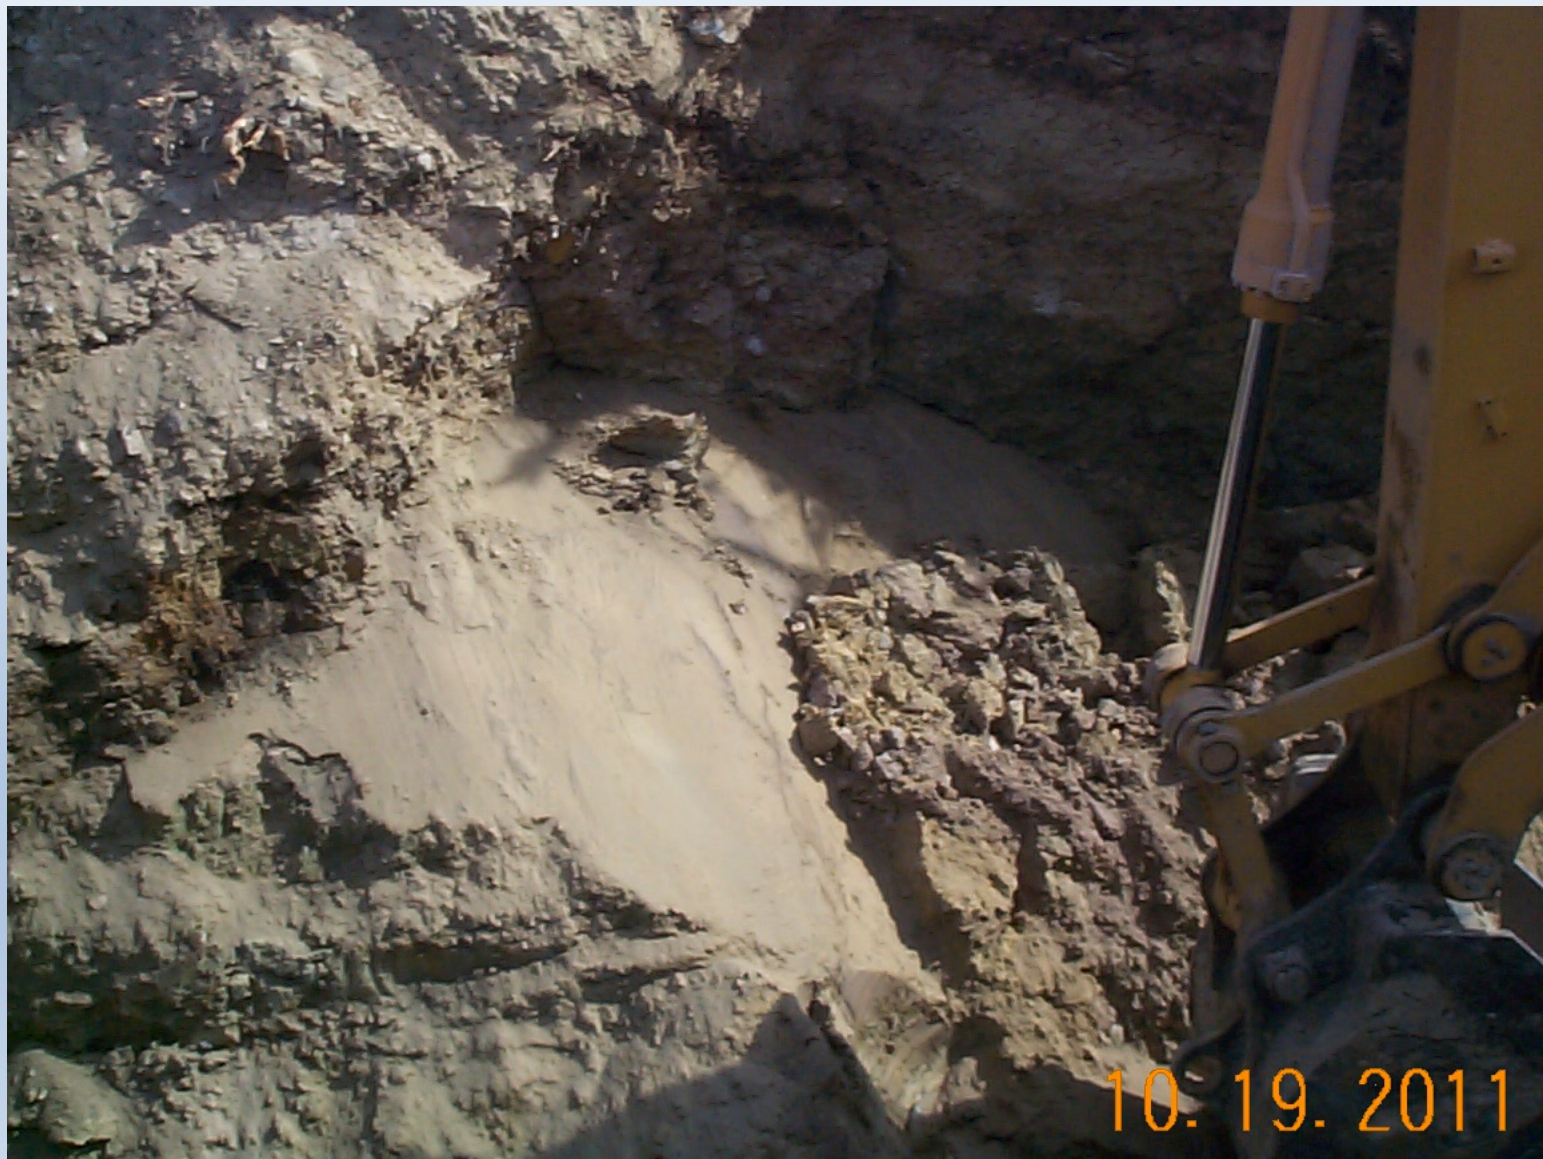
Slide Plane!

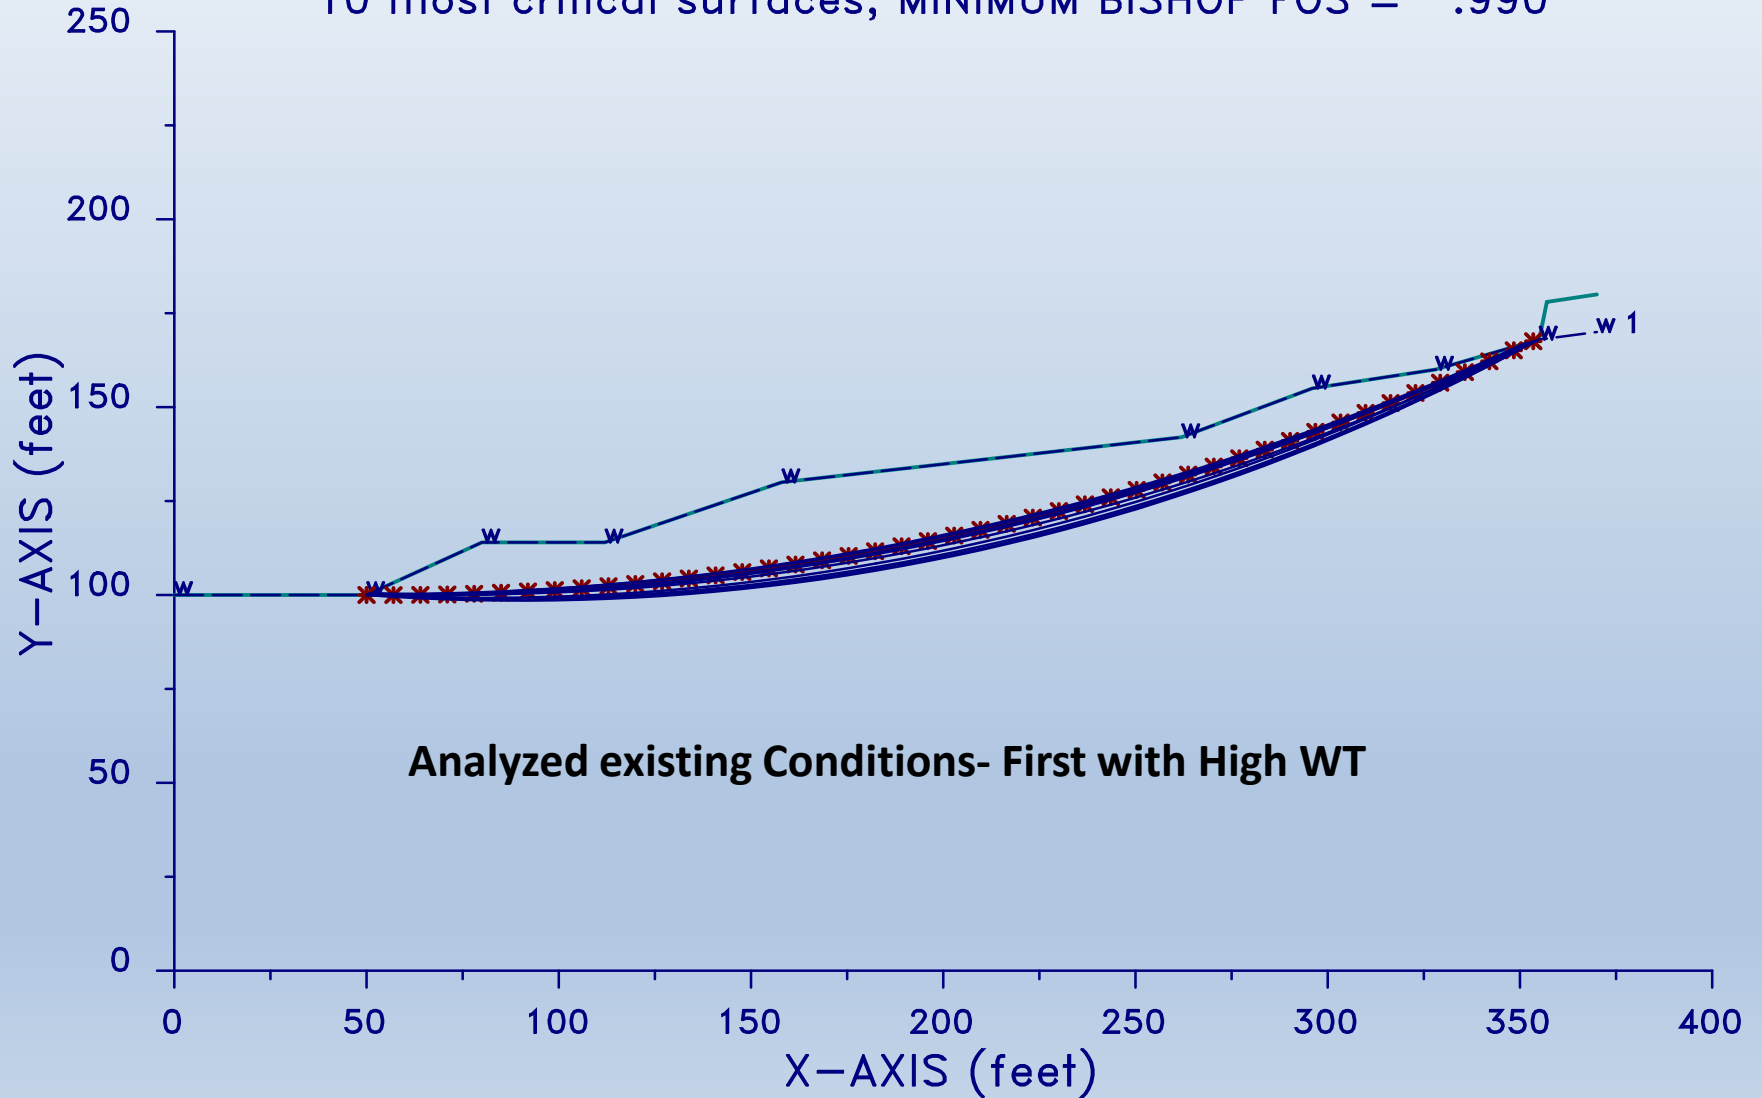
Teton Slump Orig Failure with WT

10 most critical surfaces, MINIMUM BISHOP FOS = .990

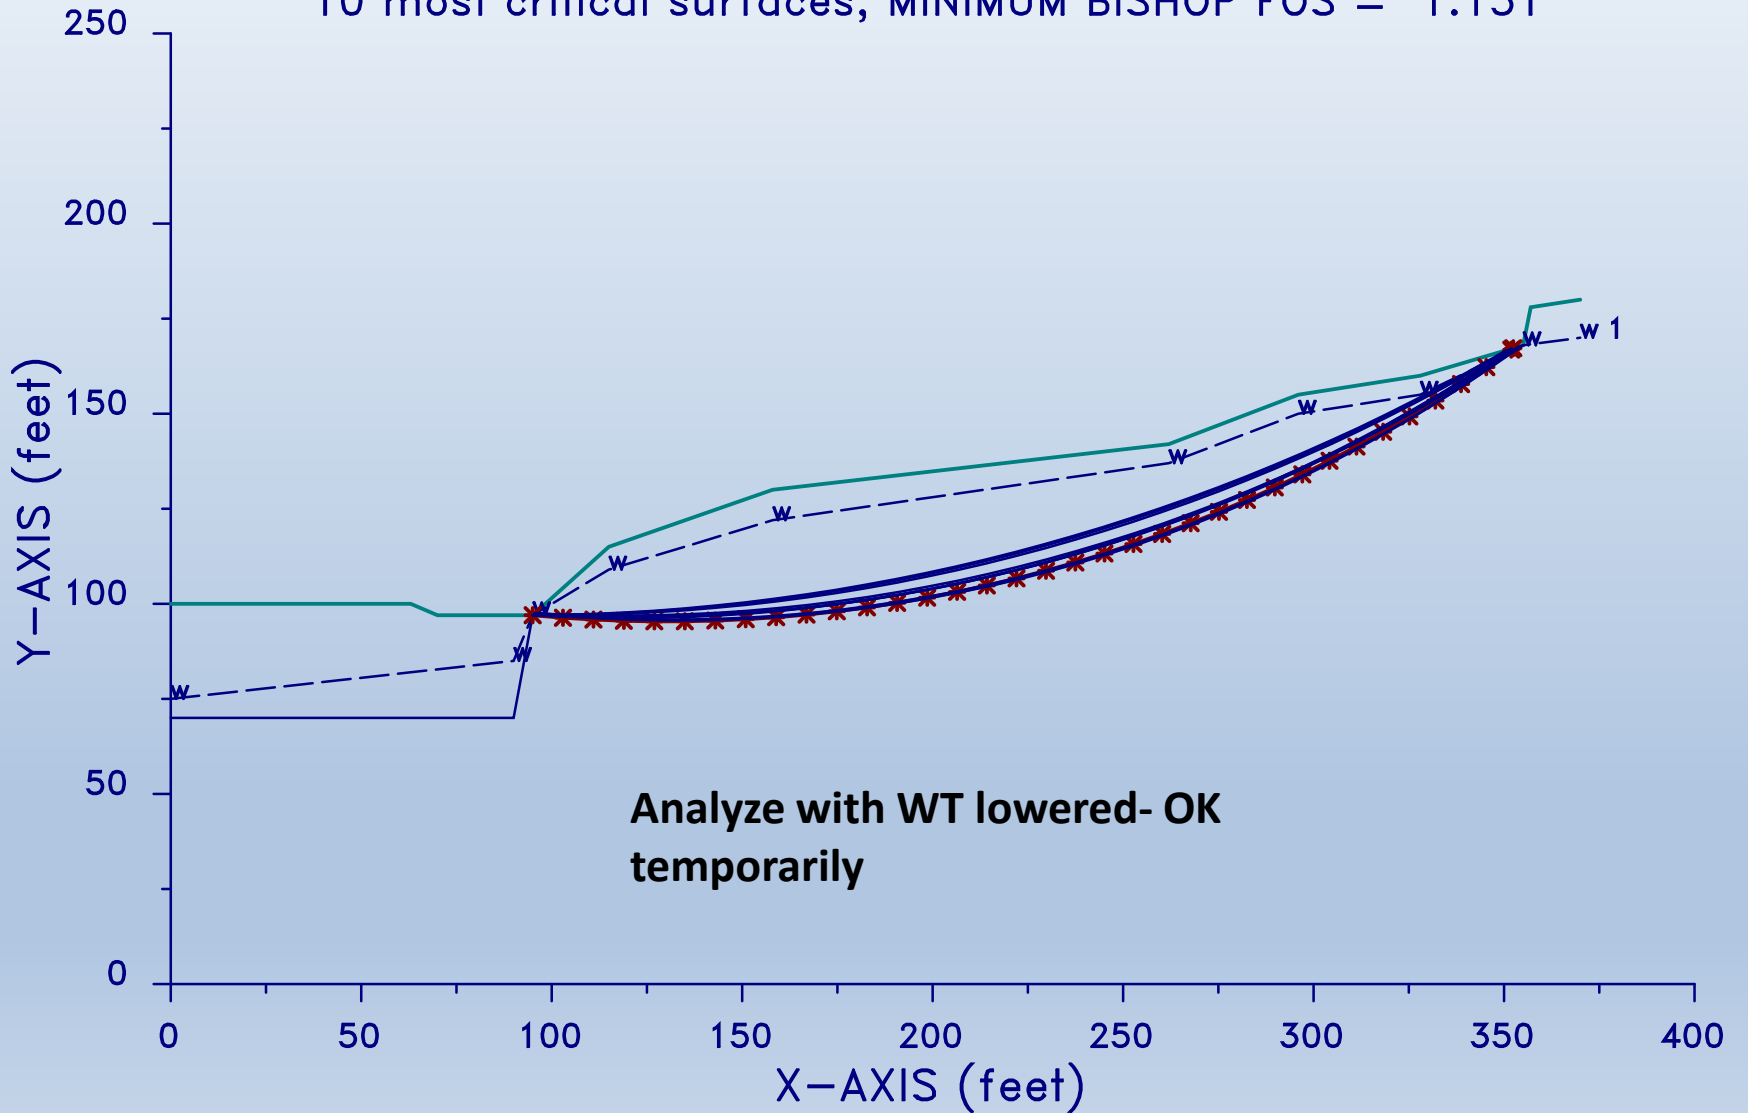
NF Teton Slide Const Cut Low WT

10 most critical surfaces, MINIMUM BISHOP FOS = 1.151

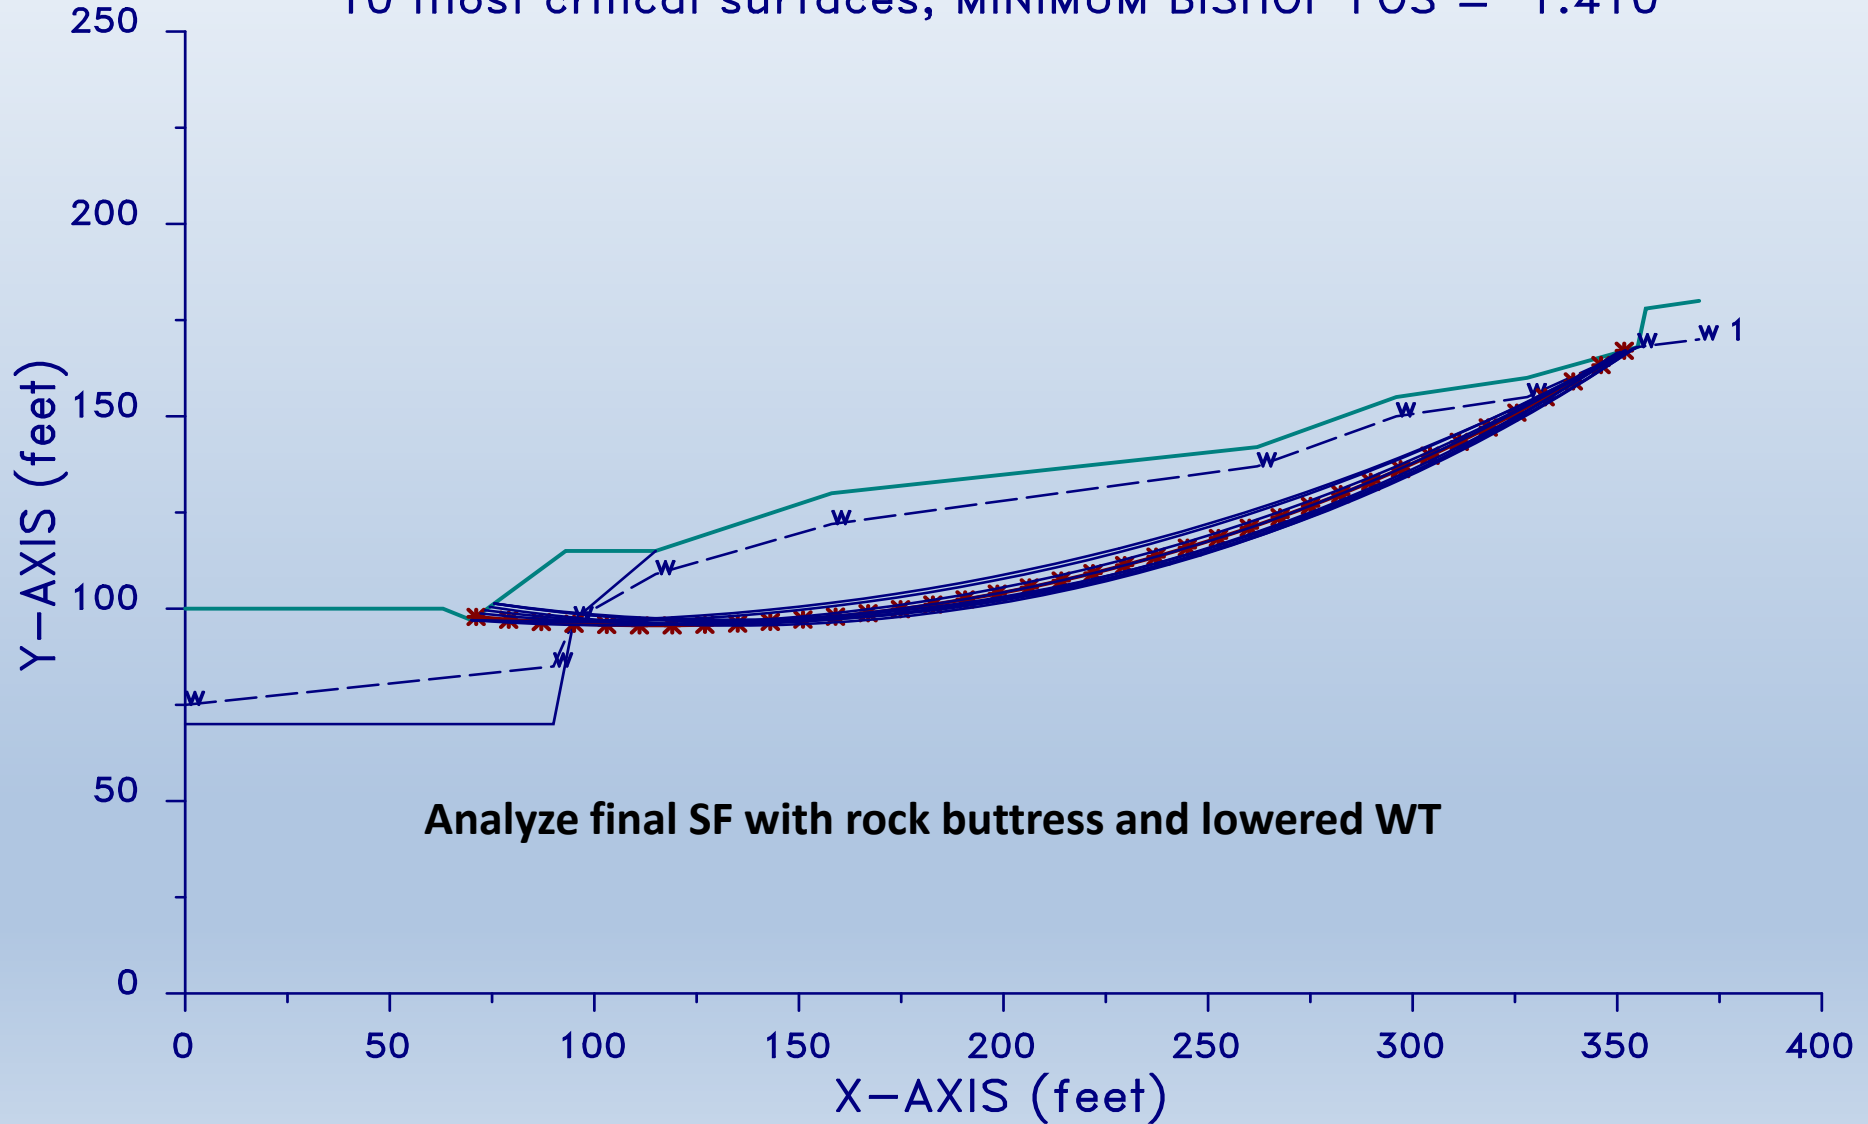
NF Teton Slide Small Buttress-WTlow

10 most critical surfaces, MINIMUM BISHOP FOS = 1.410
