Slope Stabilization Case Studies

SLOPE STABILIZATION CASE STUDIES IN A FOREST ENVIRONMENT

“Typical Landslide, Cut/Fill Slope Problems Encountered on Low Volume Roads in Steep Mountainous Terrain and Their Solutions”

Courtesy of: Ed Rose (Retired)
R1 Geotechnical Engineer

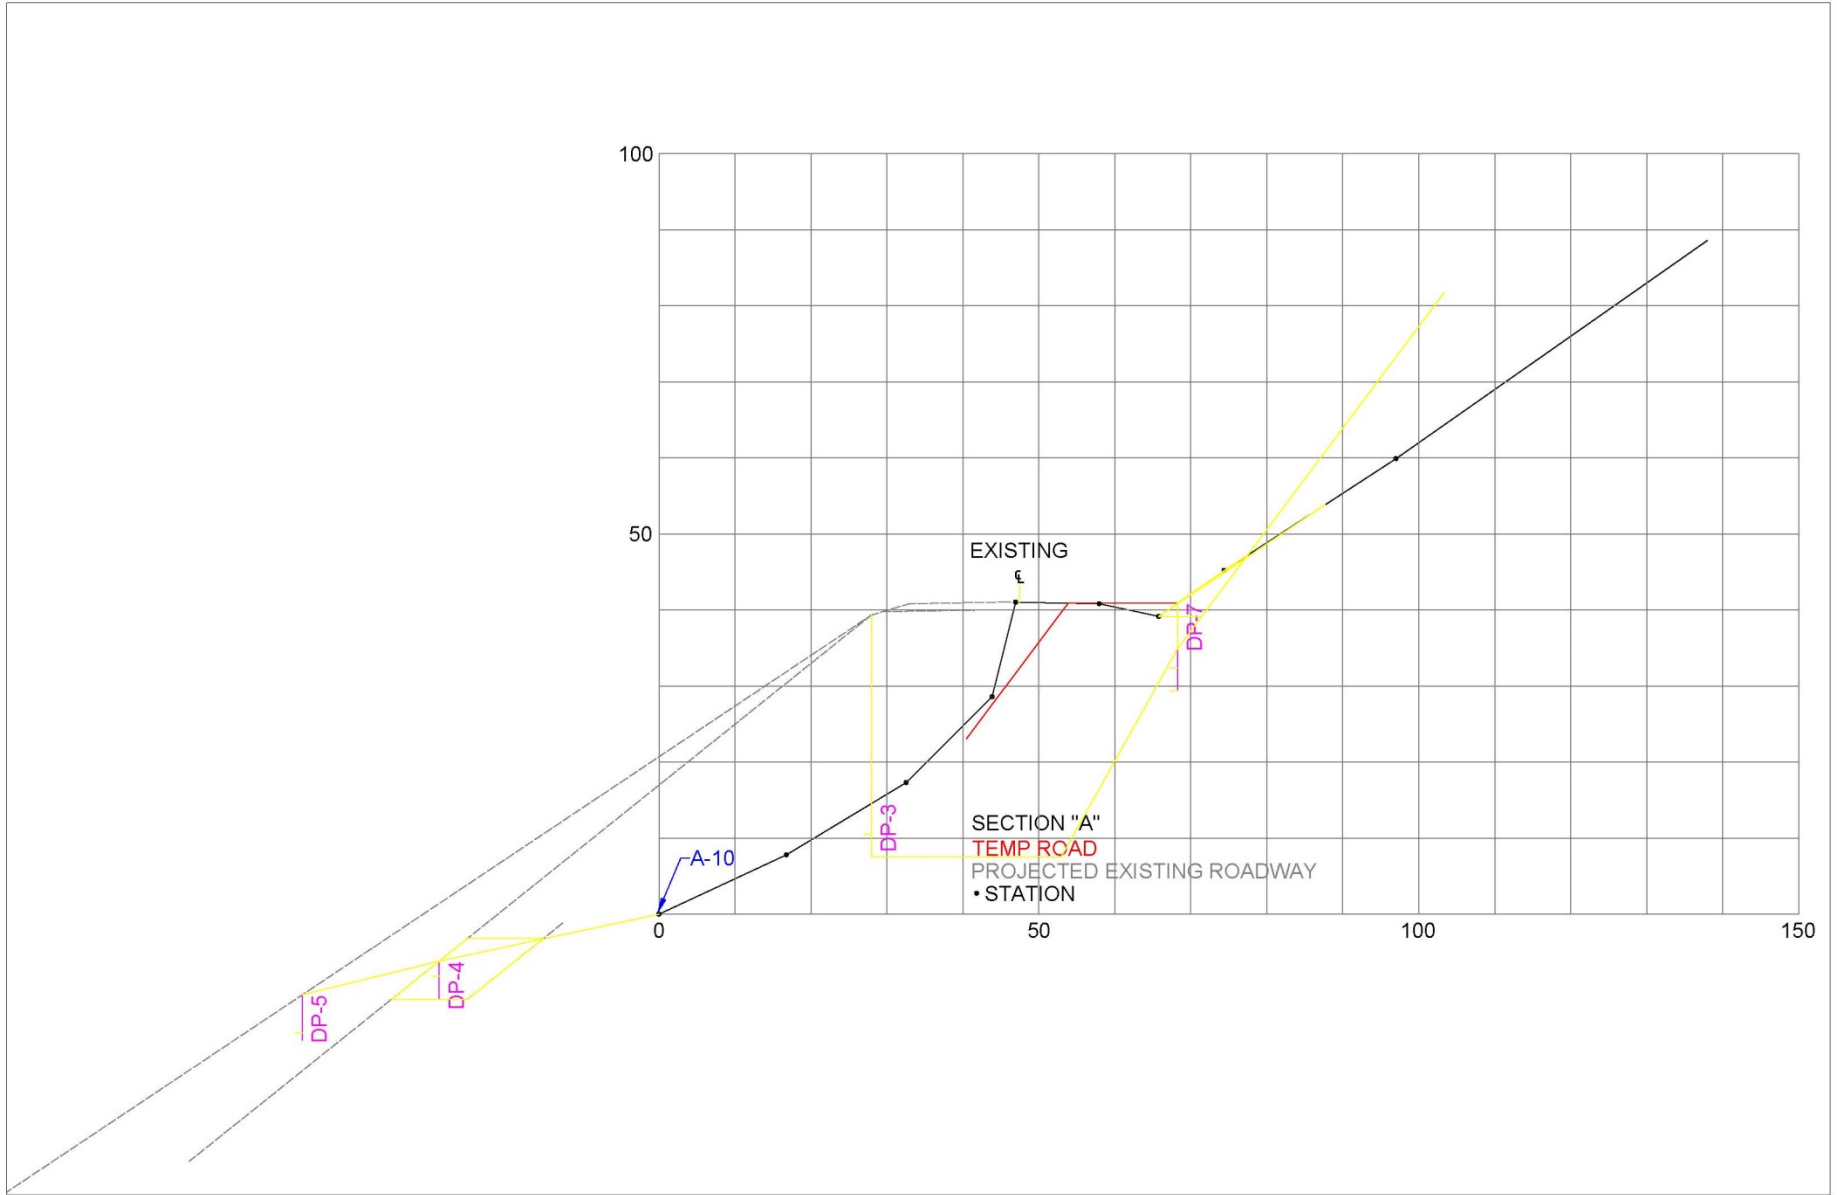
Final Subsurface Interpretation

- **Based on surface and drive probe information only**
- **See following “Geologic Cross-Sections”**
