# 2014 Oso Slide

The last 45,000 Years:

*Our*  
Observations and Current Thoughts  
On The

Geology and Failure Development/Causes

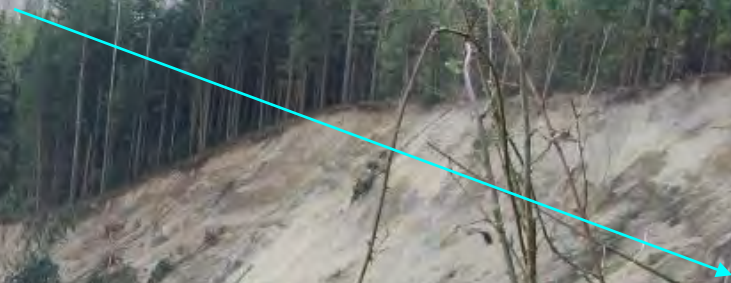
3/25/14 Photo Courtesy Snohomish County

Western Head Scarp

Aquitard

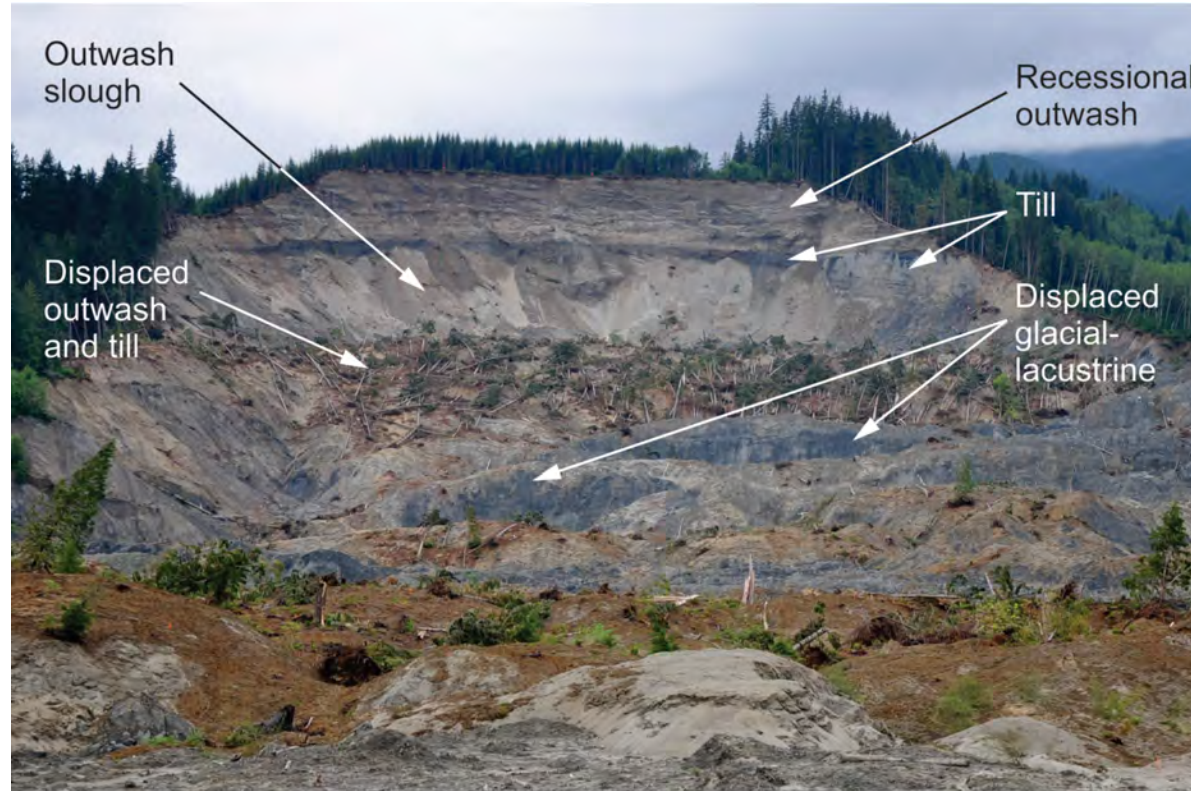
# Whitman Bench Stratigraphy (GEER, 7/22/14)

Overview of Slope Movement from SE  
From GEER Report 7/22/14

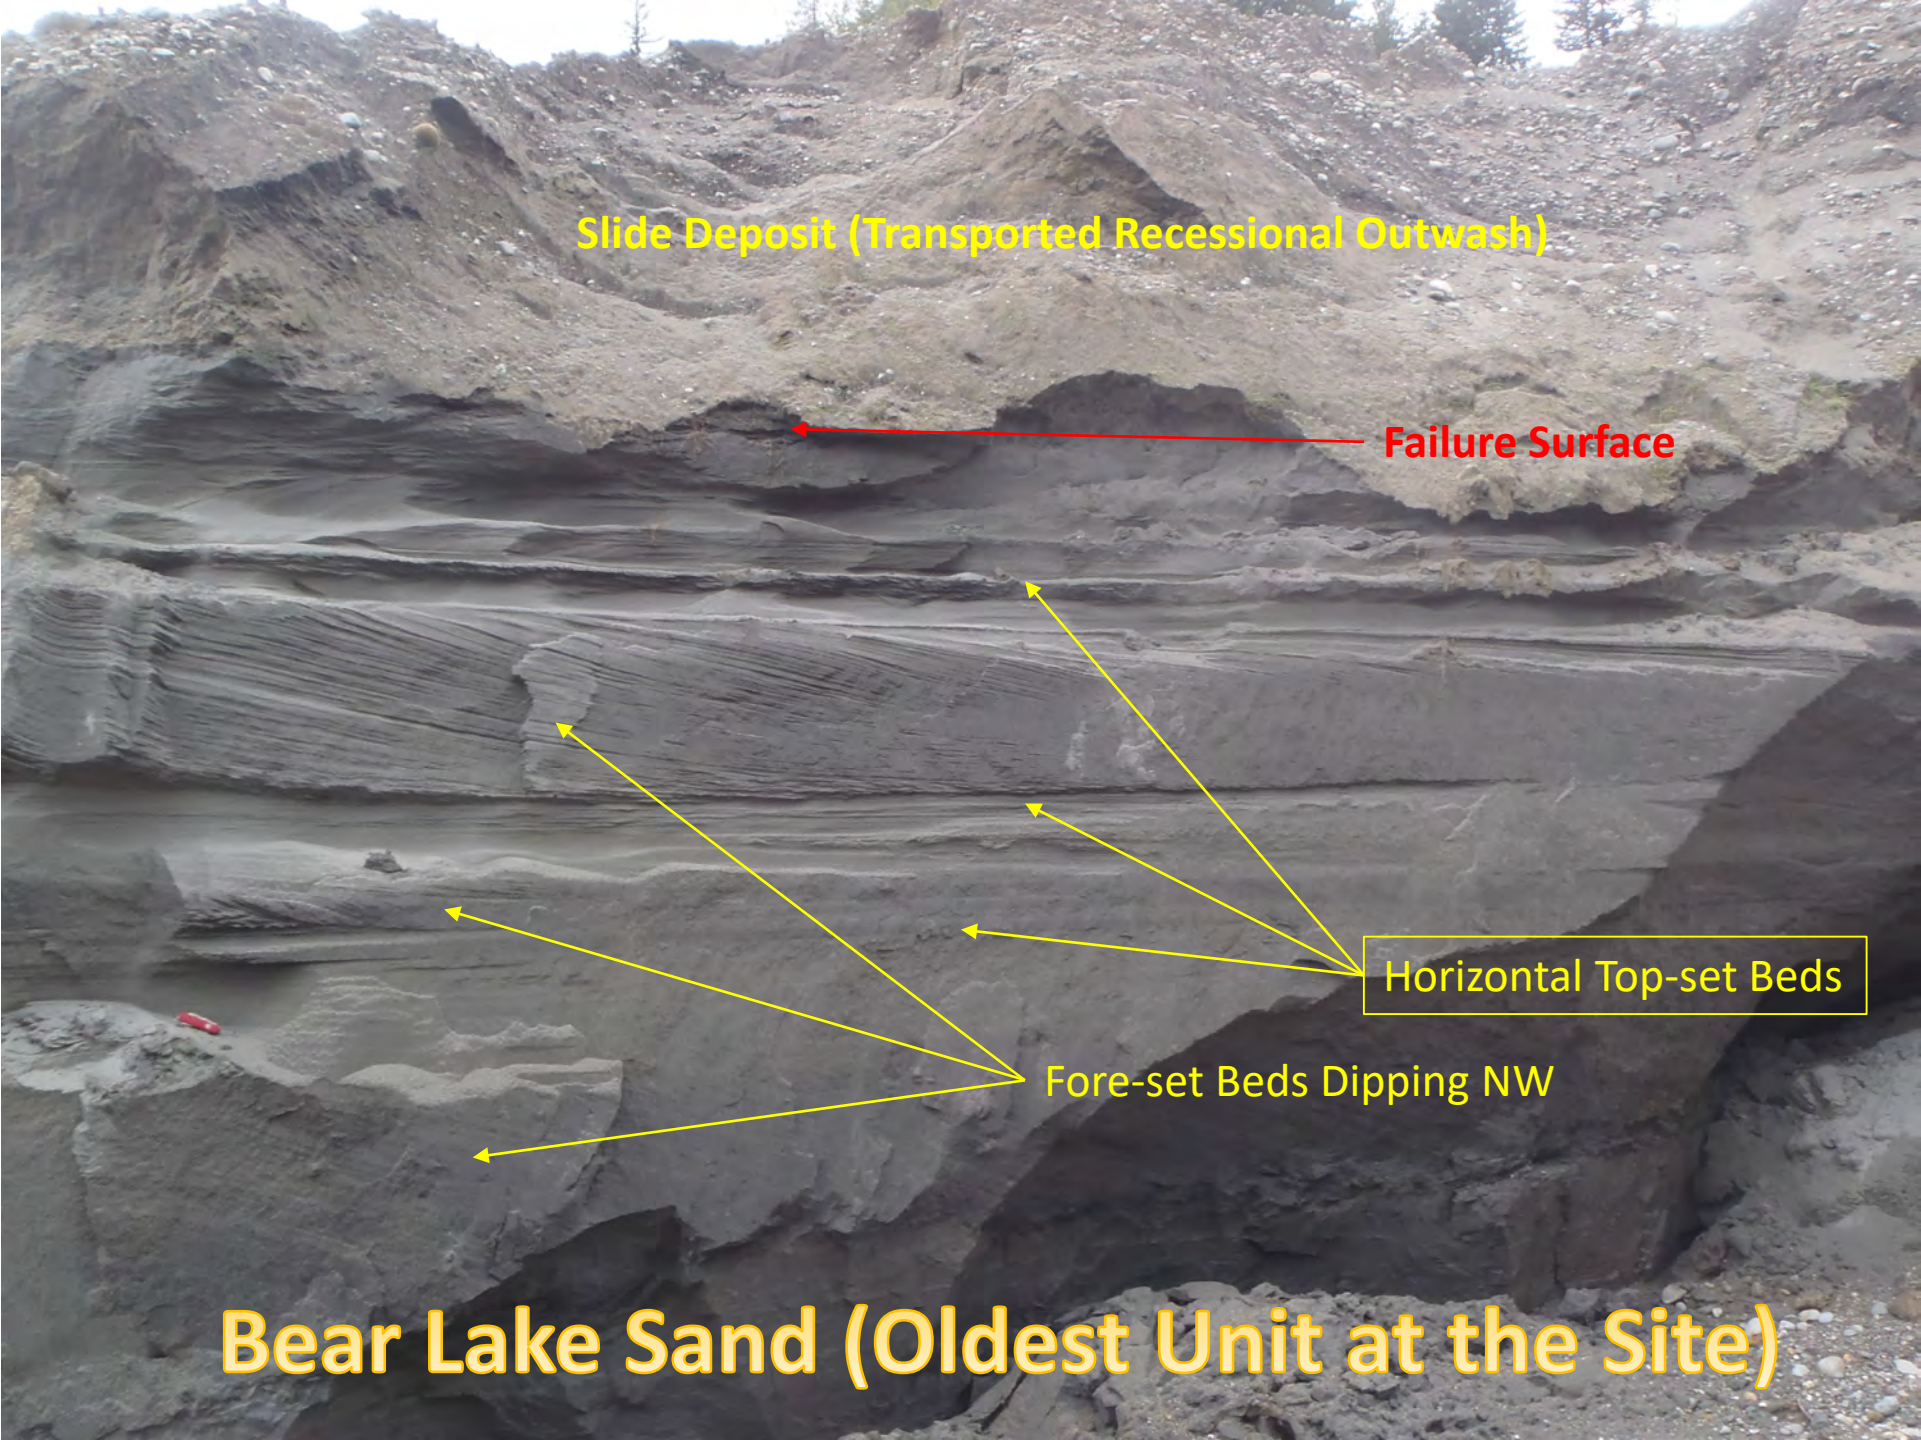
**Slide Deposit (Transported Recessional Outwash)**

**Failure Surface**

**Horizontal Top-set Beds**

**Fore-set Beds Dipping NW**

**Bear Lake Sand (Oldest Unit at the Site)**

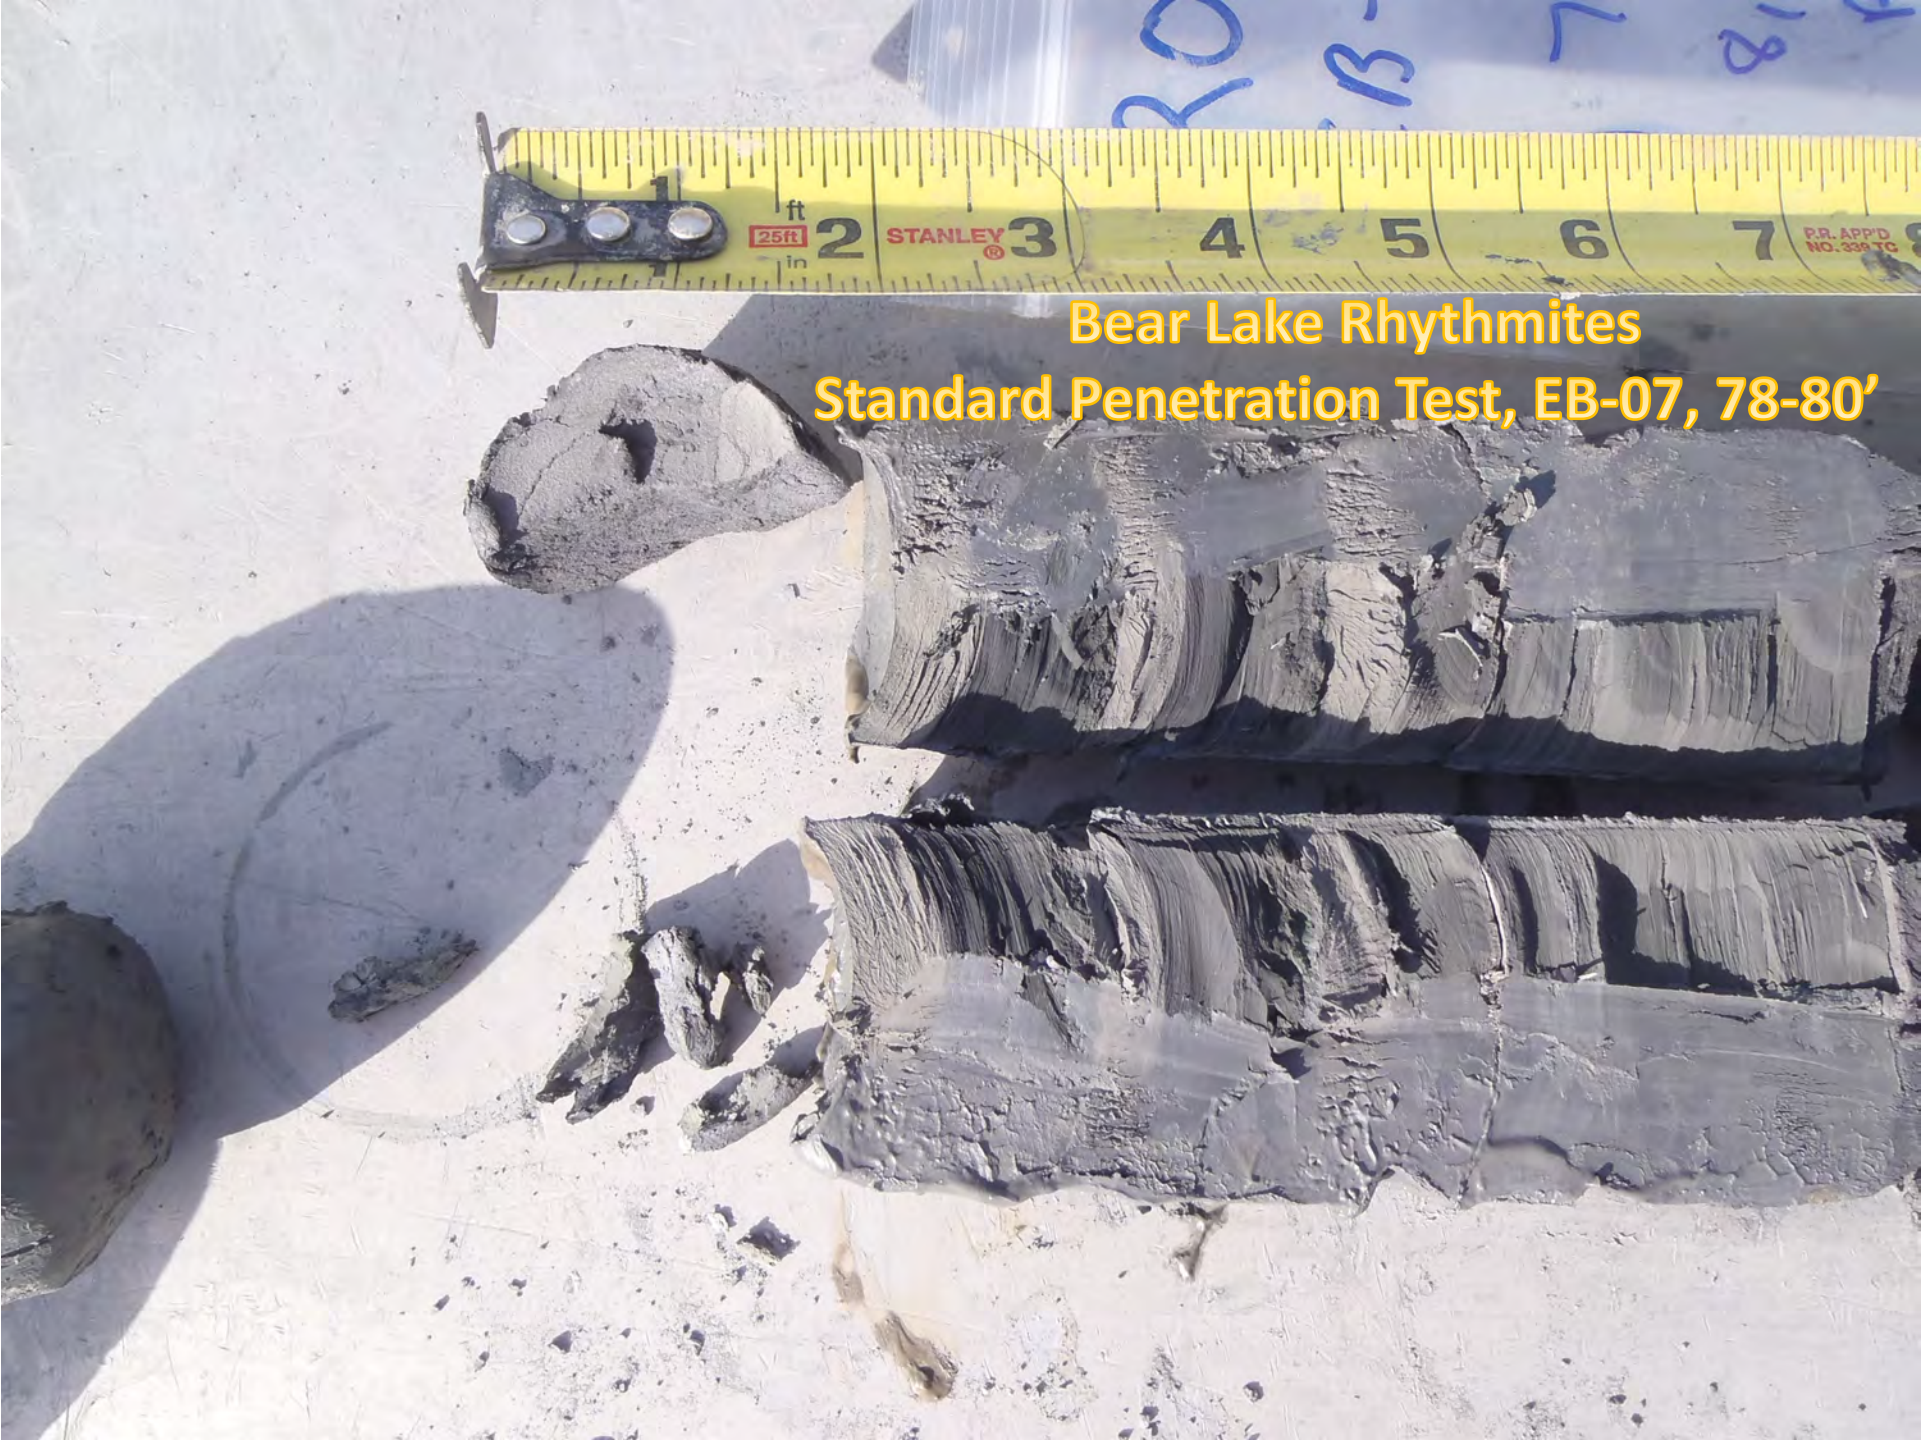
**Bear Lake Rhythmites  
Standard Penetration Test, EB-07, 78-80'**

**Bear Lake Rhythmites  
Dames and Moore Sampler (2.5" ID)**

**Note Thickness of Individual Laminae Smaller than Color Banding**

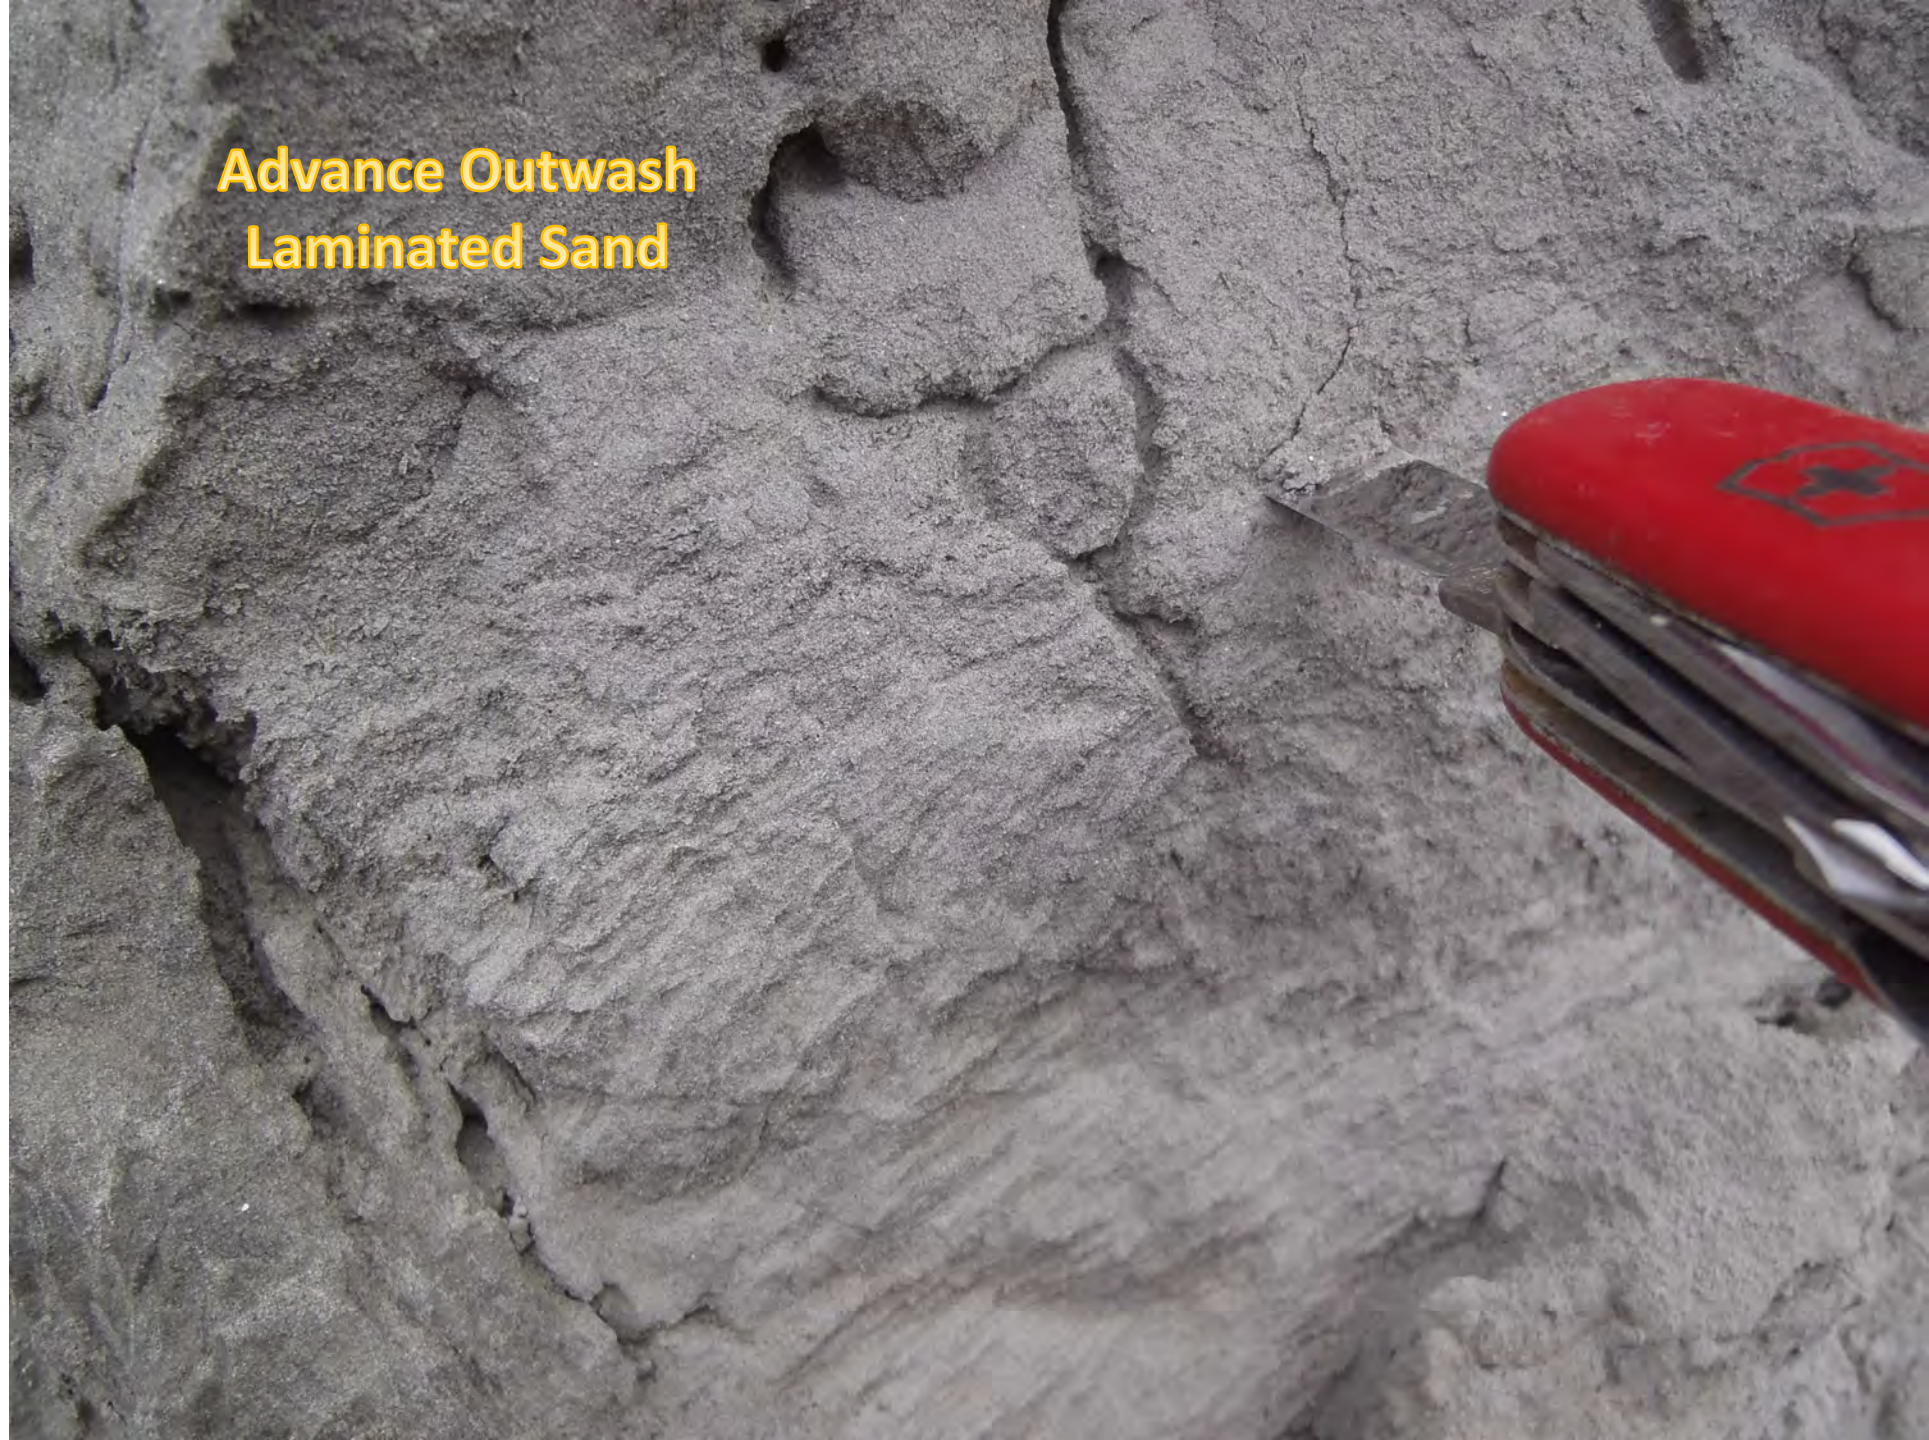
Advance Outwash  
Laminated Sand

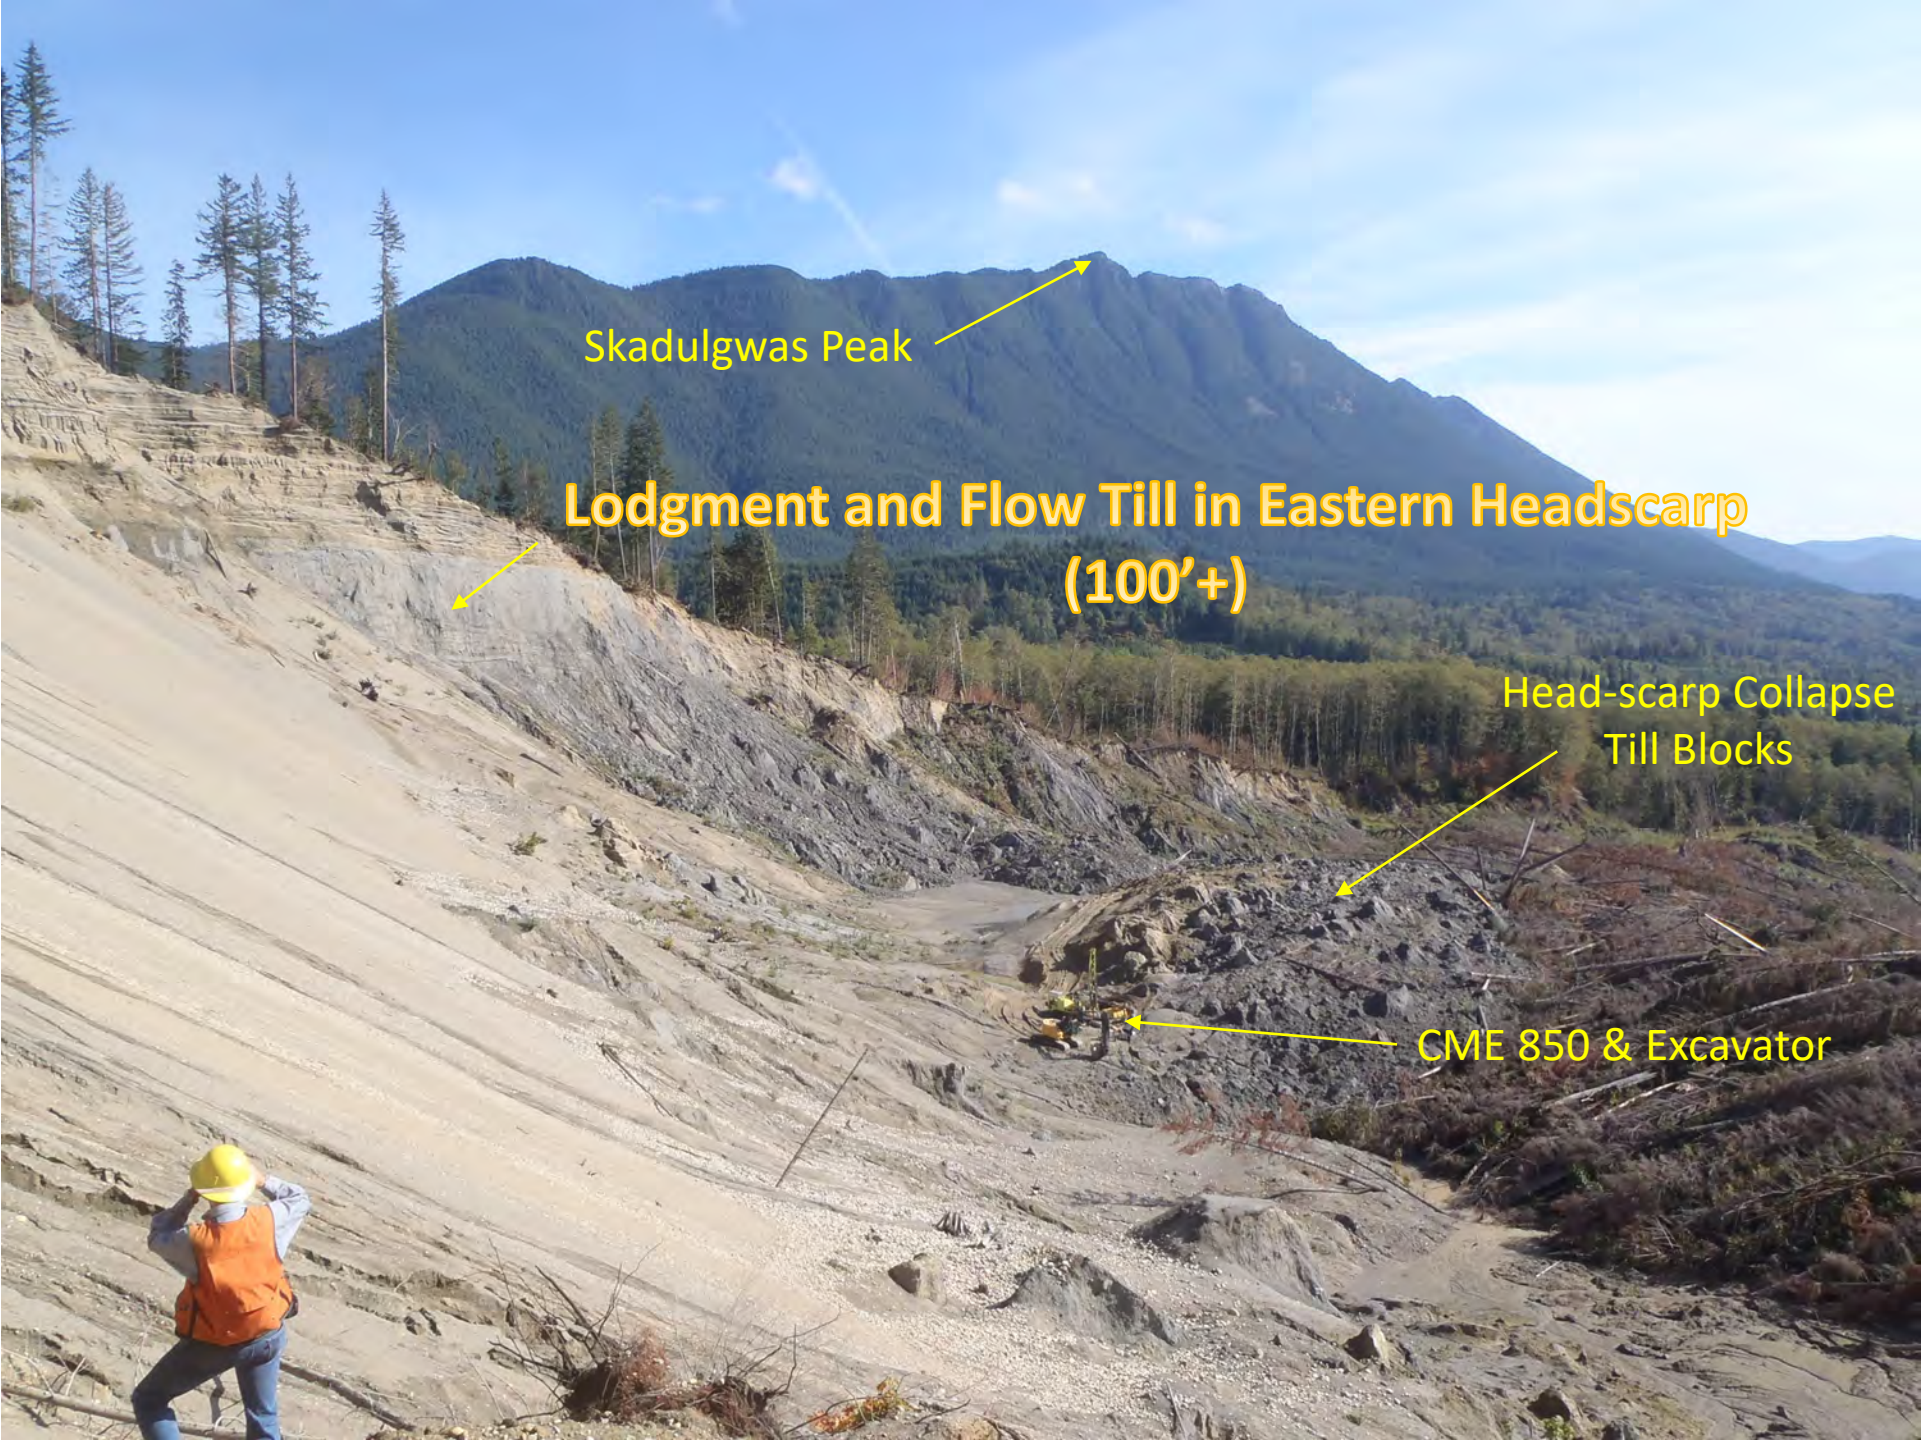
Lodgment and Flow Till in Eastern Headscarp  
(100'+)

Head-scarp Collapse  
Till Blocks

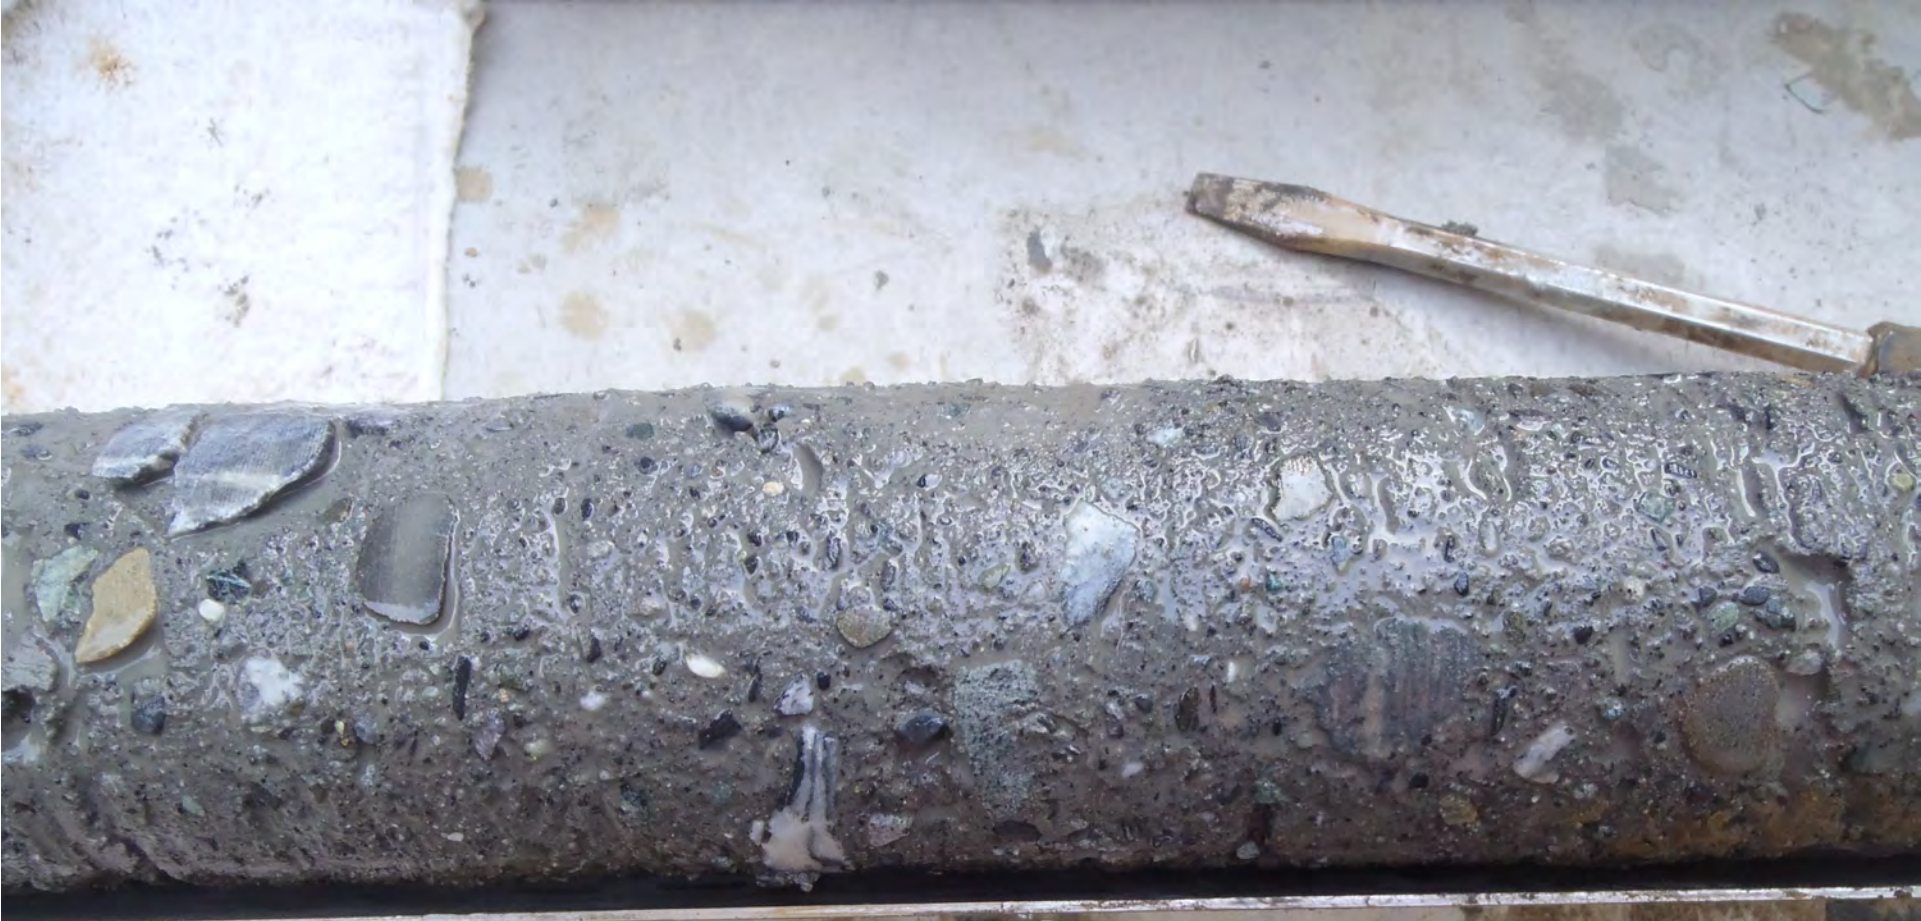
Lodgment Till Core in EB-02

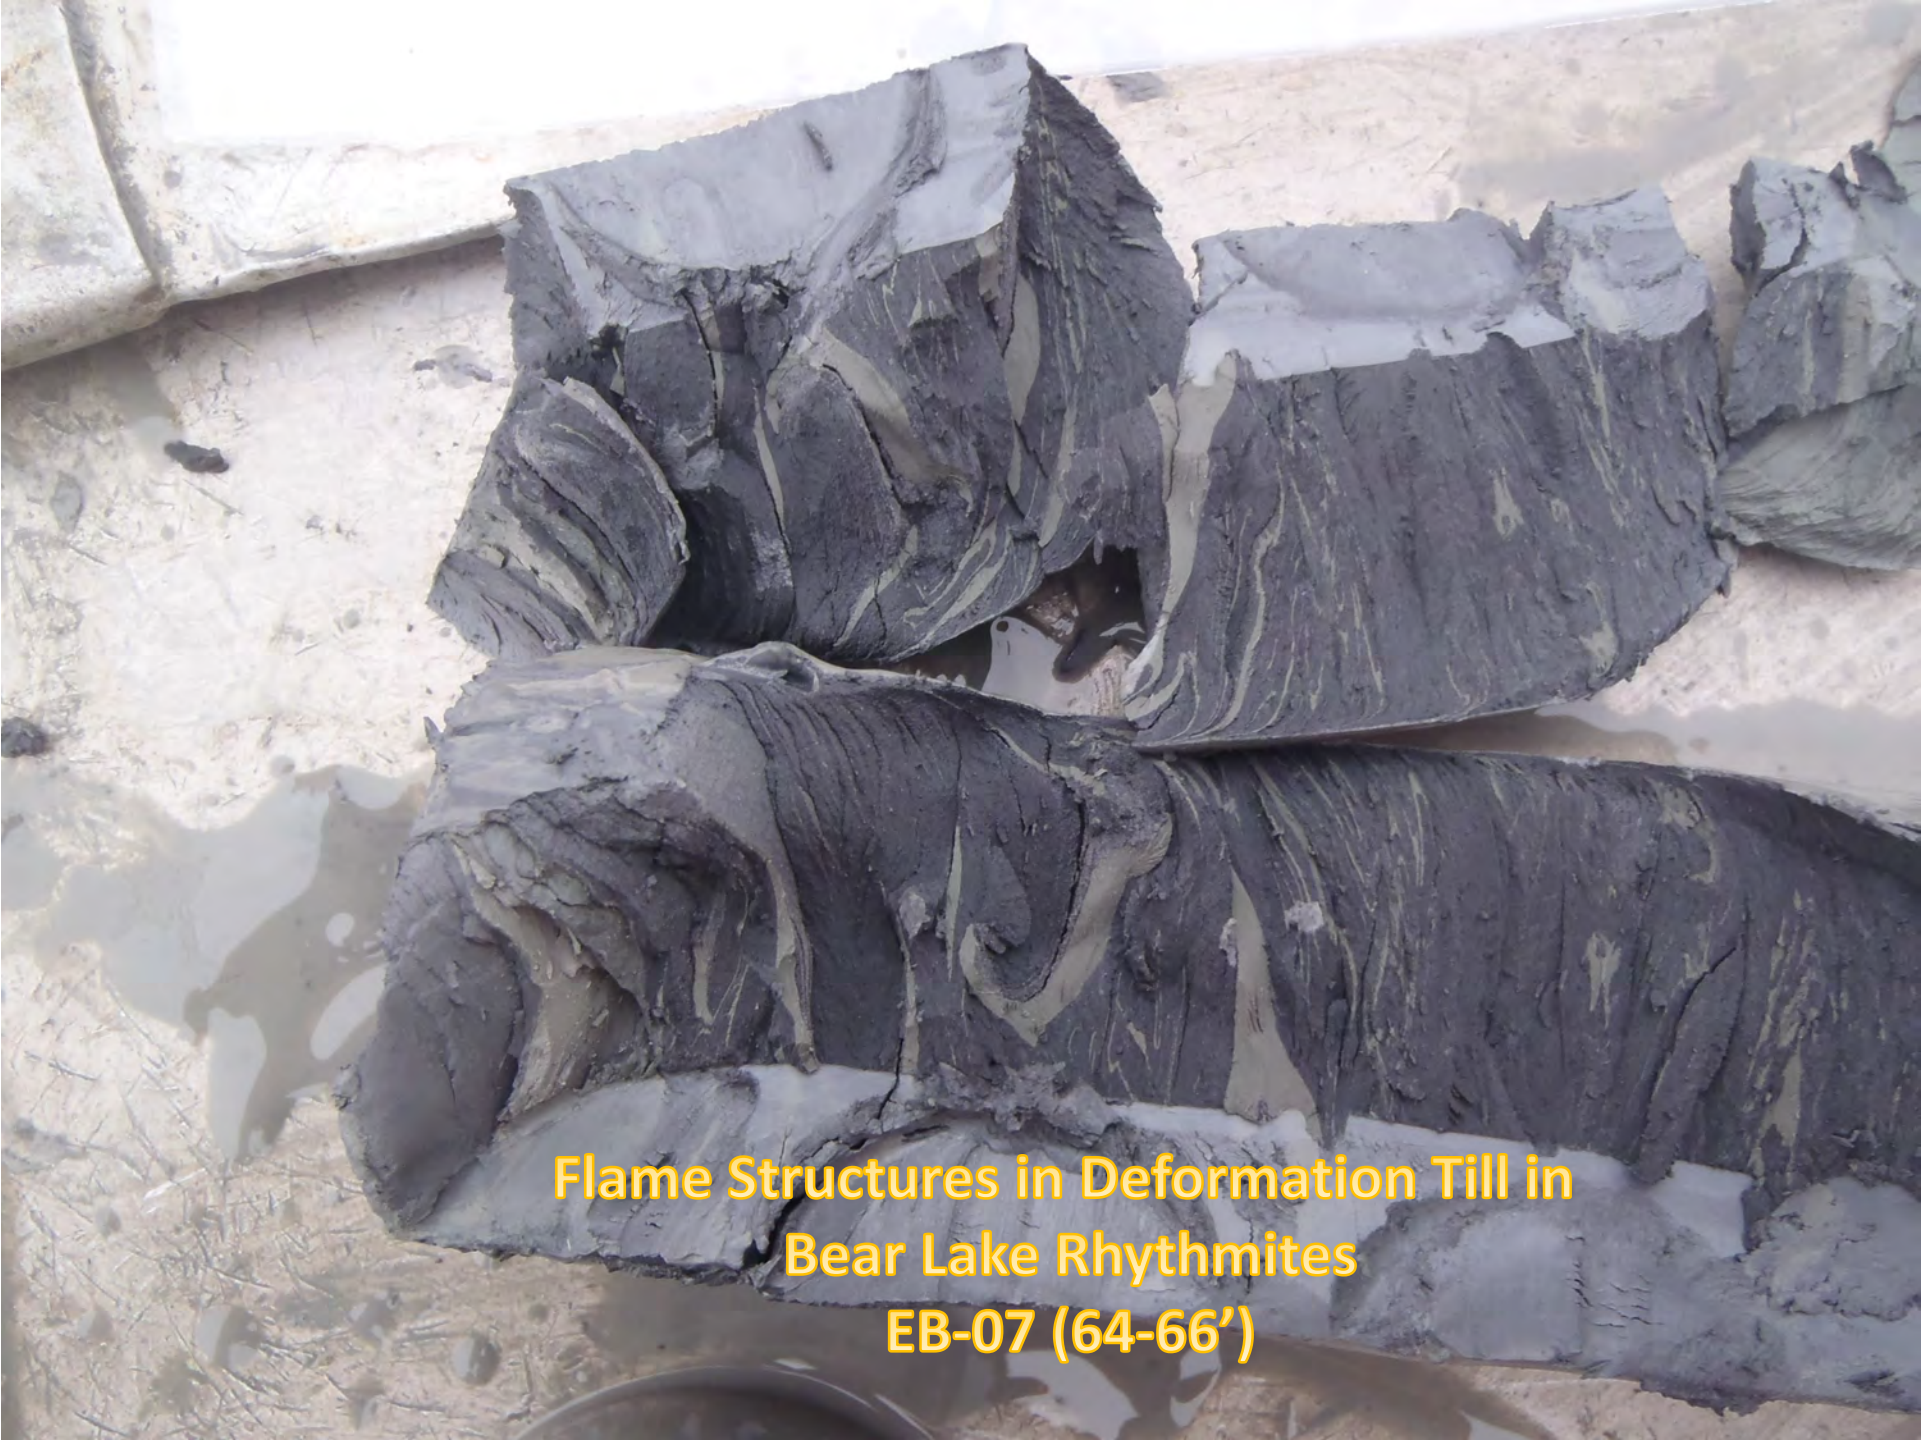
Flame Structures in Deformation Till in  
Bear Lake Rhythmites  
EB-07 (64-66')

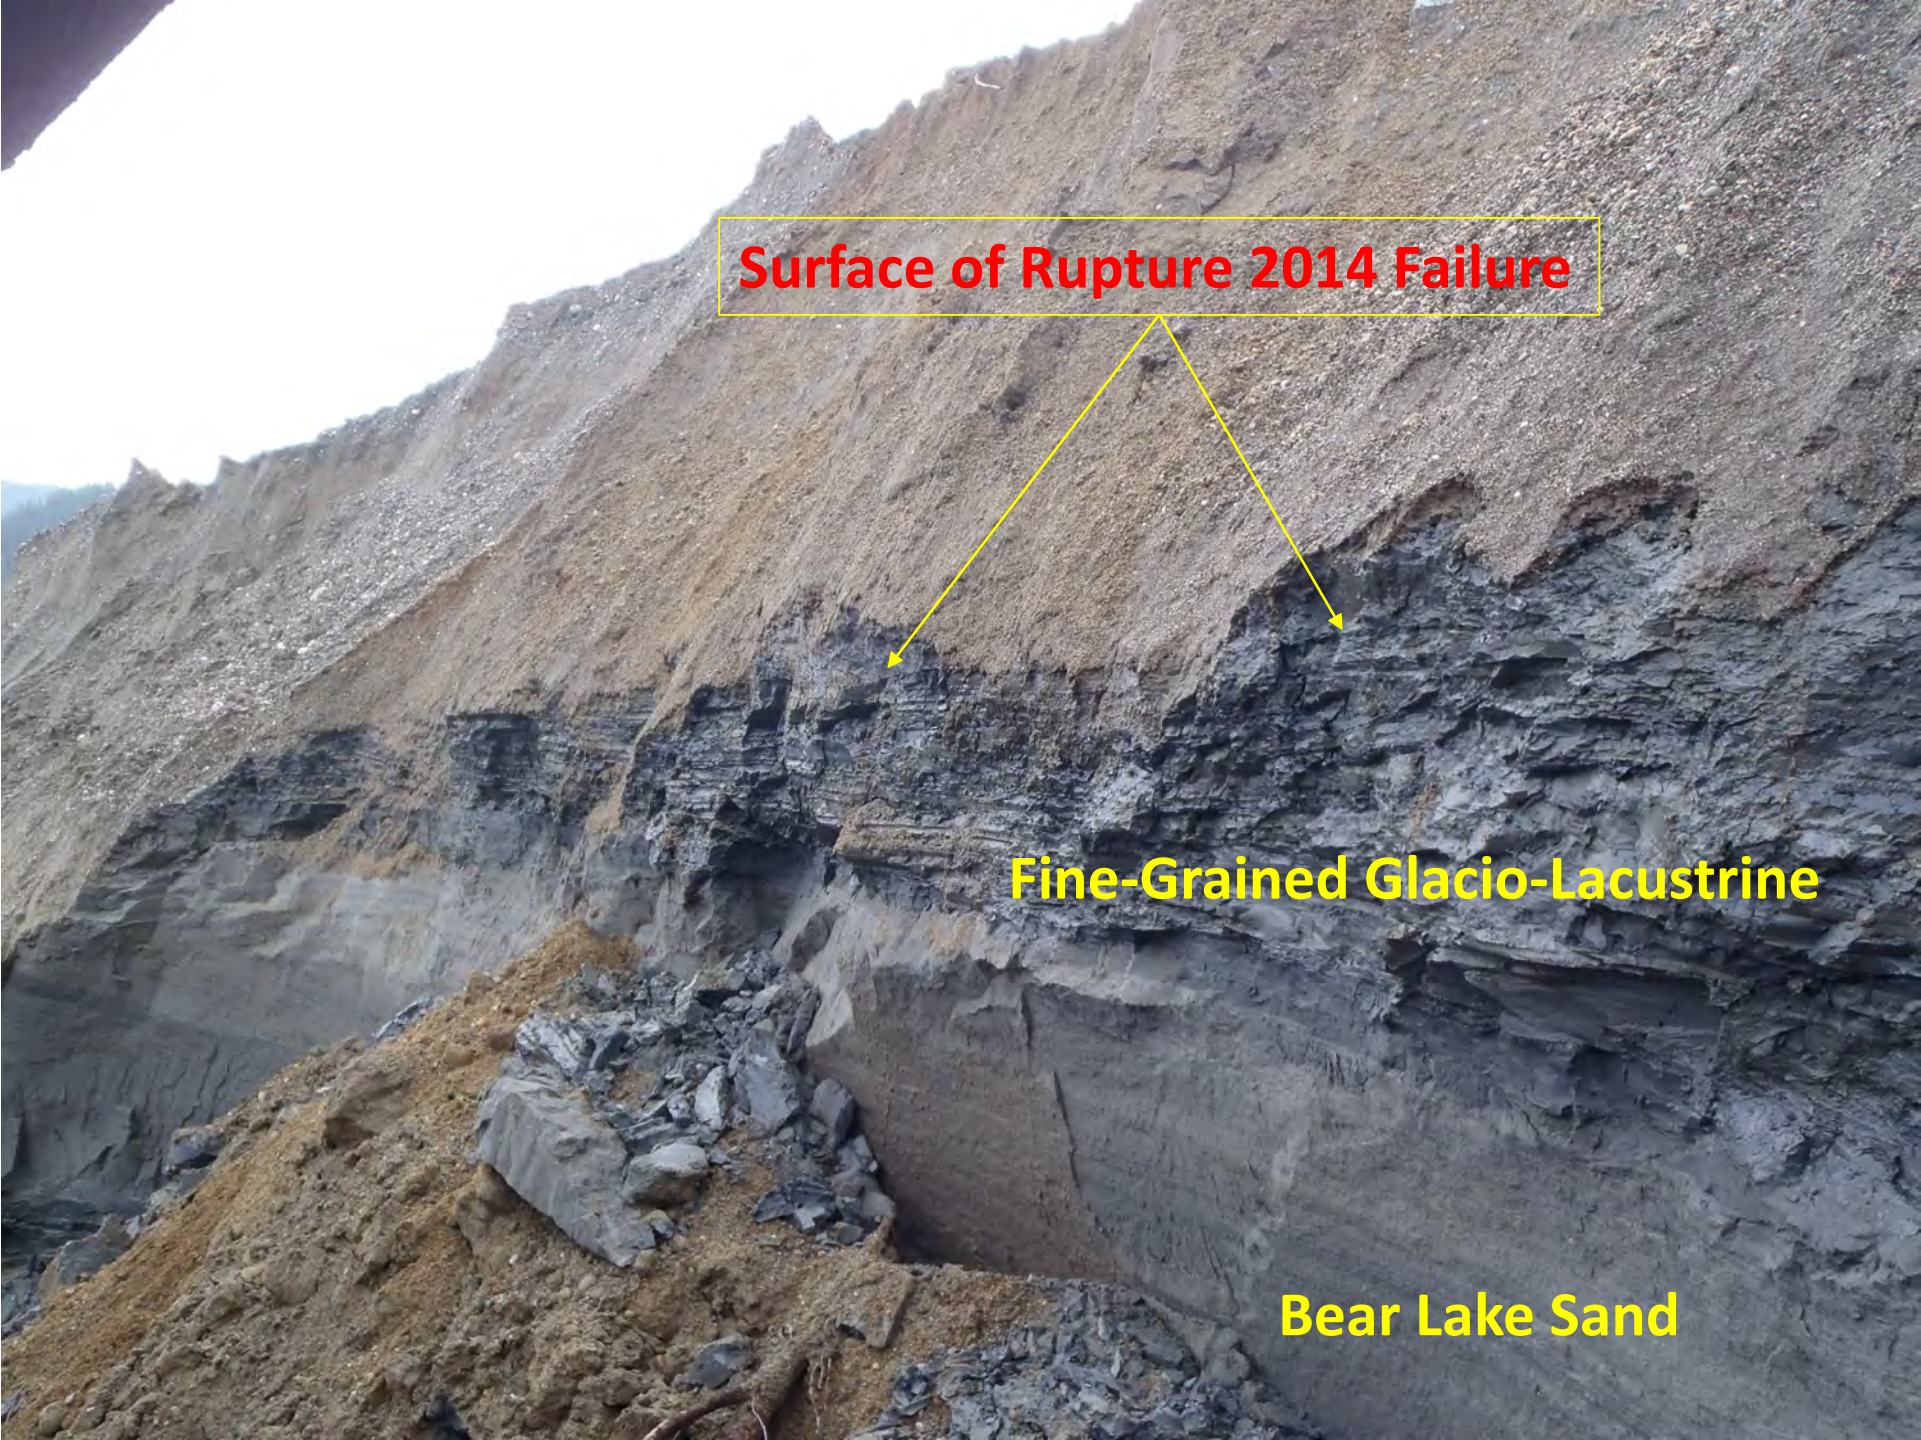
**Whitman bench**

**Mid-Slope Bench**

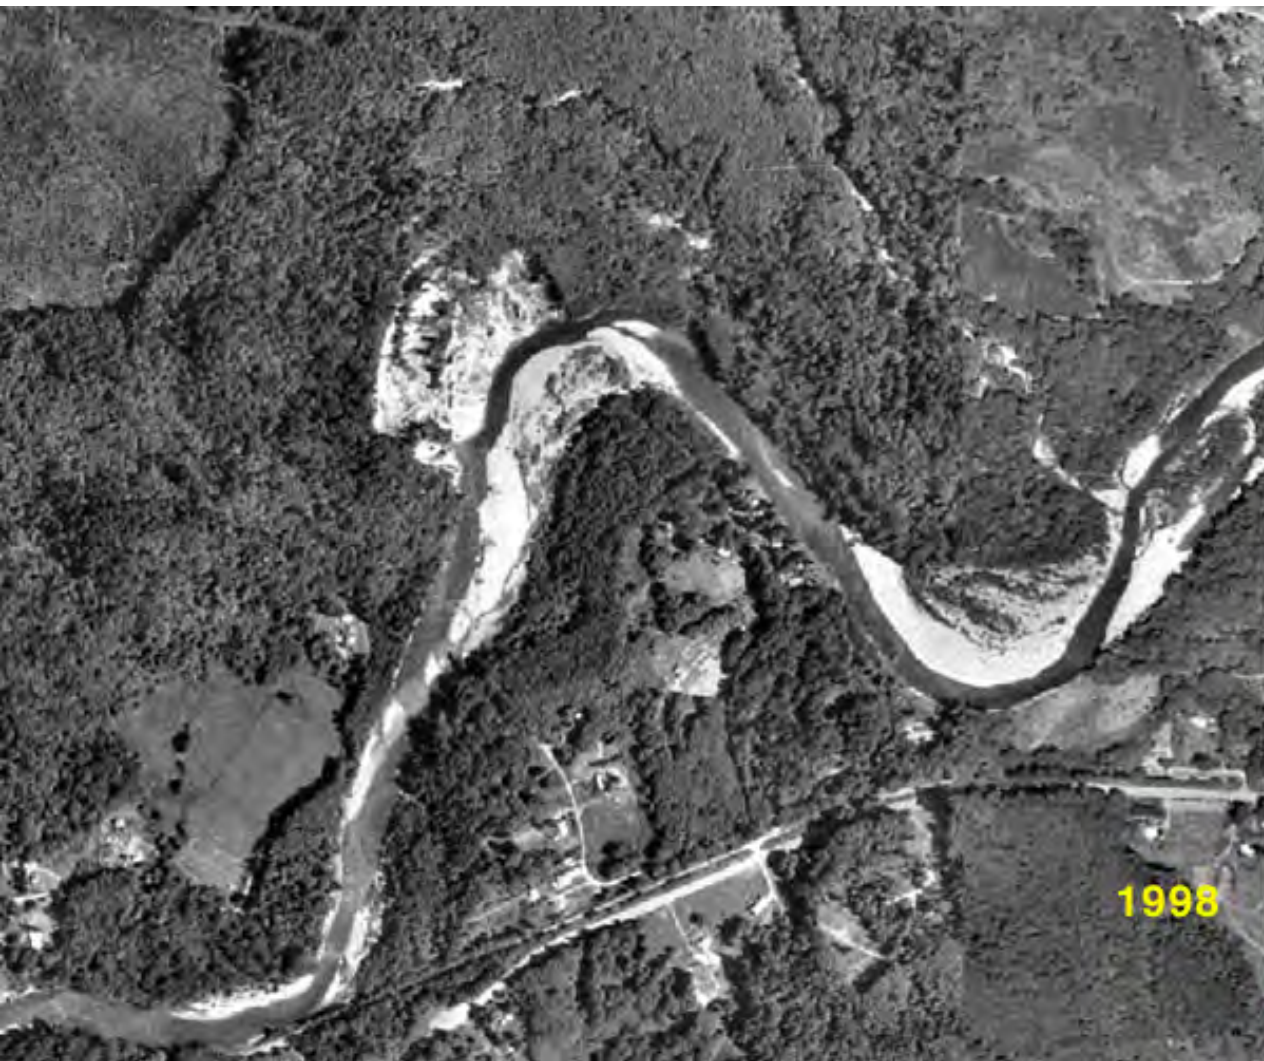
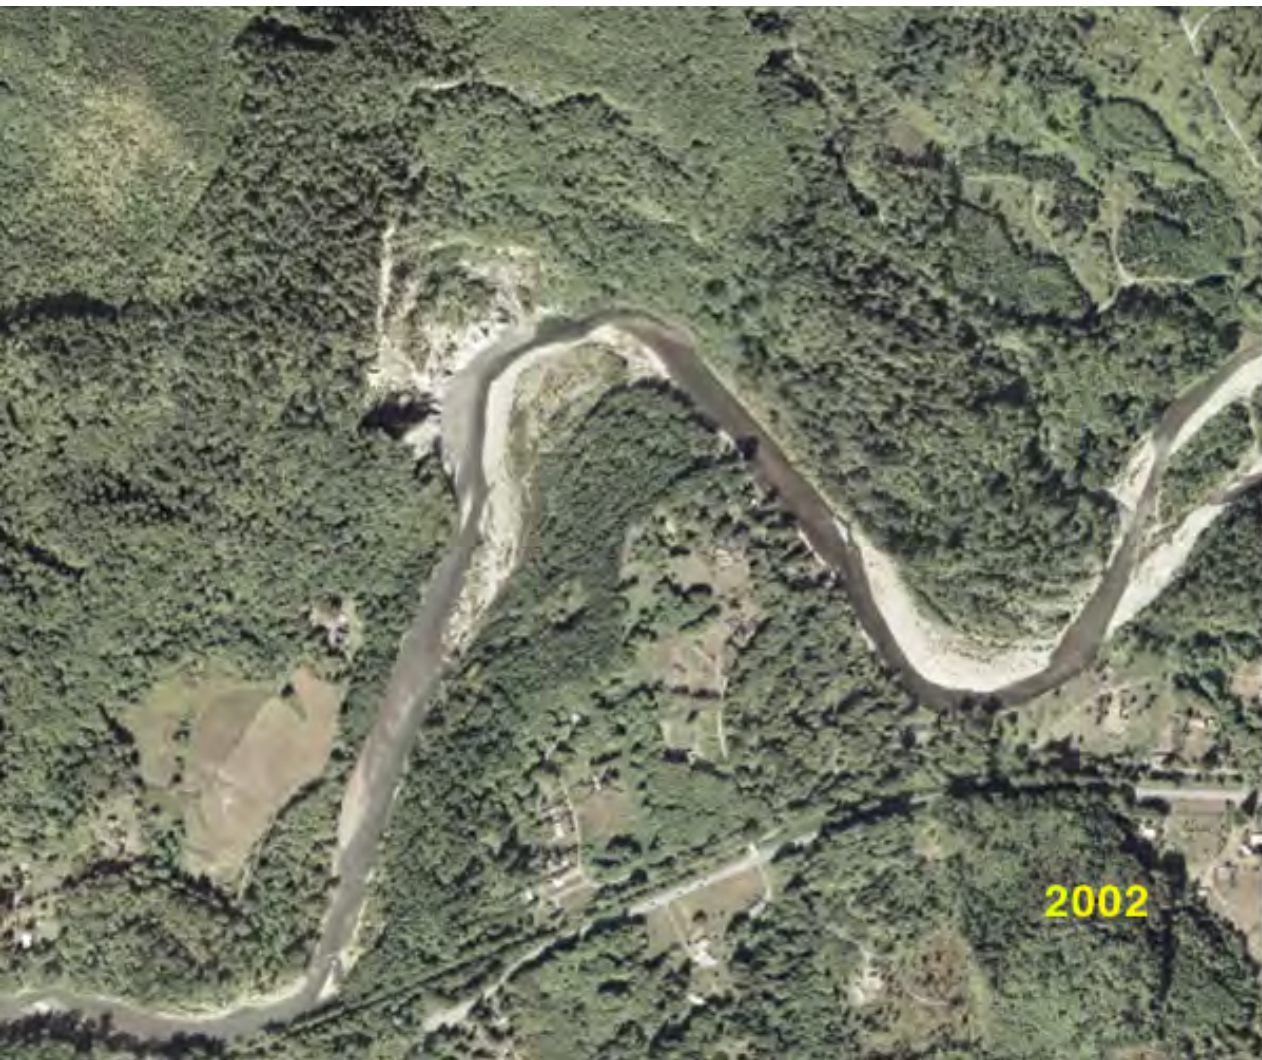
**Whitman Bench**

**Mid-Slope Bench**

**Surface of Rupture**

**Bear Lake Sand**

**2003 Photo Courtesy of Bucky Tart**
