# 2014 Oso Slide

The last 45,000 Years:

*Our*  
Observations and Current Thoughts  
On The

Geology and Failure Development/Causes

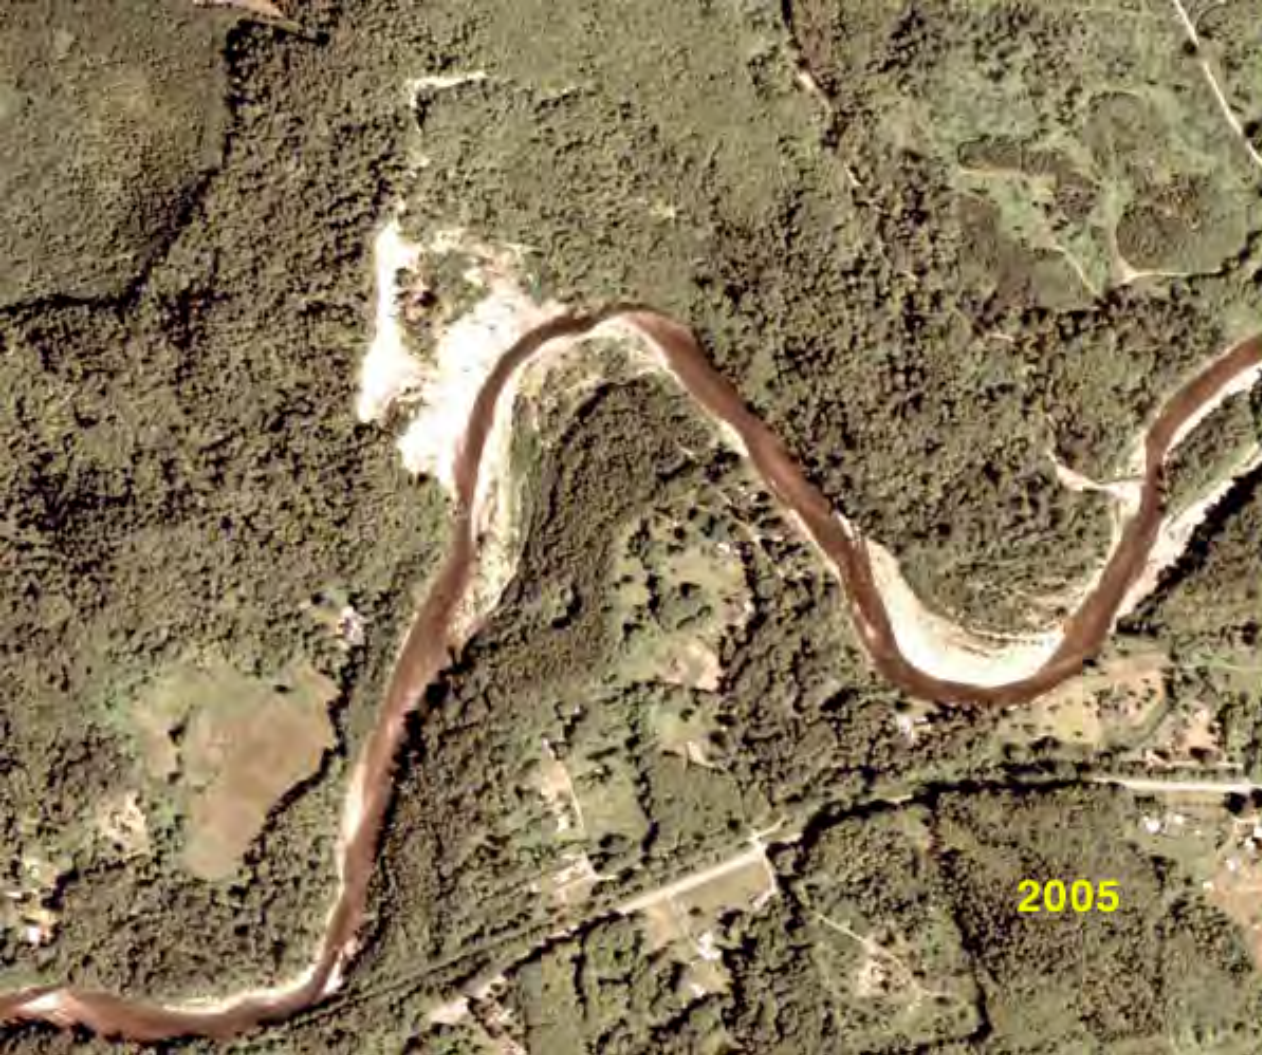
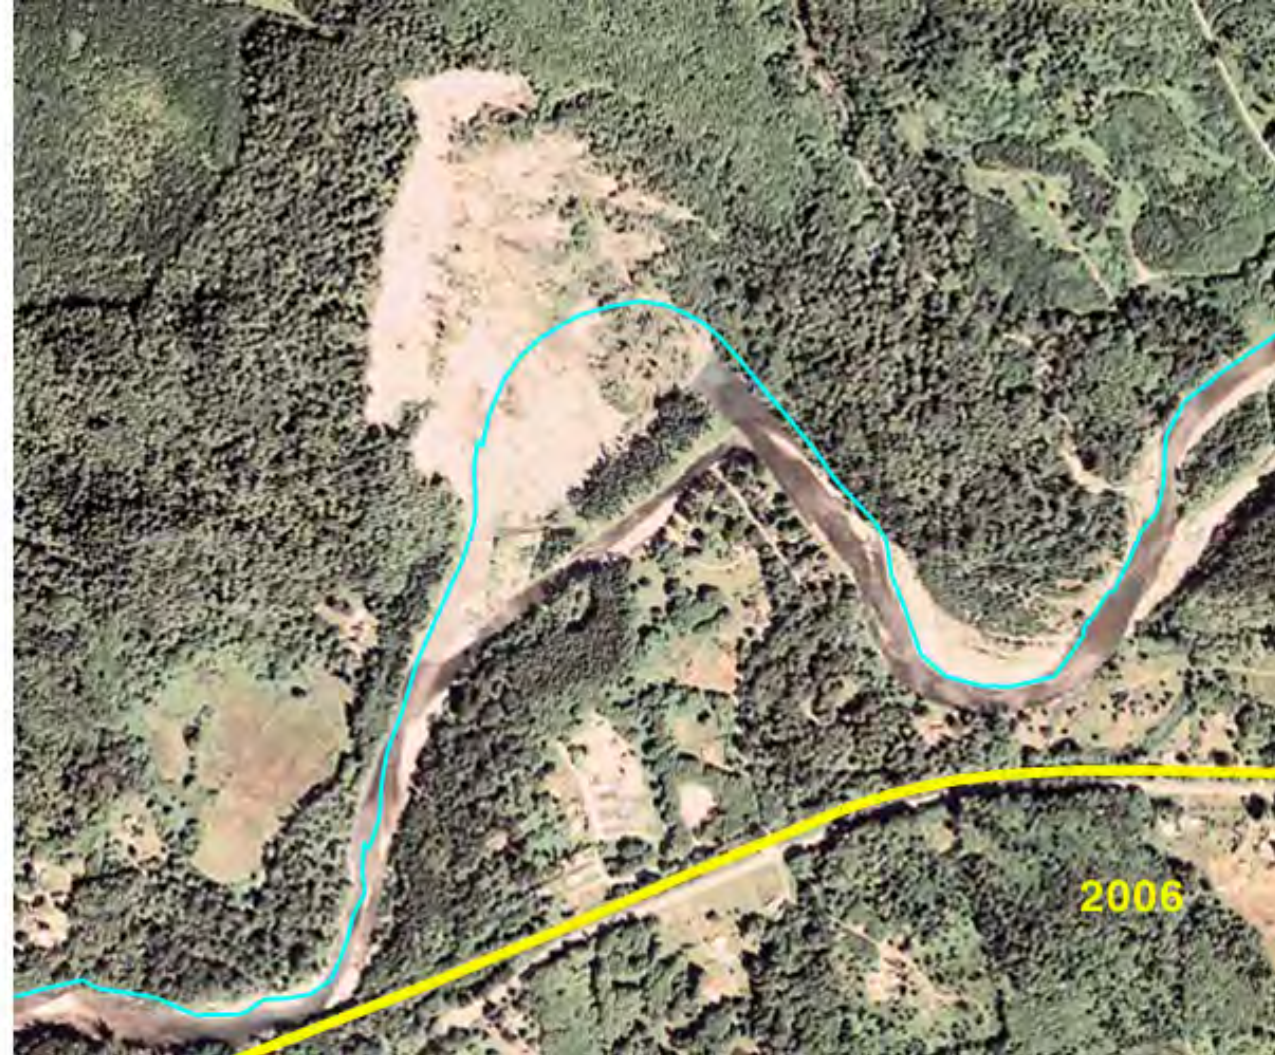
**Whitman bench**

**Mid-Slope Bench**

**2006 Photo Courtesy Bucky Tart**
